Your Inspection Report

5432 Main St
Toronto, ON

Thursday, February 24, 2011

Report No. 24497, v.3

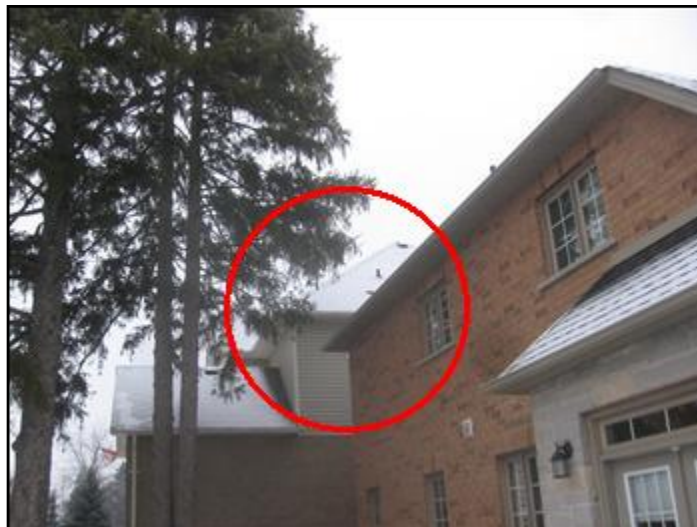
Condition: • [Tree branches rubbing against roof cause wear](#)

Trees will also allow vermin to access roof

Location: Northeast Roof

keep branches trimmed back

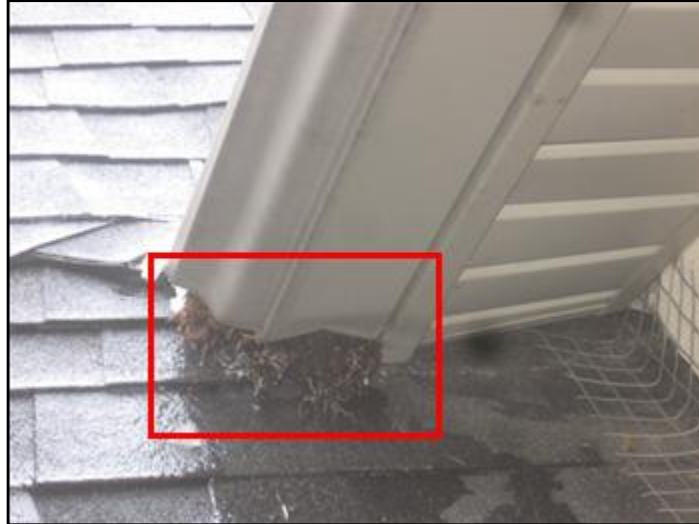
Condition: • [Upper roof draining onto lower roof causes wear](#)

Gutters on dormers are clogged with organic material. As rain water drains through this muck it will stain the shingle covering on the lower roof. Consider re-sloping the small sections of gutter and installing downspouts that drain directly into the lower gutter.

clogged with leaves and debris

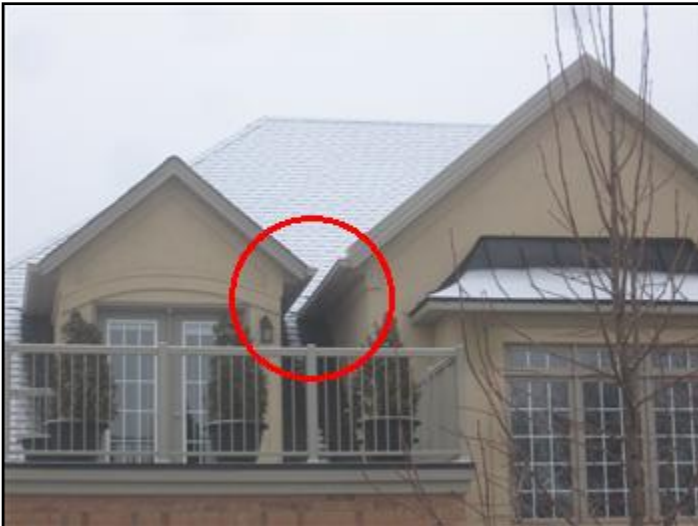
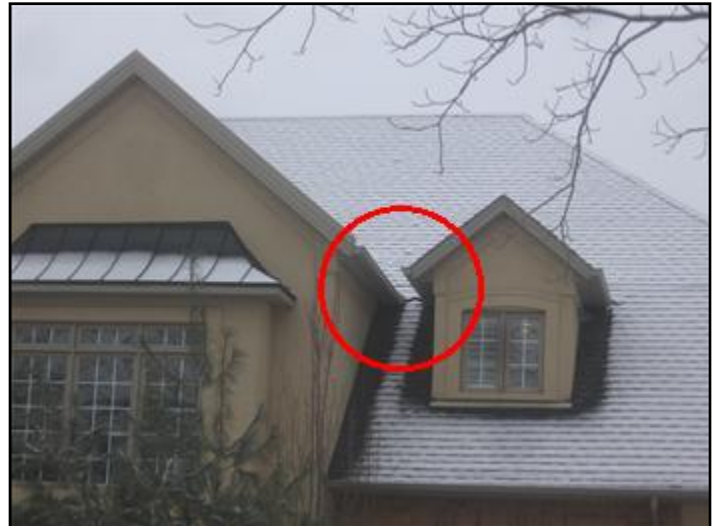
Condition: • [Valleys converging creates a vulnerable area for roof leaks](#)

Small sections of roof between dormer and west peak will see a lot of water and will wear more quickly.

water gets funnelled through a narrow section

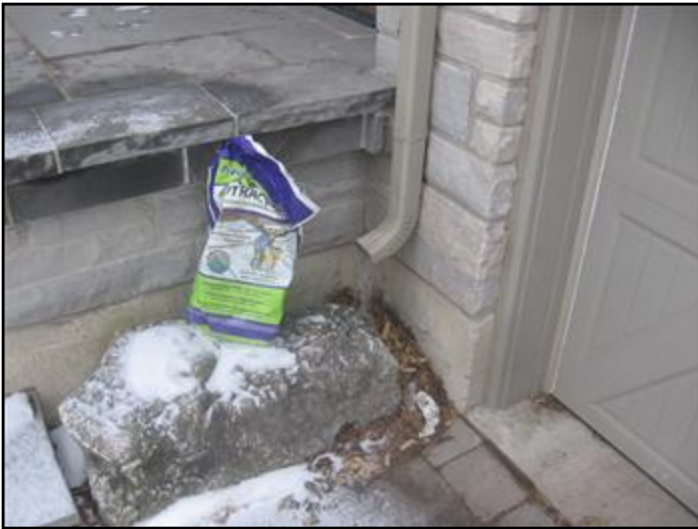
beside garage

Condition: • [Downspout ends too close to home. It should direct water at least 6 feet from building.](#)

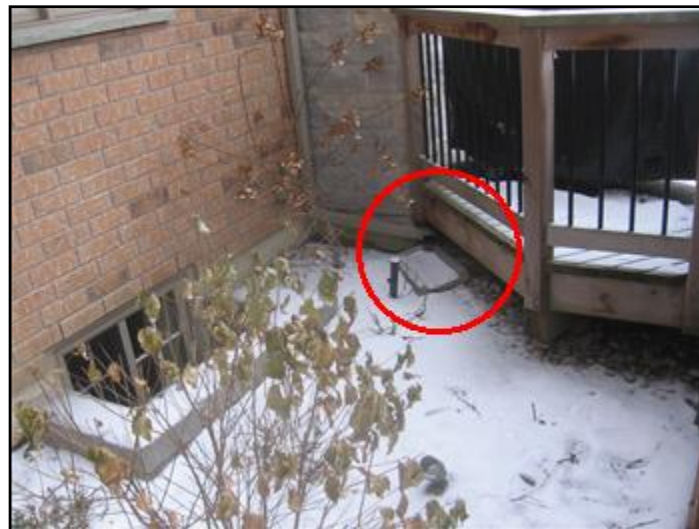
Condition: • [Ends too close to posts supporting porch/deck; provide downspout extension to discharge water at least 6 feet from posts.](#)

provide extension

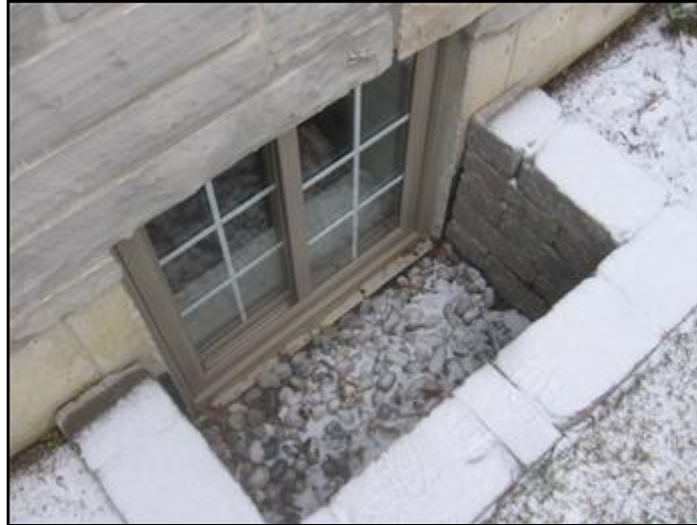
Condition: • Deep window well may be a fall hazard if there are small children in the home. Consider adding a grate if there is a problem.

deep window well

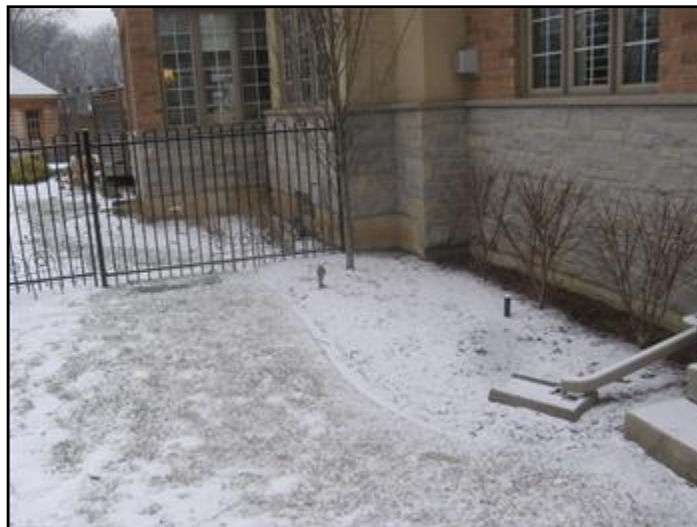
at west side

Condition: • Gardens against the house walls increase the risk of moisture problems in the basement, especially if these are watered regularly. Monitor this and relocate gardens if necessary. Do not over-water gardens.

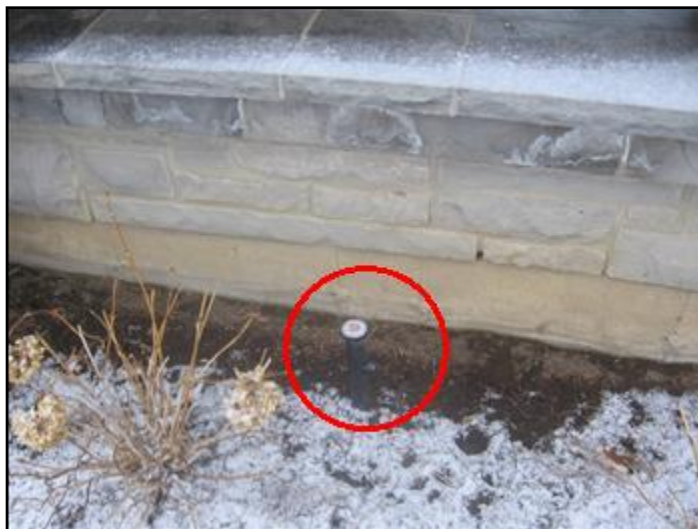
Condition: • Care should be taken with lawn sprinkler systems (irrigation systems). These can wet and damage exterior walls and cause leakage problems into basements and crawlspaces. Water should not be directed against or adjacent to the building.

ensure spray is directed away from house

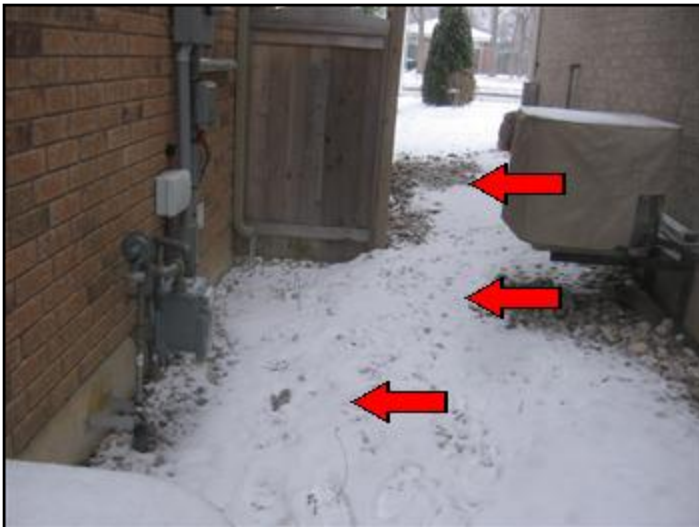
Neighbour has added a lot of material around his home and has created a grading problem towards the back of the house. Your NE downspout now empties into a low area that cannot drain very effectively. Redirecting the downspout will improve conditions but the grading may have to be built up at this corner to create a swale or ditch that will keep water away from the foundation. Pay very close attention to this area during the rainy season to determine if improvements are needed. Building up may be complicated as the gate will have to be modified as well. A landscape architect may have other ideas on how to improve drainage here.

neighbour has built up his side significantly

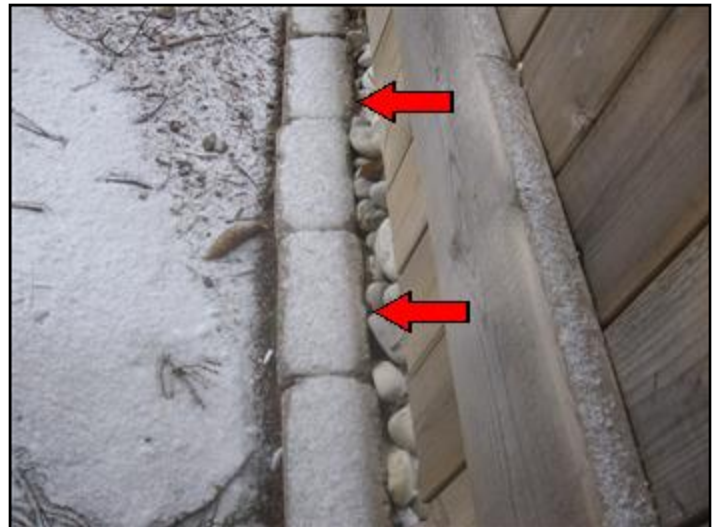
small retaining wall is bowing, leaning

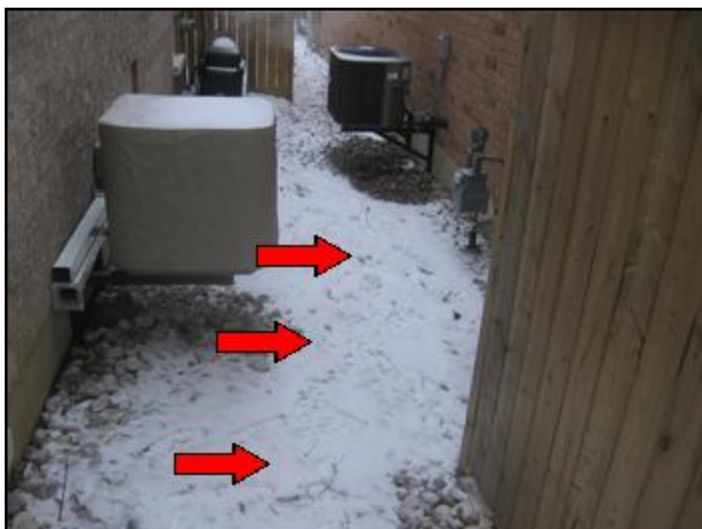
slopes towards house

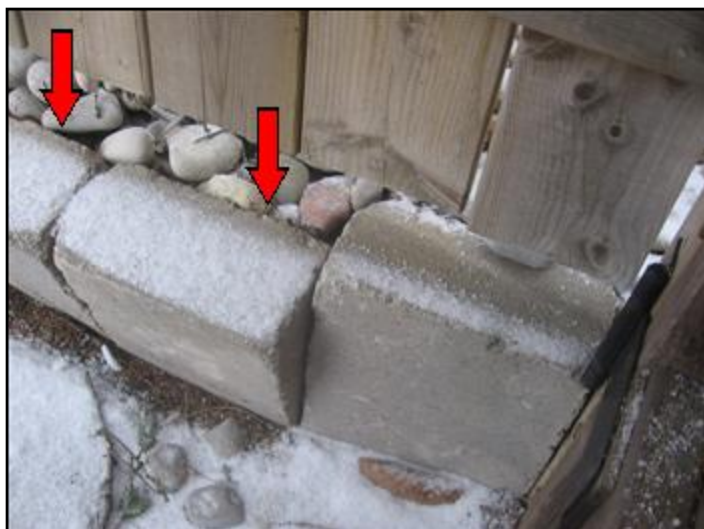
pressure from neighbours landscaping

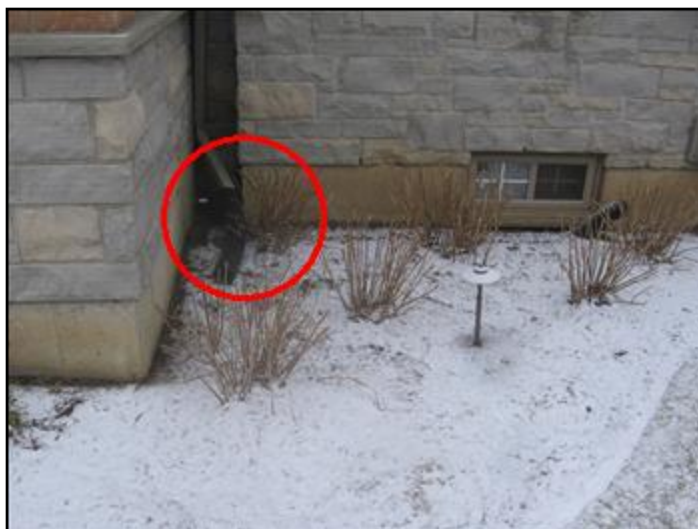
Garden at west side has a small low area that may not drain well. Extend the downspout at this location and monitor drainage.

downspout empties at low area

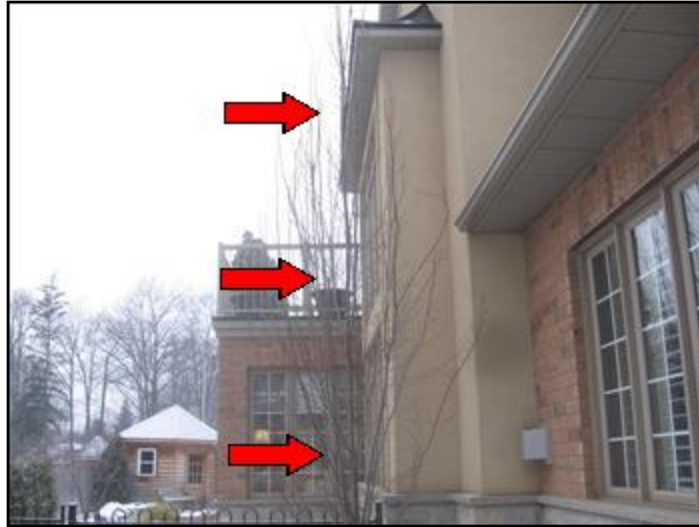
Condition: • [Shrubs/trees too close to building – trimming needed](#)

Small tree is likely providing a means for vermin to access the roof. Removal of the tree is a better solution.

trim branches

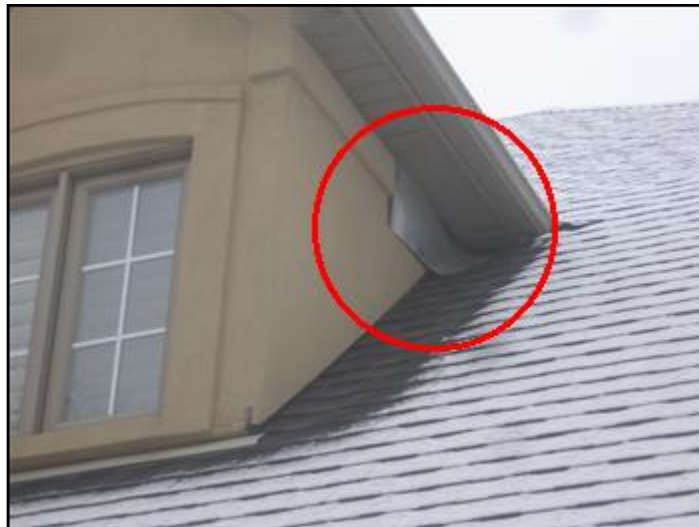
Suspect there is wall and soffit damage behind the sheet metal patch job on the SW dormer.

proper repairs needed

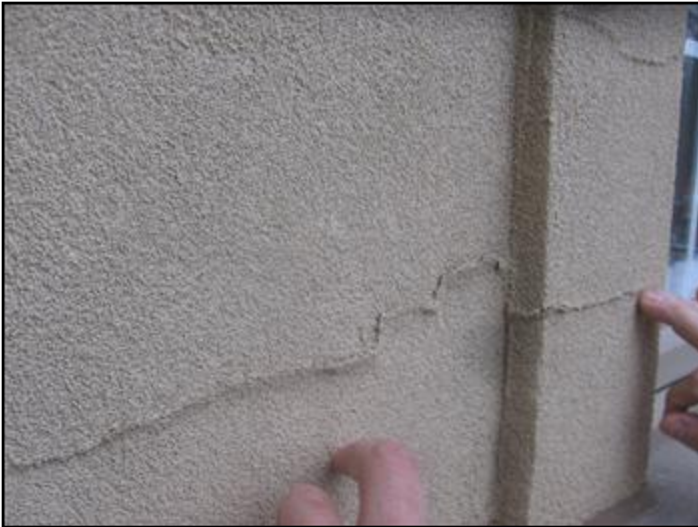
at west wall

Condition: • [EIFS \(synthetic stucco\) - poor finishing details](#)

Some minor cracks will have to be repaired before the material starts to break up.

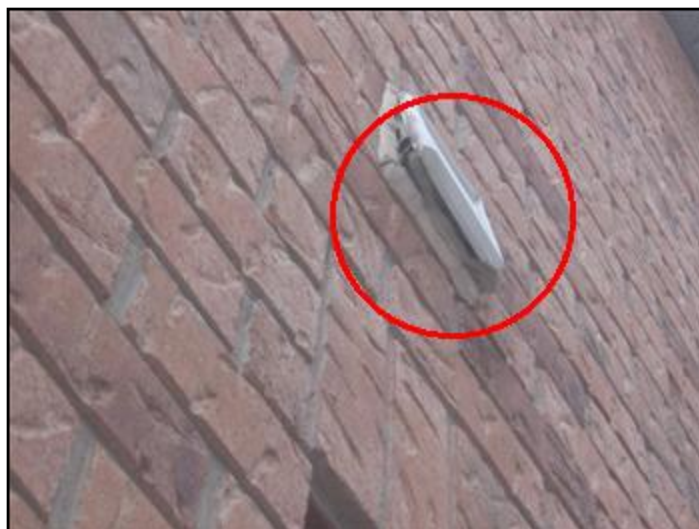
Condition: • [Vent not well sealed](#)

caulking needed

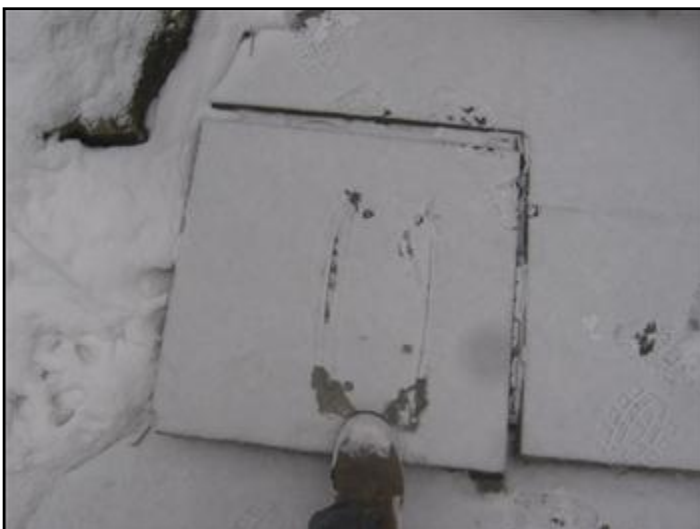
Condition: • [Loose](#)

loose stone

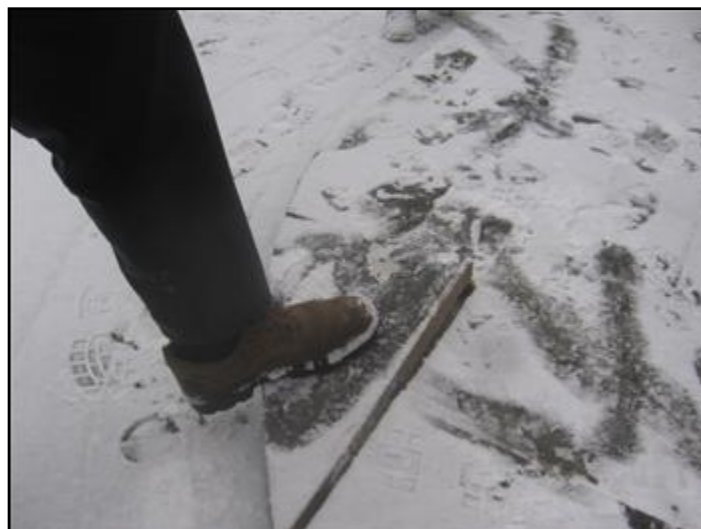
trip hazard

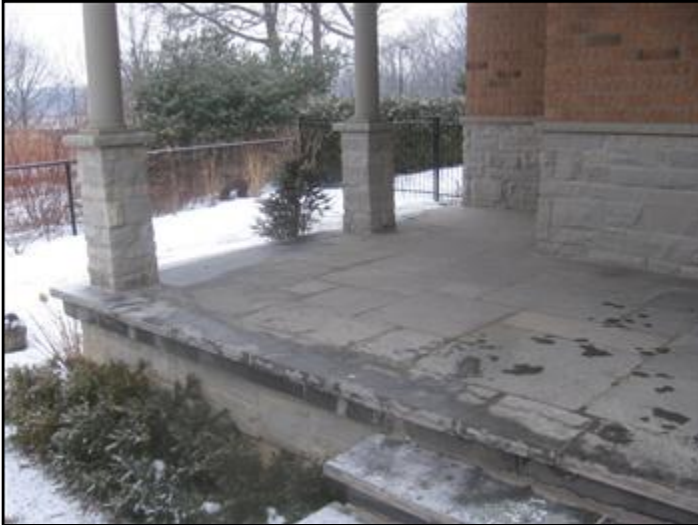
Missing handrail at porch is a fall hazard for small children.

no handrail- fall hazard

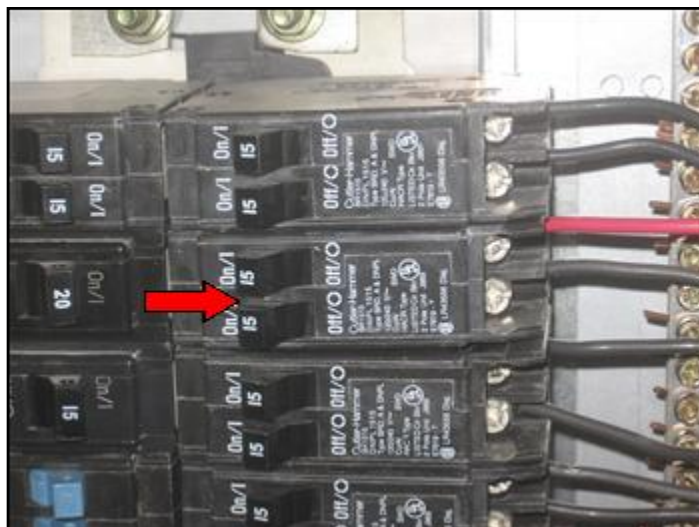
Condition: • [Link missing on multiwire circuit](#)

There are a handful of circuits whose breakers may need to be linked. Find out what is on these circuits and add linking if there is a safety hazard.

linking may be needed

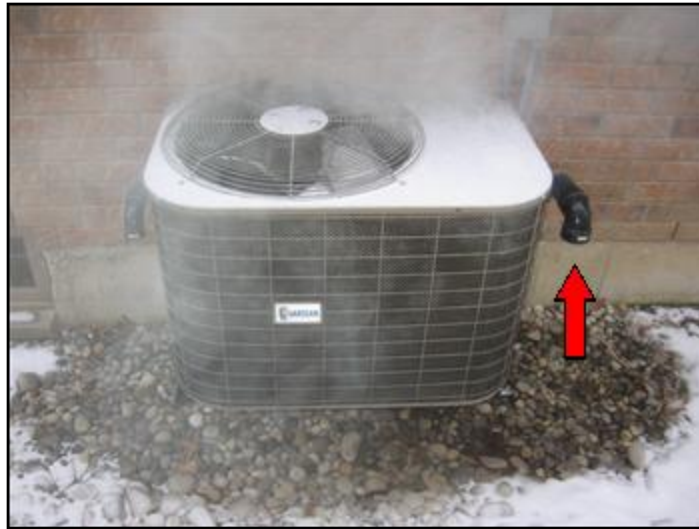
Condition: • [Vent from water heater should be 6 feet from unit](#)

water hater discharge too close

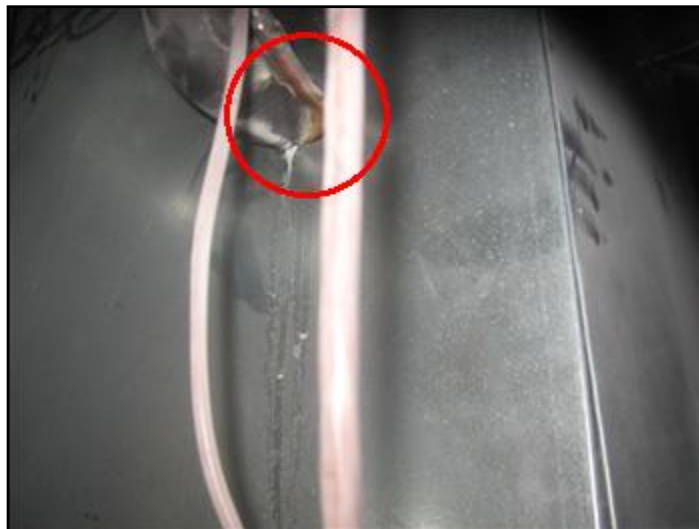
Condition: • [Unsealed gap at plenum](#)

seal to prevent cold air loss

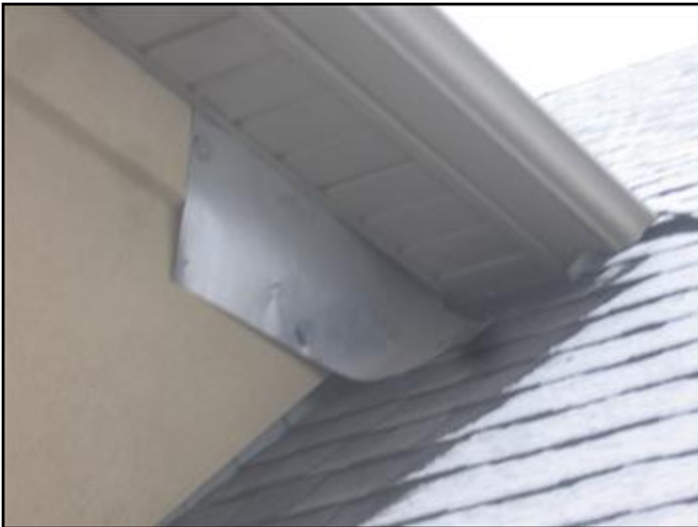
Something has been living in this attic for a long period of time and has compressed all of the insulation.

crude patch job at front dormer- entry site?

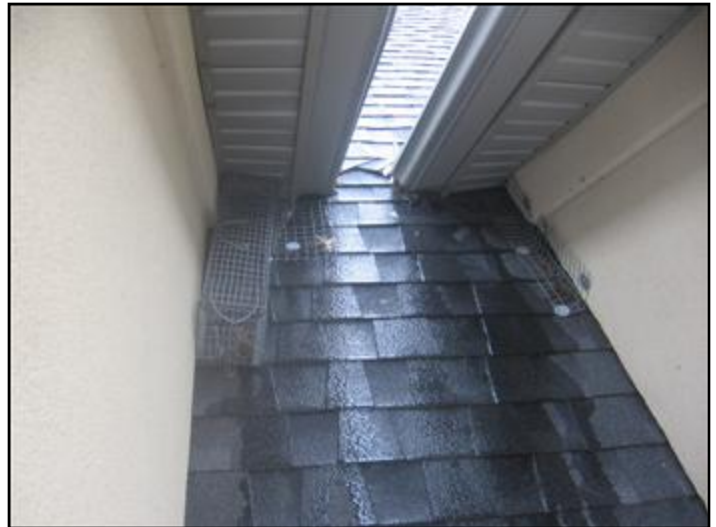
vermin screens at rear soffit

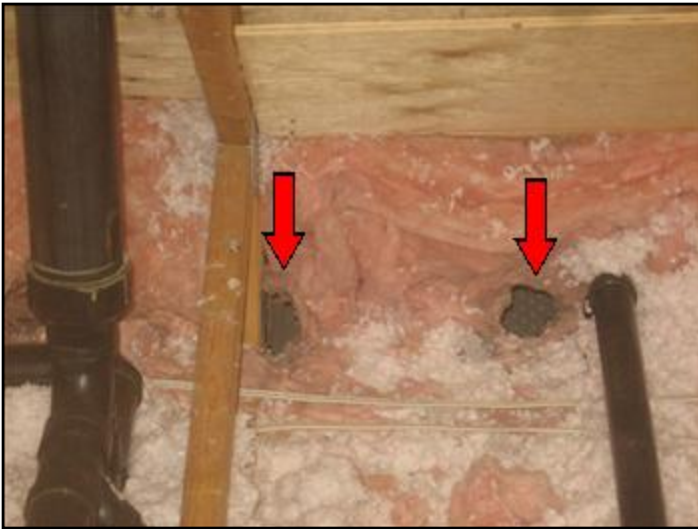
holes through insulation in soffit

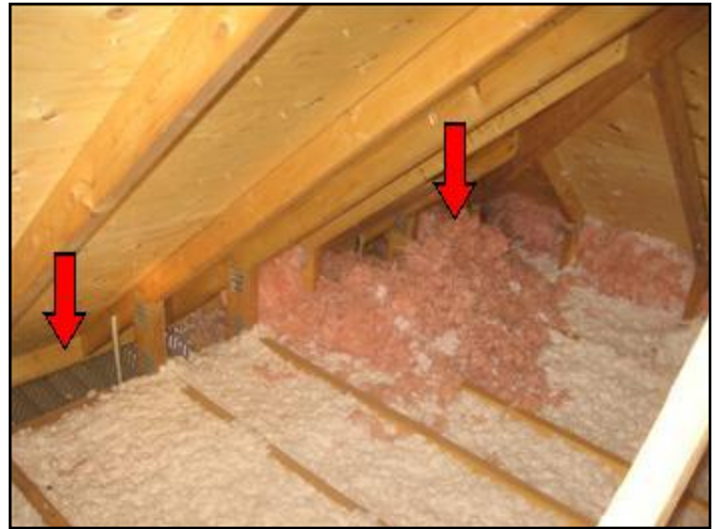
insulation has been moved to make a nest

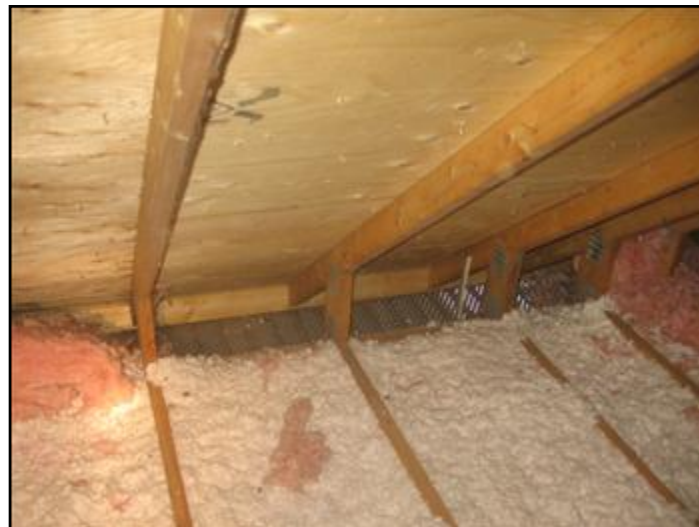
Condition: • [Insulation level below modern standards \(R 40\)](#)

insulation missing (removed) at soffit

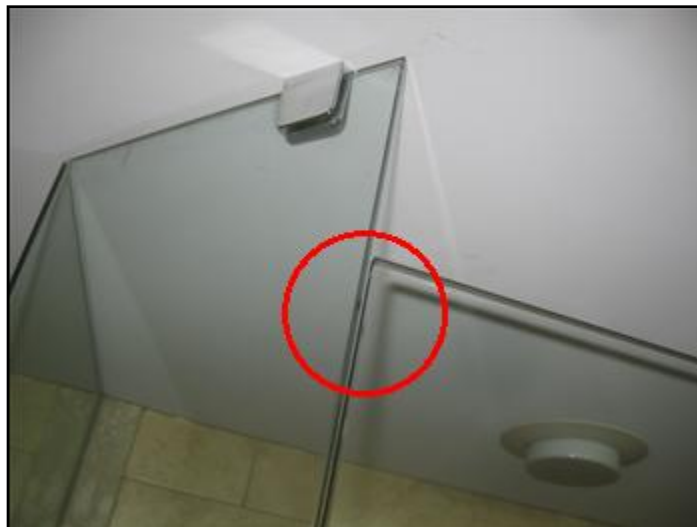
Condition: • [Door does not close tightly](#)

adjustment needed

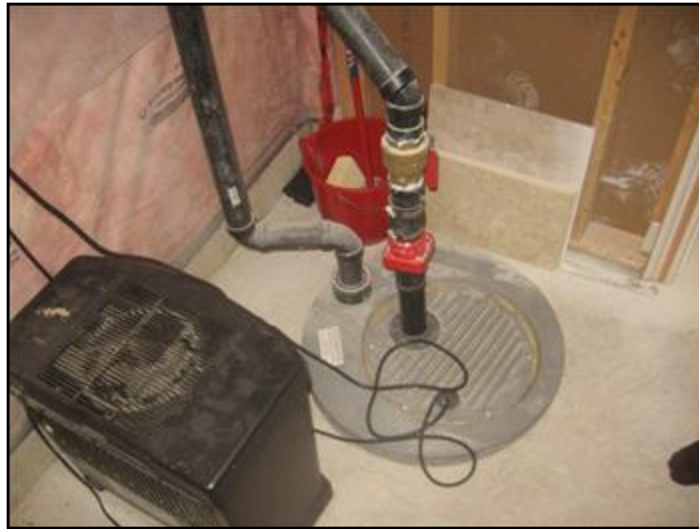
Condition: • Failure of the solid waste pump could cause significant damage. Installation of a high water alarm on this system would be wise.

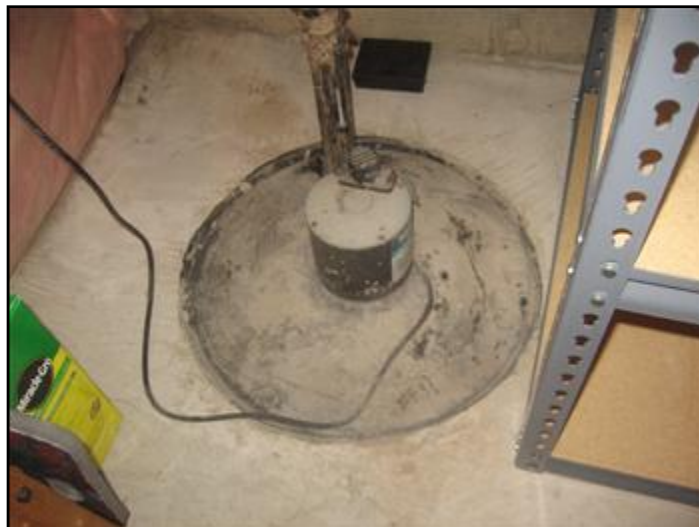
Condition: • Low quality pedestal style pump is not very powerful and prone to failure. Installation of a good quality submersible sump pump is recommended.

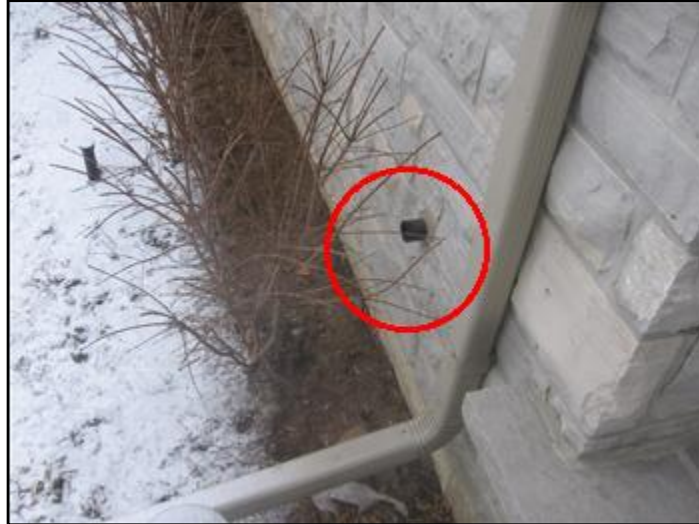
Condition: • [Discharge pipe should extend more than 6 feet away from the foundation](#)

provide extension on discharge pipe

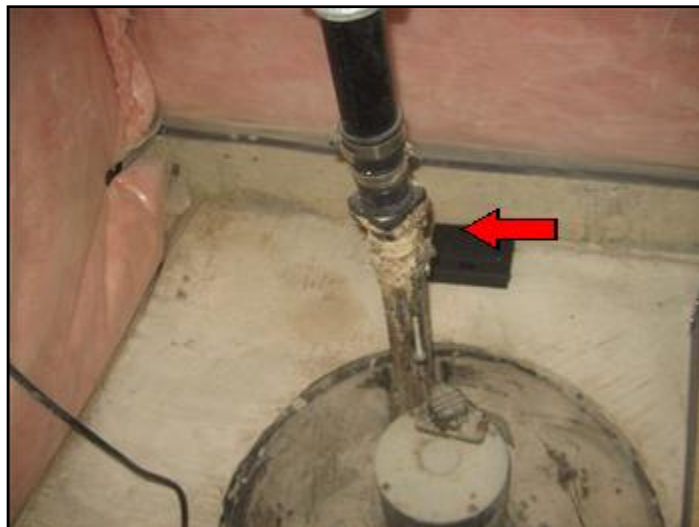
Evidence of previous leakage noted at backflow preventer. Seller may be able to explain when and why repairs were done- ask for details.

previous leakage noted
