# YOUR INSPECTION REPORT

25 Colony Ct  
Dallas, TX

Thursday, August 1, 2019

# PROPERTY INSPECTION REPORT

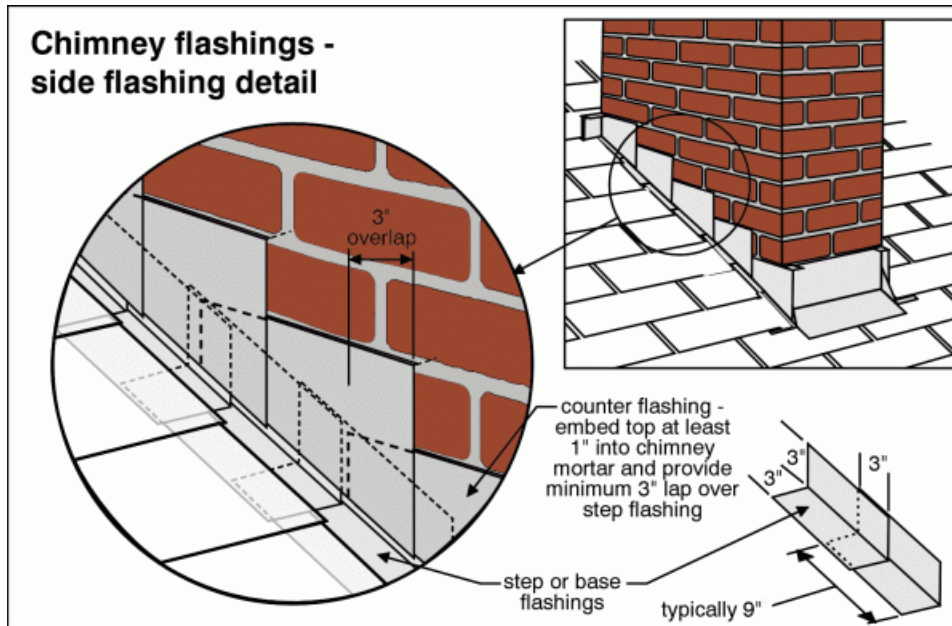
## Chimney flashings - side flashing detail

**1. Condition:** • Missing top, bottom, side flashings

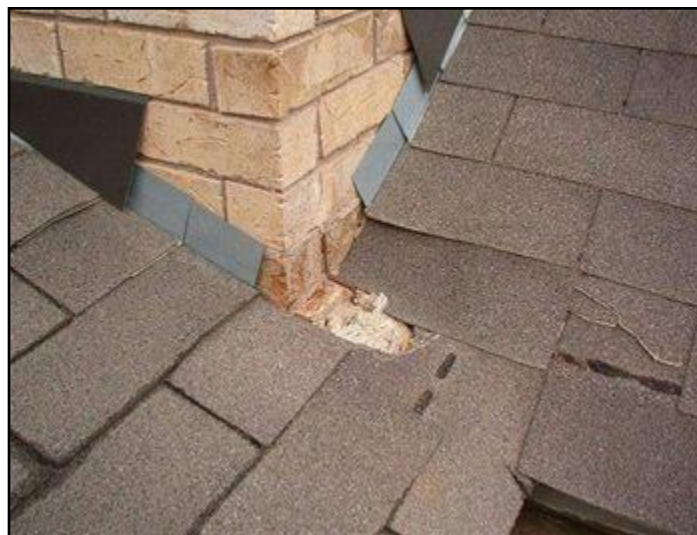
**Implication(s):** Chance of water damage to contents, finishes and/or structure

**Location:** North Second Floor

1. Missing top, bottom, side flashings

**Task:** Correct

**Time:** Immediate

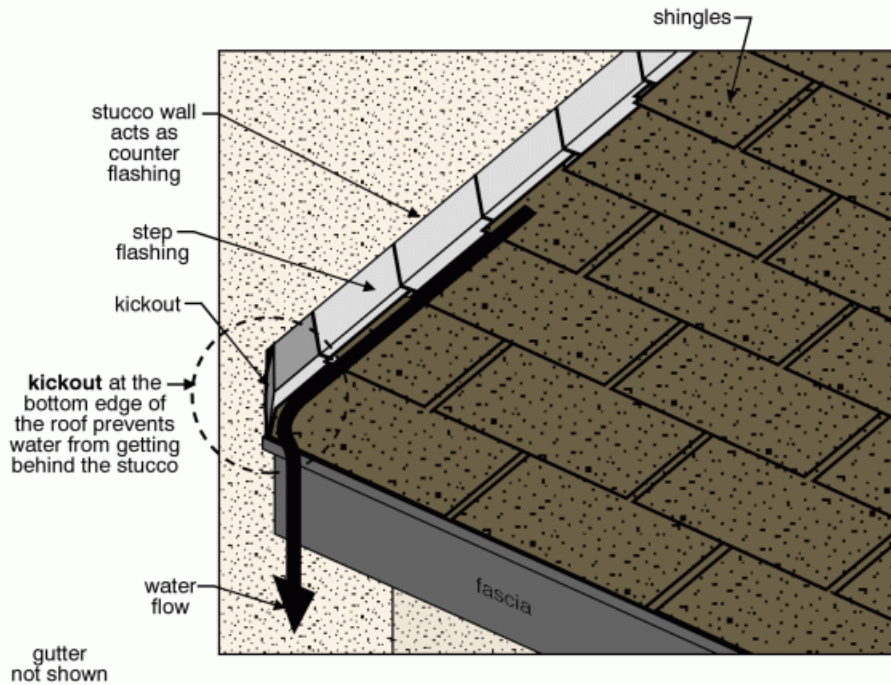
## Kickout prevents siding/wall damage

2. **Condition:** • Kickout flashing - missing

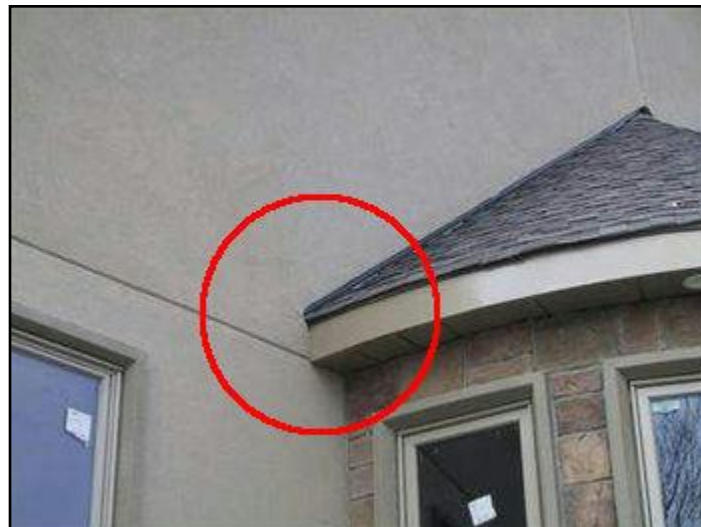
**Implication(s):** Chance of water damage to contents, finishes and/or structure

**Location:** North First Floor

2. No kickout flashing

**Task:** Improve

**Time:** Less than 1 year

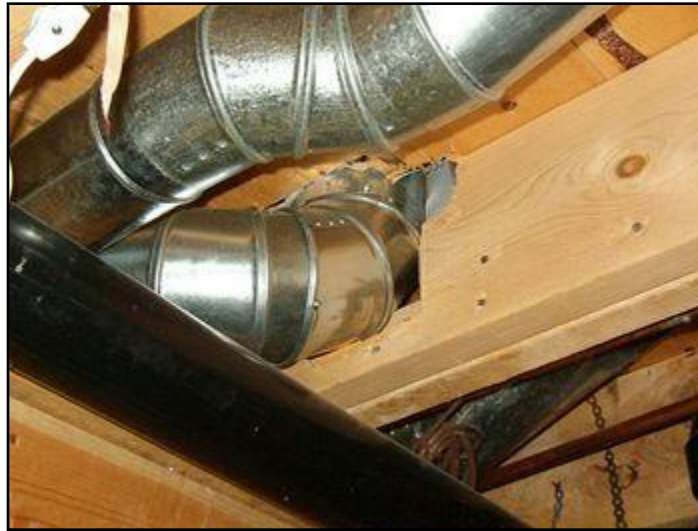
**4. Condition:** • Notches or holes

**Implication(s):** Weakened structure

**Location:** West

3. Notches or holes

**Task:** Replace

**Time:** Immediate

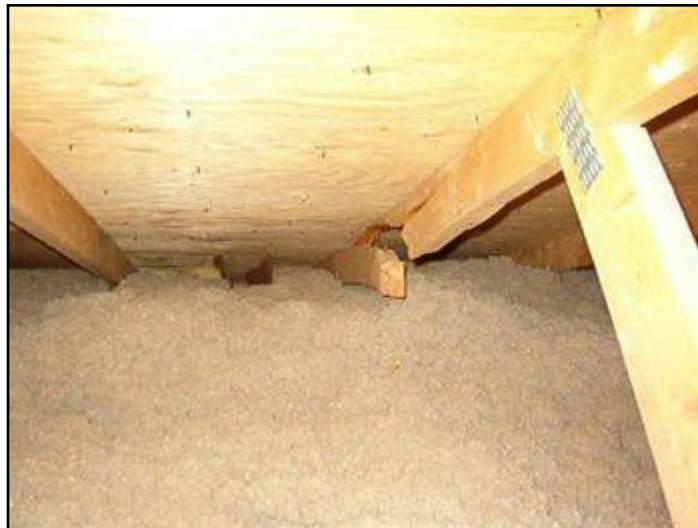
**5. Condition:** • Split

**Implication(s):** Weakened structure | Chance of structural movement

**Location:** Northwest Attic

4. Split

**Task:** Repair or replace

**Time:** Immediate

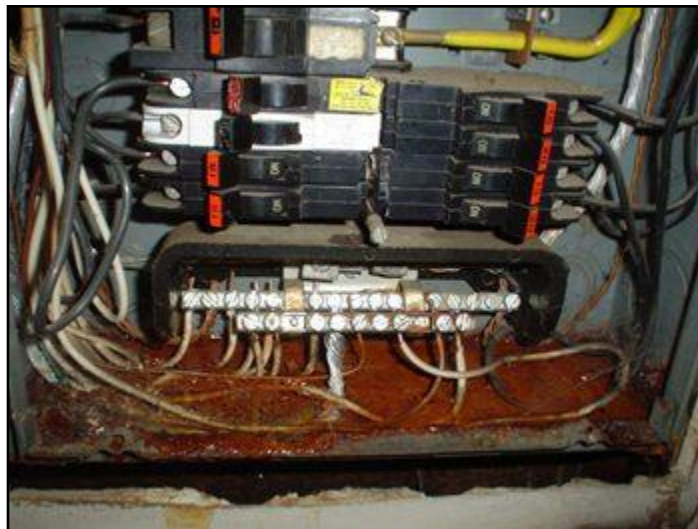
**6. Condition:** • Rust or water in panel

**Implication(s):** Fire hazard | Electric shock

**Location:** North Utility Room

5. Rust or water in panel

**Task:** Replace

**Time:** Immediate

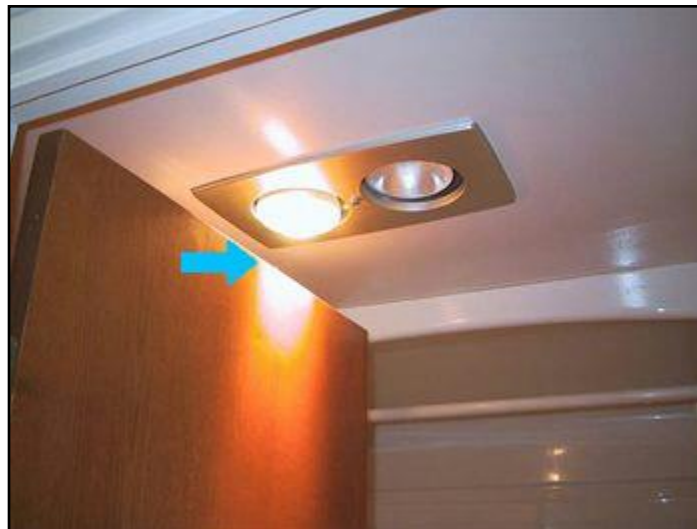
**7. Condition:** • Heat lamps over doors

**Implication(s):** Fire hazard

**Location:** East Second Floor Bathroom

6. Heat lamps over doors

**Task:** Correct

**Time:** Immediate

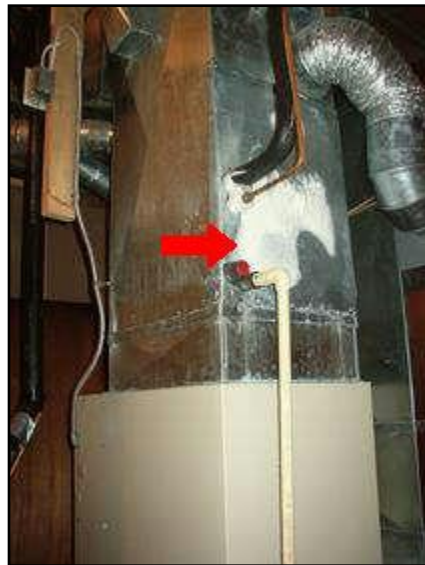
**9. Condition:** • Frost

**Implication(s):** Reduced comfort | Increased cooling costs

**Location:** Utility Room

7. Frost

**Task:** Service

**Time:** Immediate

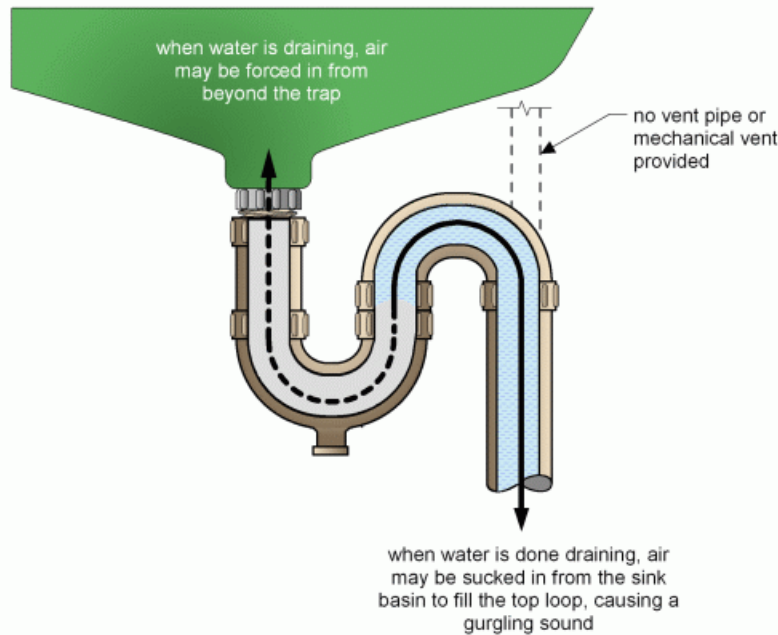
## S-traps can lead to siphoning

**11. Condition:** • Nonstandard shape or material  
 This unusual configuration is prone to clogging.  
**Implication(s):** Fixtures slow to drain | Reduced operability  
**Location:** Laundry Area  
**Task:** Improve  
**Time:** Less than 1 year

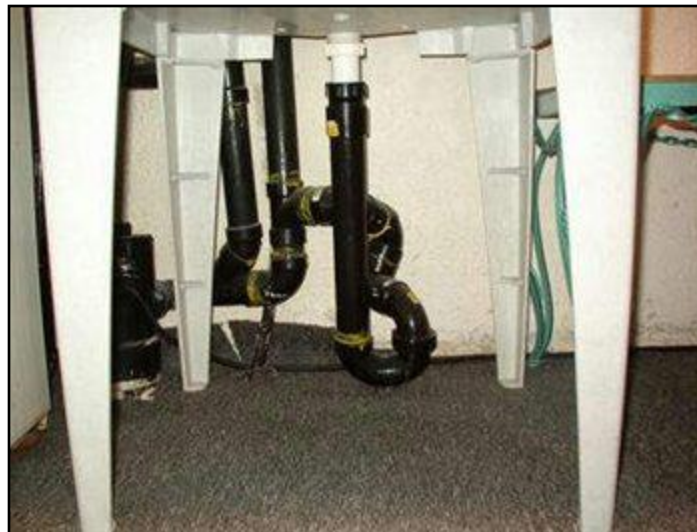
8. Nonstandard shape or material

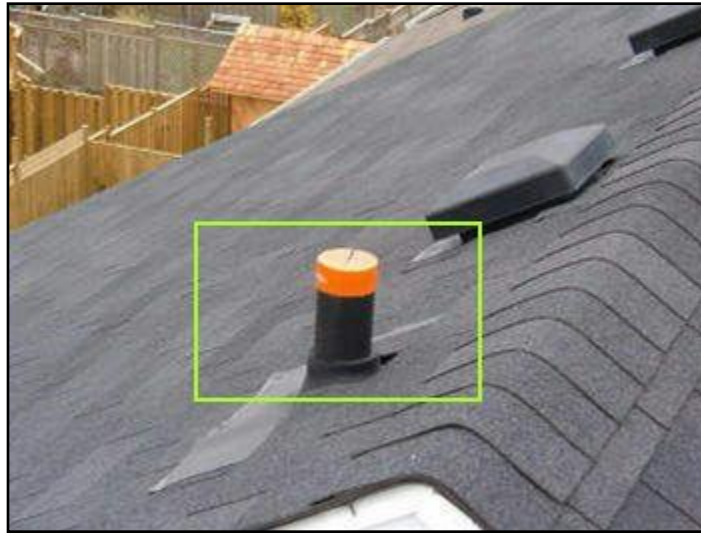
**12. Condition:** • Vent termination problems

**Implication(s):** Reduced operability | Sewer gases entering the building

**Location:** West central part of roof

9. Vent termination problems

**Task:** Remove cap

**Time:** Immediate

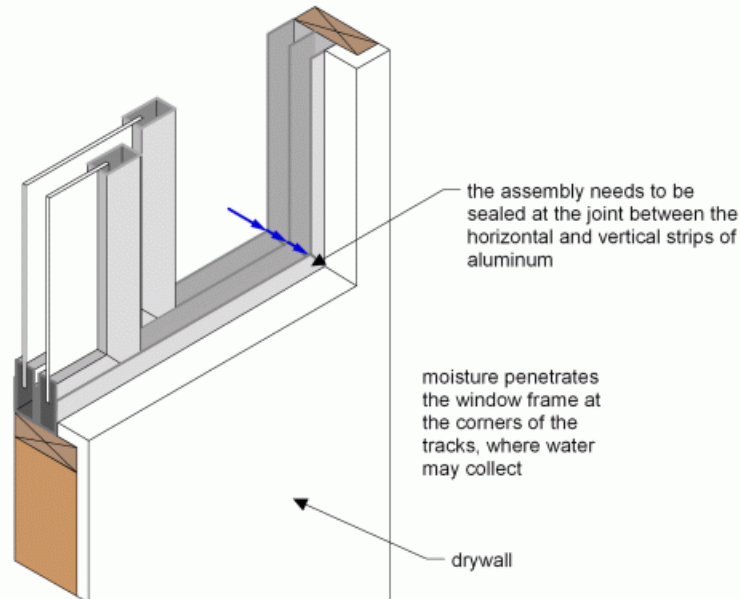
## Leaking corner of older vinyl or aluminum frame window

**14. Condition:** • Water leaks

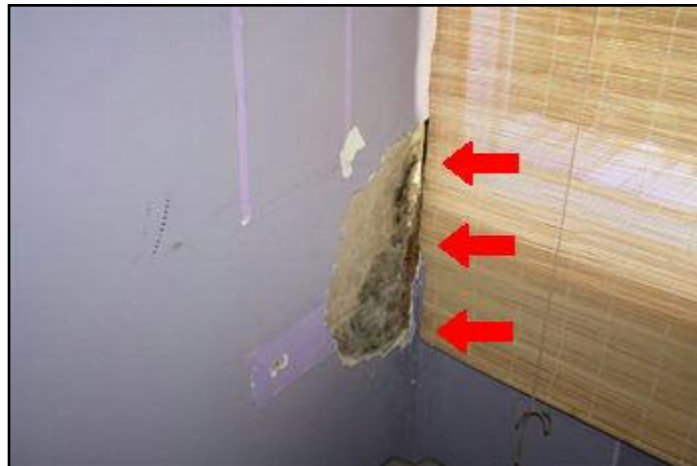
Evidence of leakage was noted at the bottom of one window. A moisture meter indicated the area was not wet at the time of the inspection. The situation should be monitored, and repairs may be necessary if leakage occurs.

**Implication(s):** Chance of damage to structure | Chance of damage to finishes and structure

**Location:** East Second Floor Bedroom

10. Water leaks

**Task:** Monitor

**Time:** Ongoing
