Your Inspection Report

2027 St. John Street
Oshawa, ON L1J 8C1

INSPECTION DATE:
Tuesday, August 27th, 2019

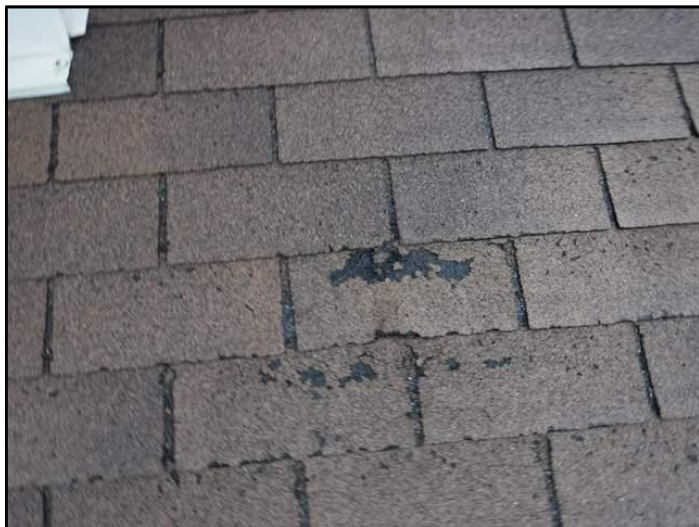
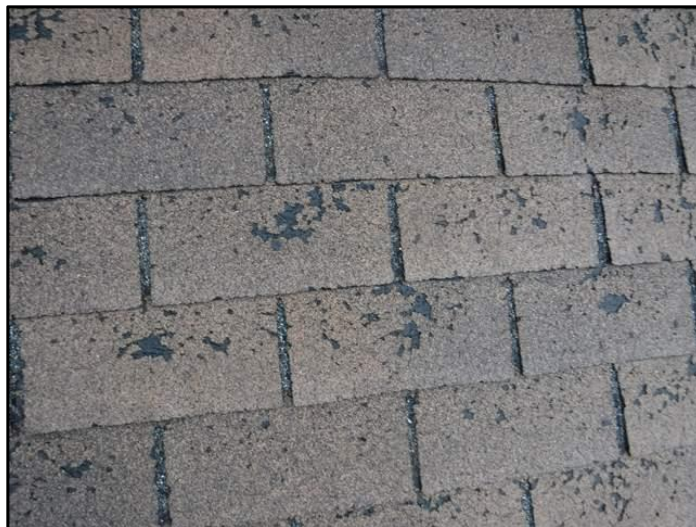
Notes: The south (front) facing portion of the roof is older than the north (rear) facing portion. The south facing is showing signs of granular loss, cupping and damage. Maintenance and annual check-up will be required but plan on replacing within 3 years.

Implications: Chance of water damage to contents, finishes and/or structure

Near end of life expectancy

Task: Replace

Time: Less than 3 years

Cost: \$2,500 - \$5,000

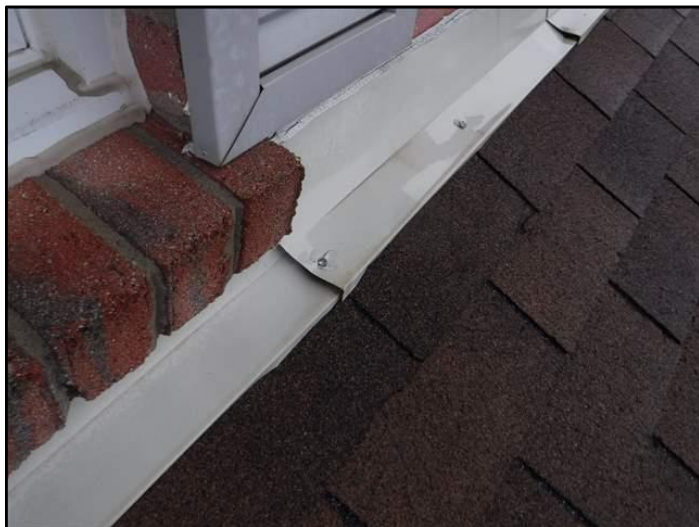
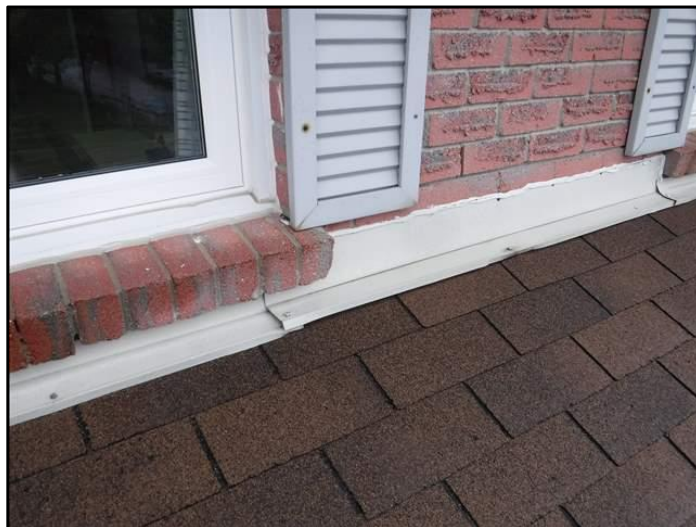
Notes: Loose areas.**Implications:** Chance of water damage to contents, finishes and/or structure**Location:** Various**Task:** Improve**Time:** When re-roofing/re-shingling

Inspect & repair, as needed.

Inspect & repair, as needed.

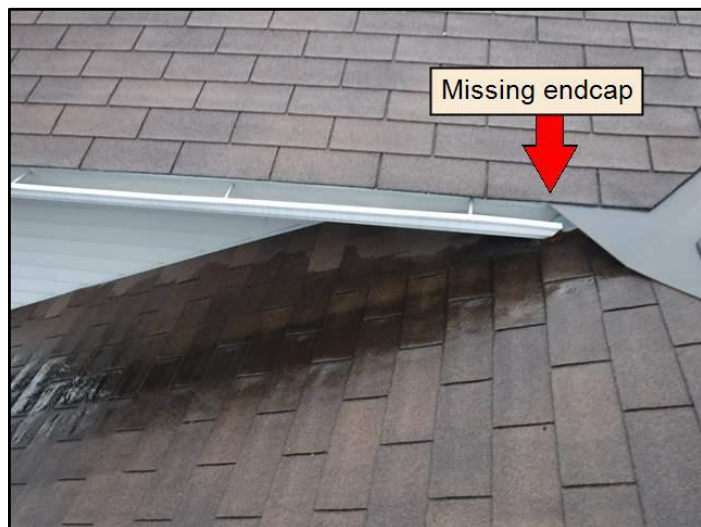
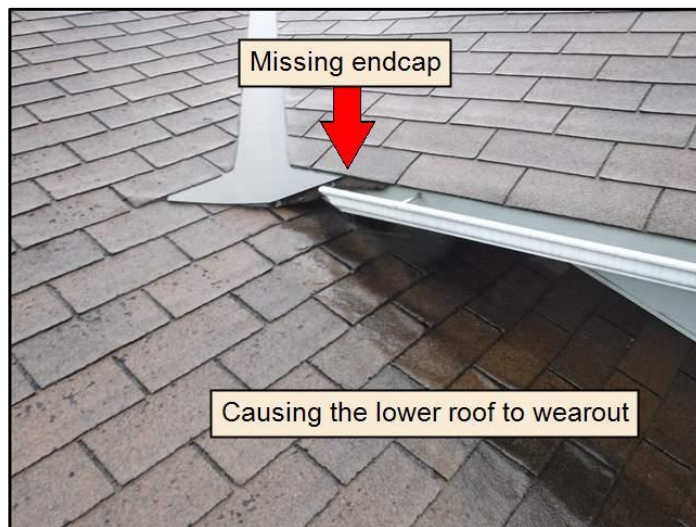
Implications: Chance of water damage to contents, finishes and/or structure

Rear - Discharge onto roofs

Front - Discharge onto roofs

Notes: Add a downspout from upper to lower gutters to reduce "wear" of the lower roof.

Time: As soon as possible

Cost: Minor

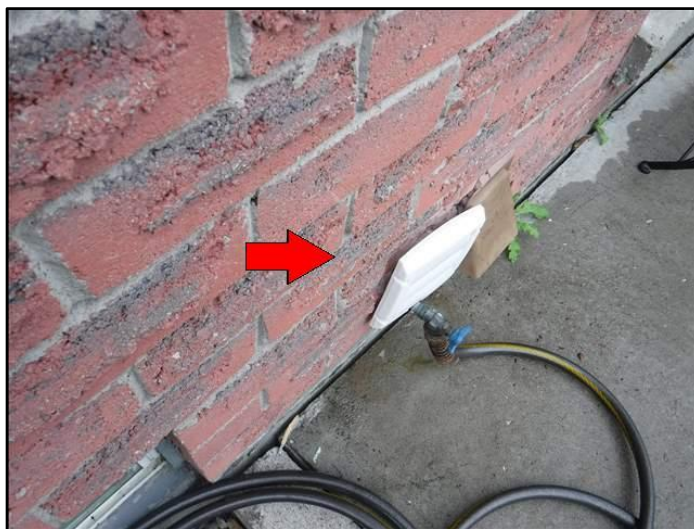
Cover damaged

Notes: Install correctly and seal around the edge.**Implications:** Increased operating costs**Location:** Rear**Task:** Correct**Time:** As soon as practical**Cost:** Minor

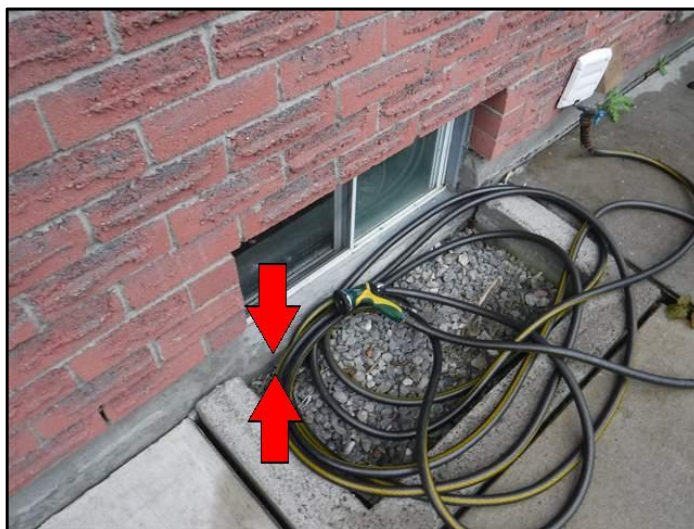
Window close to grade in well.

Increase threshold height by lowering well depth.

Location: Rear**Task:** Improve**Time:** Less than 2 years**Cost:** Minor

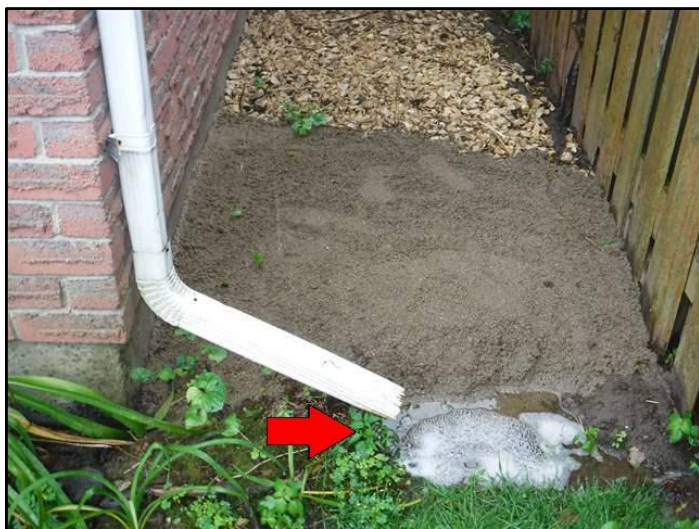
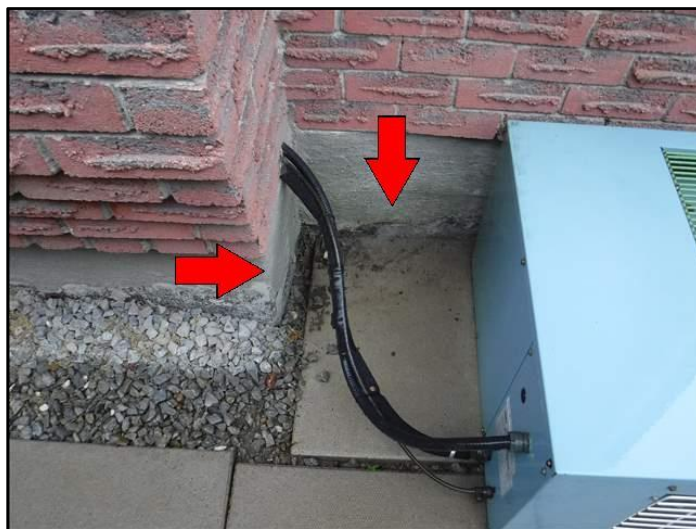
Improper slope or drainage

Implications: Chance of water damage to contents, finishes and/or structure

Low area.

Notes: When trying to minimize basement leakage, it is always best to be proactive and slope the grading away from the house. Maintain positive slope away from house.

Time: As soon as possible

Cost: Minor

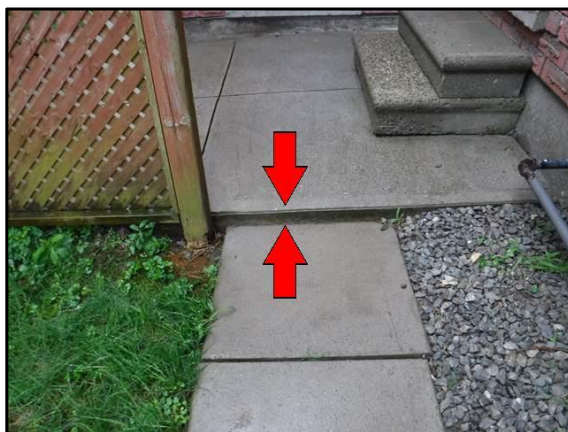
Uneven (trip hazard)

Implications: Physical injury**Location:** East**Task:** Correct**Time:** As soon as practical**Cost:** Depends on approach

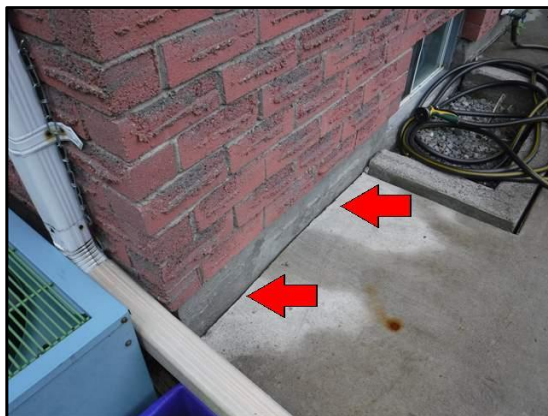
Unsealed gap at building

Notes: Check annually where the cement walk and the foundation wall meet. Ensure gap is sealed and maintained to prevent potential of water penetration.**Implications:** Chance of water damage to contents, finishes and/or structure**Location:** East / Rear**Task:** Inspect annually**Time:** Regular maintenance**Cost:** Minor

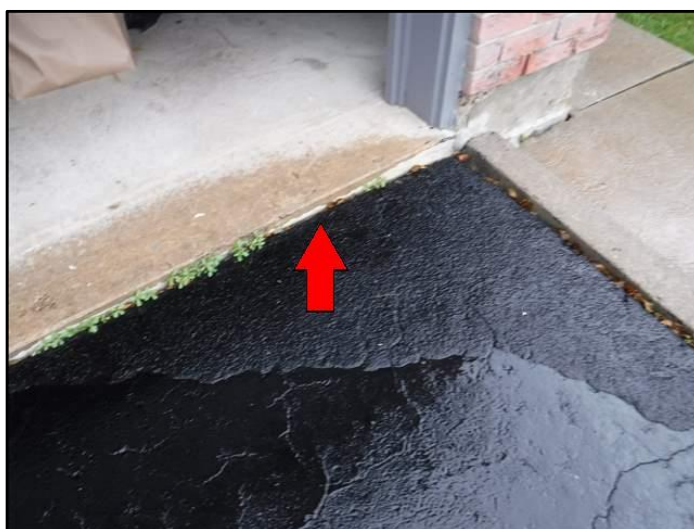
Uneven (trip hazard)

Notes: Appears the driveway has settled (as expected). Resurface when required (\$1000+) or repair locally area only (minor cost).

Time: As soon as practical

Cost: Depends on approach

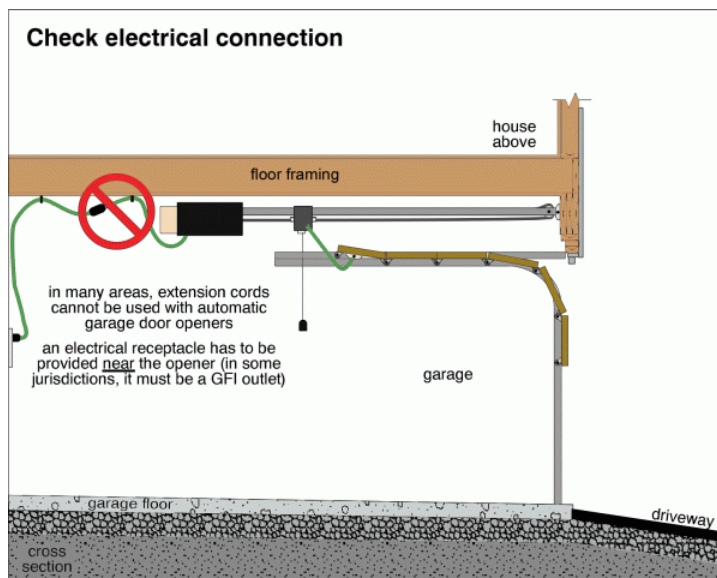
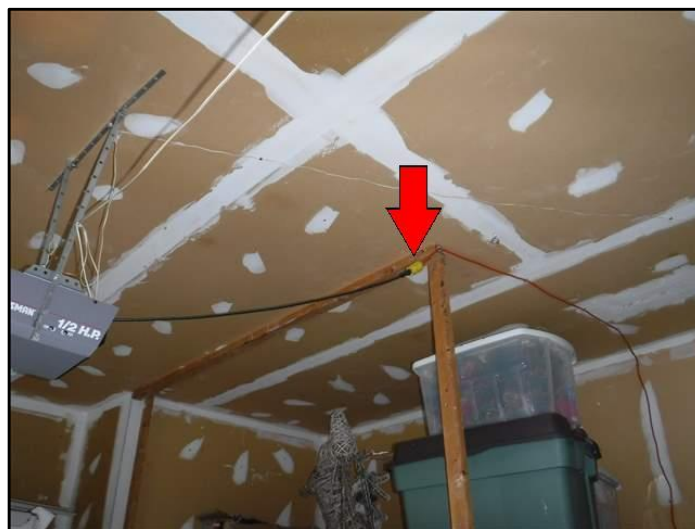
Extension cord for opener

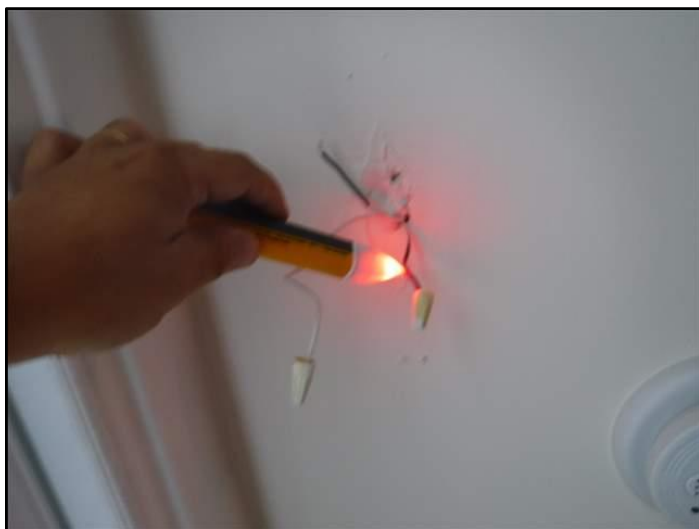
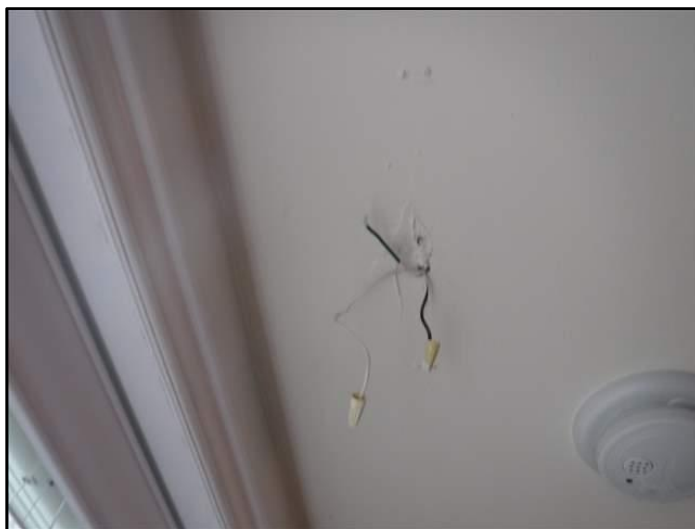
Missing

Implications: Electric shock | Fire hazard

Time: As soon as possible

Cost: Minor

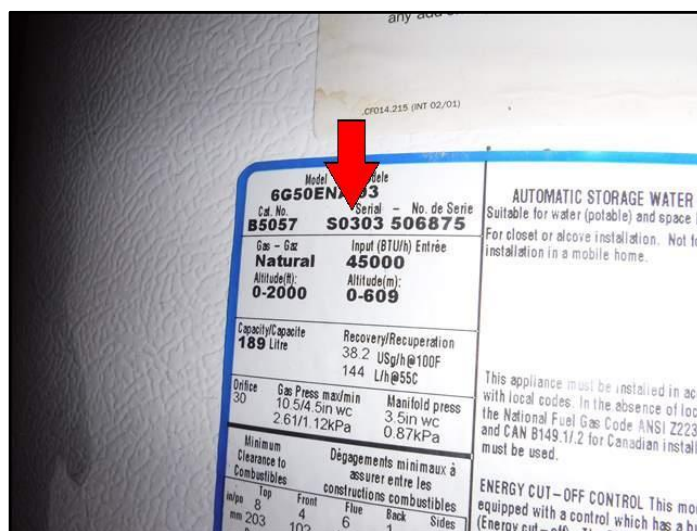
16 years ('03)

Notes: Some insurance companies ask that the unit be replaced due to its age and because the basement is finished. The goal is to prevent water damage due to tank failure.

Task: Replace

Time: Unknown, unless insurance company requires that it be replaced immediately

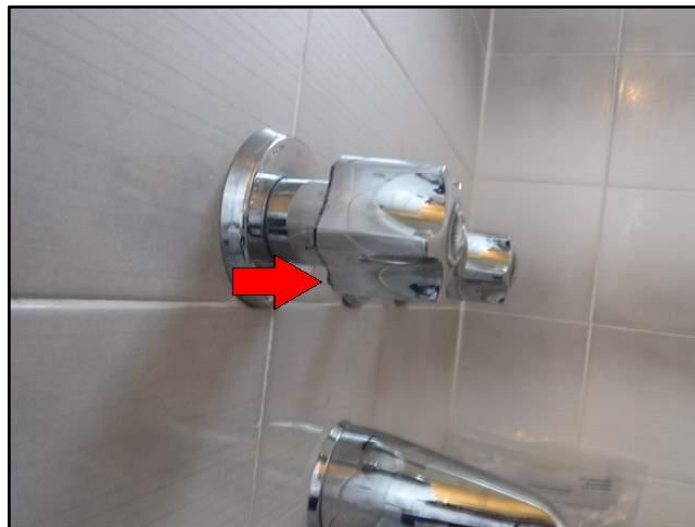
Location: Second Floor Bathroom

Leak

Implications: Chance of water damage to contents, finishes and/or structure | Sewage entering the building

Leak - hot water

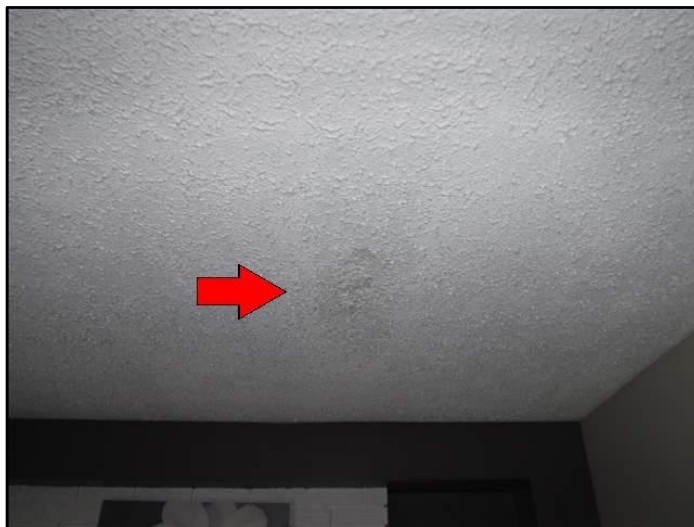
Location: Under Second Floor Bathroom

Implications: Chance of damage to contents, finishes and/or structure

Patched
