INSPECTION REPORT

443 Madison St.
Chicago, IL

INSPECTION DATE:
Thursday, March 1, 2018

RE: Report No. 3284
443 Madison
Chicago, IL

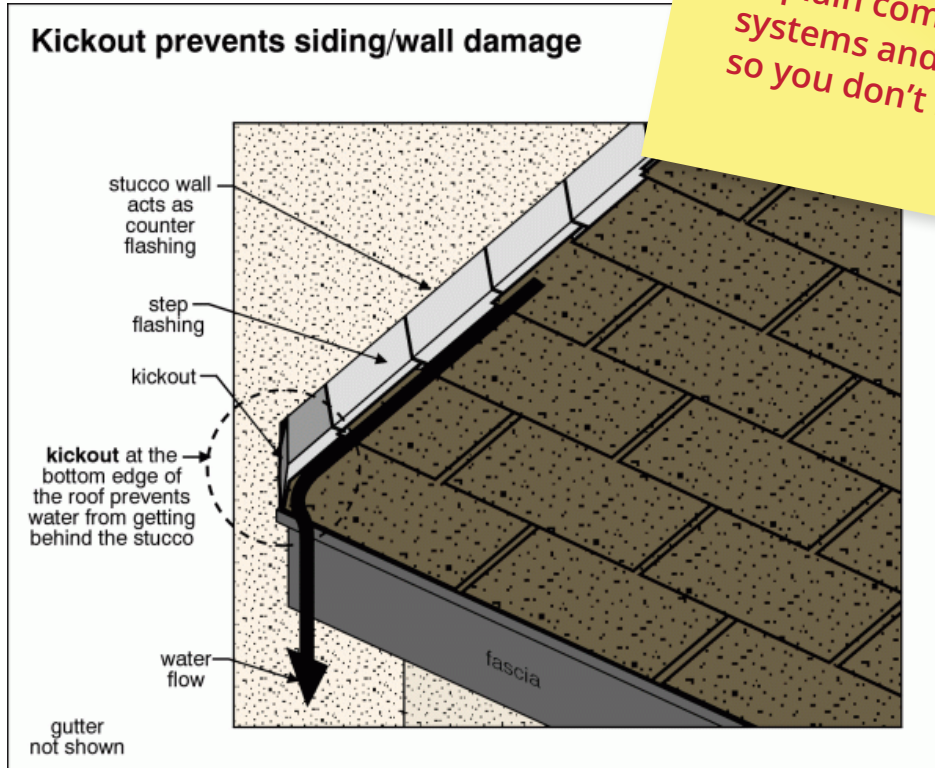
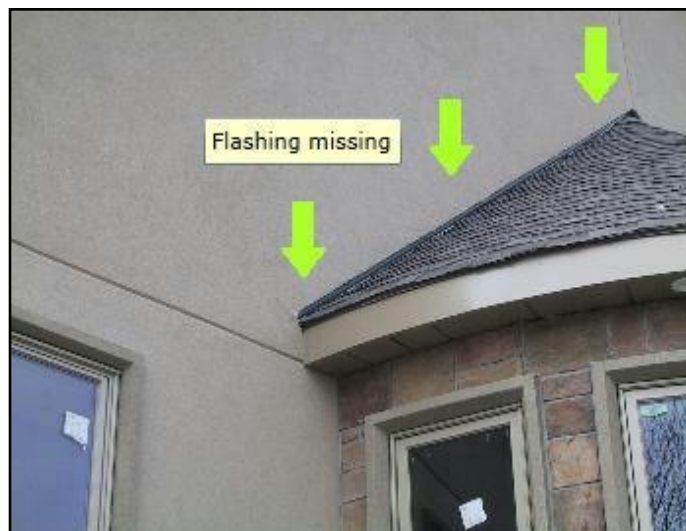
1. Condition: • **No kickout flashing**

Implication(s): Chance of water damage to contents, finishes and/or structure

Location: North First Floor

No kickout flashing at roof/sidewall junction

Task: Improve

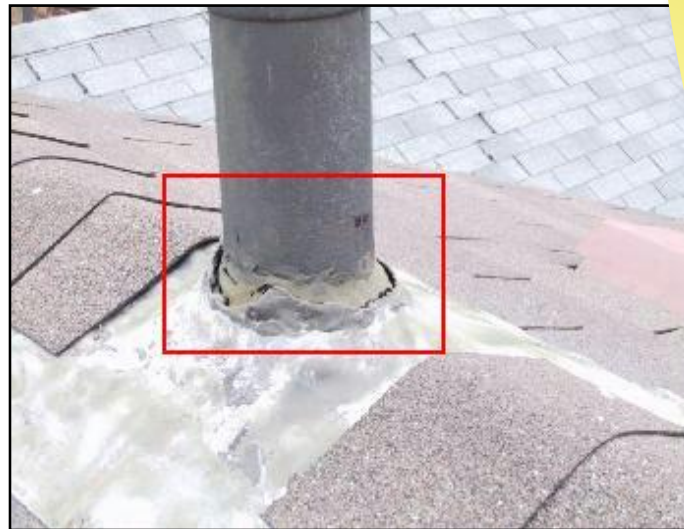
2. Condition: • [Leak](#)

Implication(s): Chance of water damage to contents, finishes and/or structure

Location: North

Leak

Task: Repair

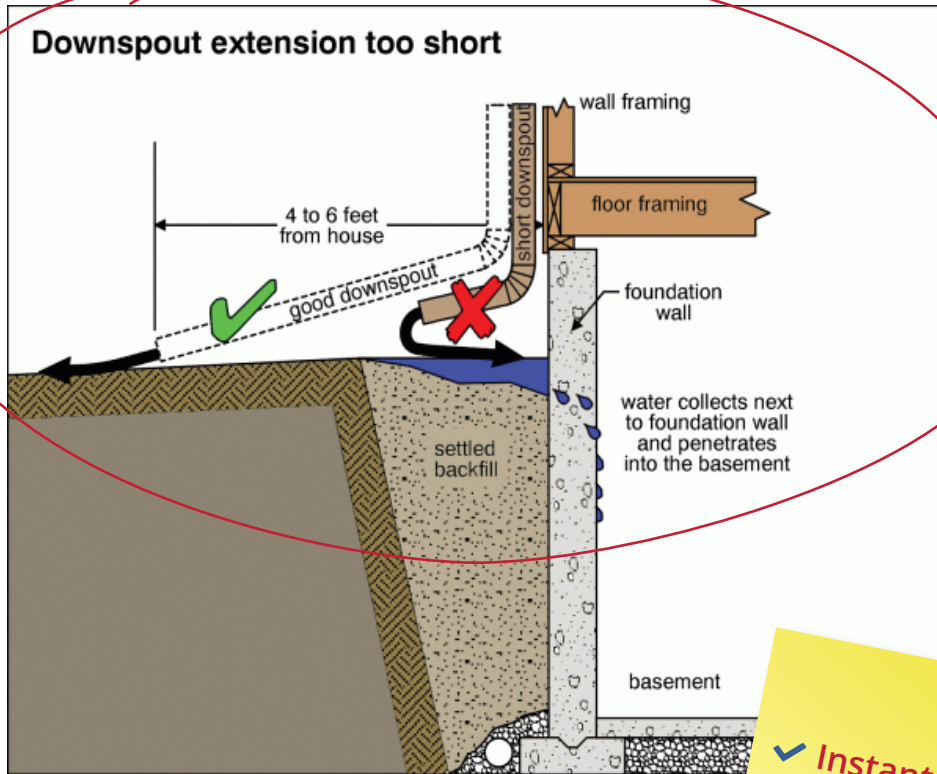
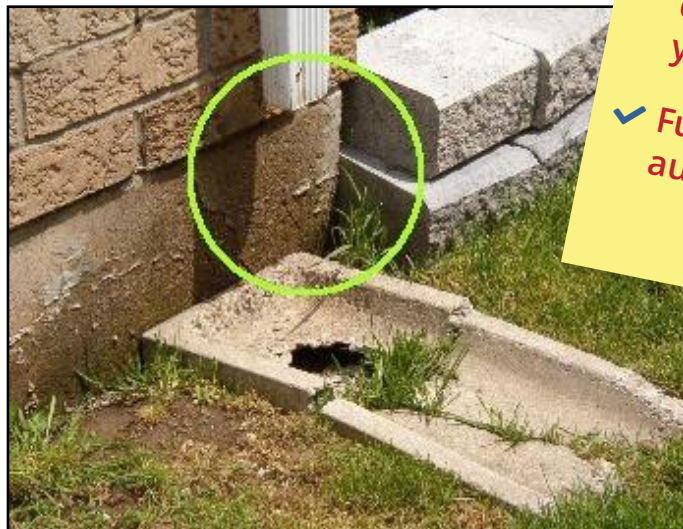
4. Condition: • [Downspouts discharge too close to building](#)

Implication(s): Chance of water damage to contents, finishes and/or structure

Location: East Exterior Wall

Downspouts discharge too close to building

The downspout should be extended to discharge at least 6 feet from the home. The splash block can be discarded.

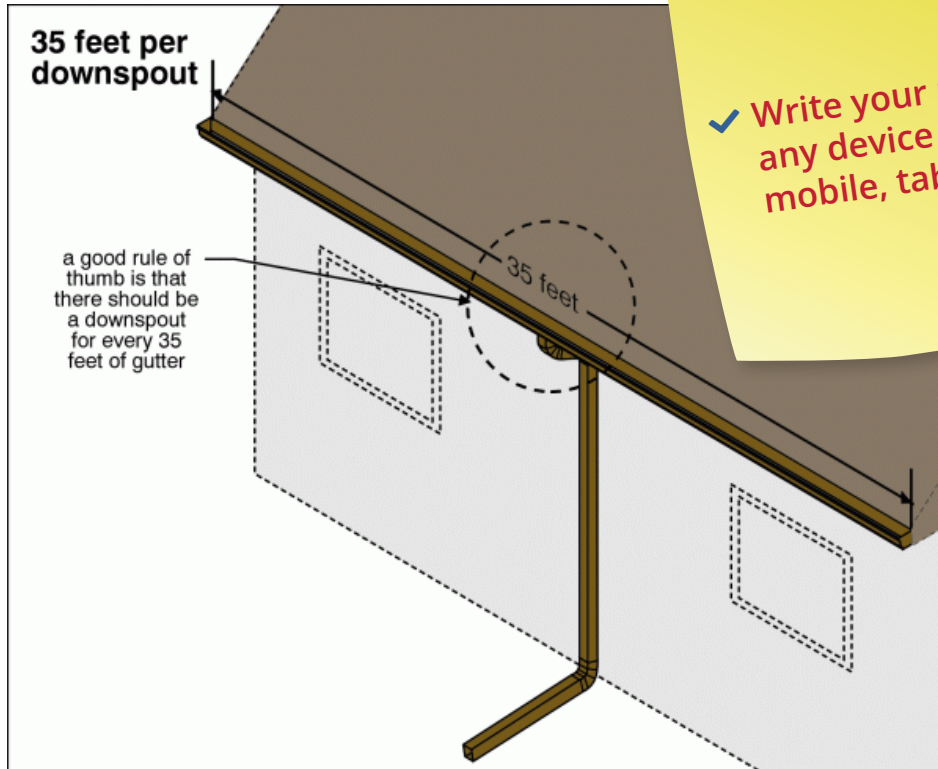
5. Condition: • [Too few](#)

Implication(s): Chance of water damage to contents, finishes and/or structure

Location: Various

Task: Provide

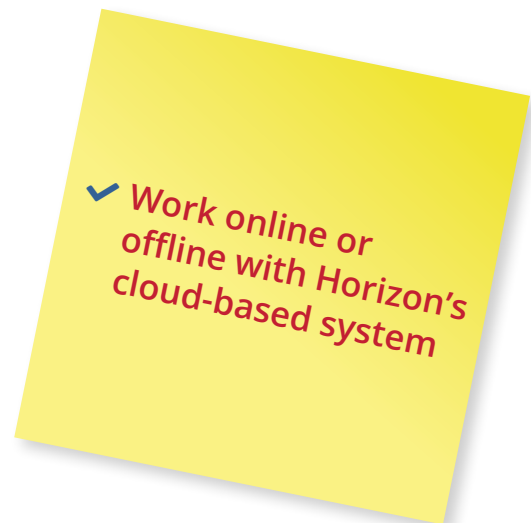
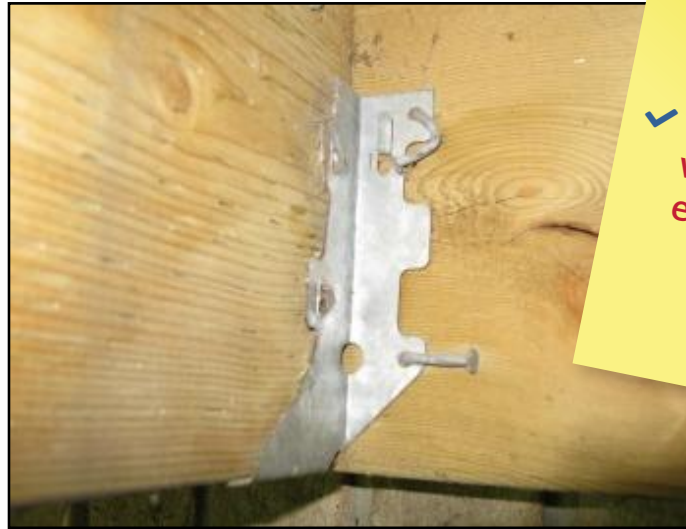
6. Condition: • [Fastener problems](#)

Joist hangers for wood deck are not properly nailed.

Implication(s): Weakened structure | Chance of movement

Location: North Exterior Wall

Poor end bearing, joist hanger connections

Task: Improve

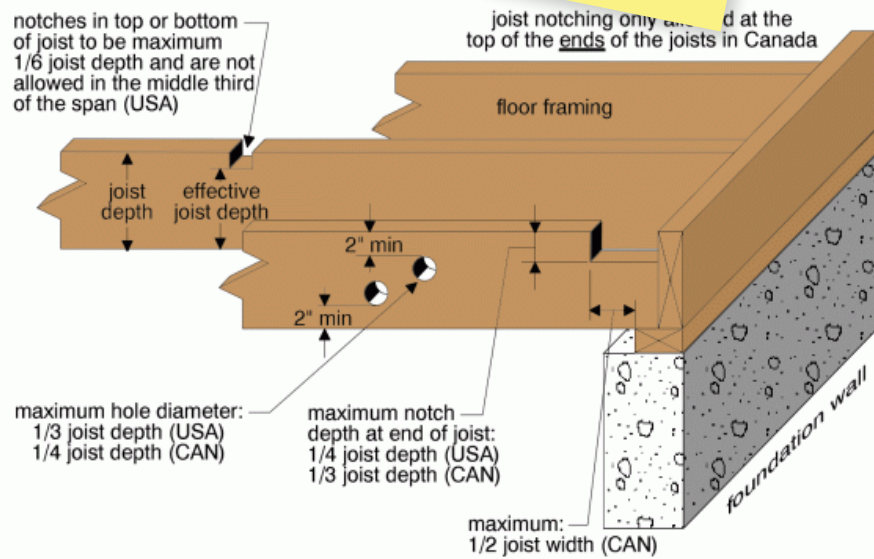
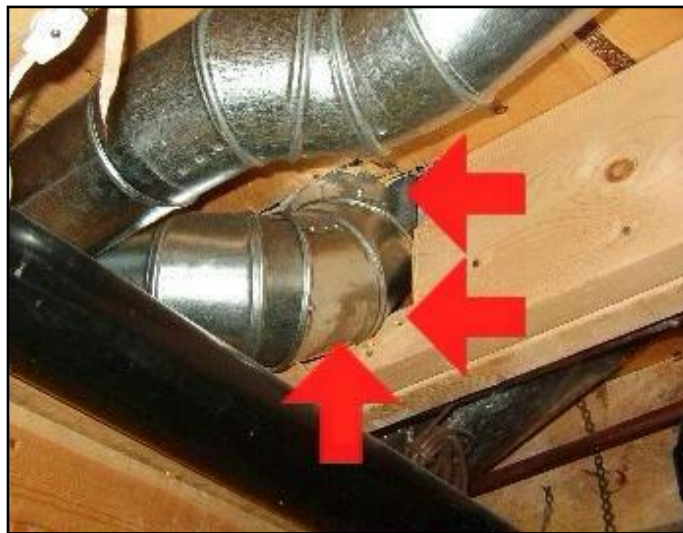
8. Condition: • [Notches or holes](#)

Previous repairs noted.

Implication(s): Weakened structure

Location: West

Joist notching and drilling

Joists are notched and weakened

Task: Repair

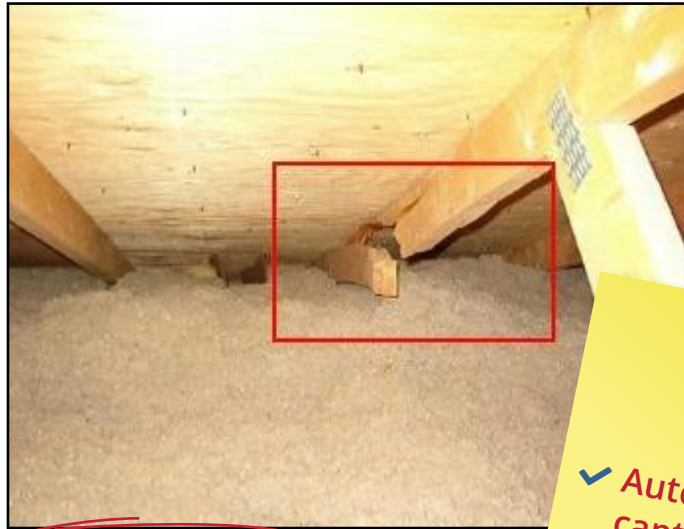
9. Condition: • [Split](#)

Implication(s): Weakened structure | Chance of structural movement

Location: North Attic

Top chord of truss is split

Task: Replace

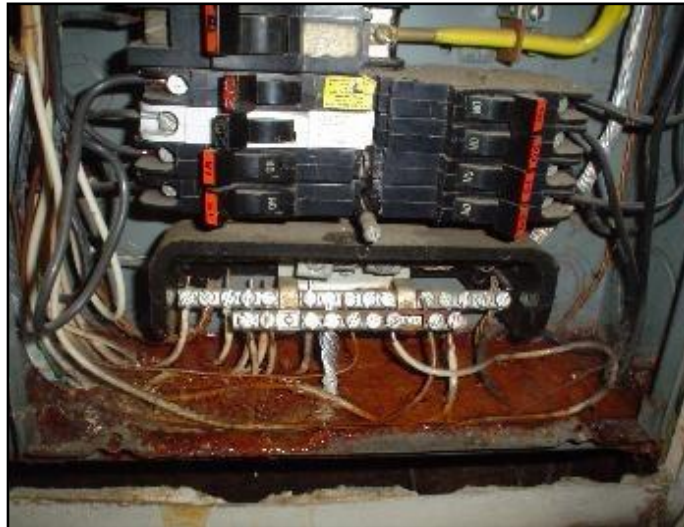
11. Condition: • [Rust or water in panel](#)

Implication(s): Electric shock | Fire hazard

Location: North Basement

Water and rust in bottom of panel

Task: Replace

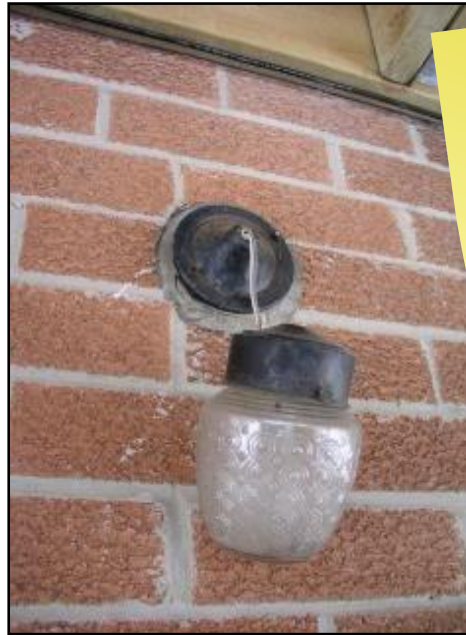
14. Condition: • [Loose](#)

Implication(s): Electric shock | Fire hazard

Location: East Exterior Wall

Light fixture is not well secured

Task: Repair or replace

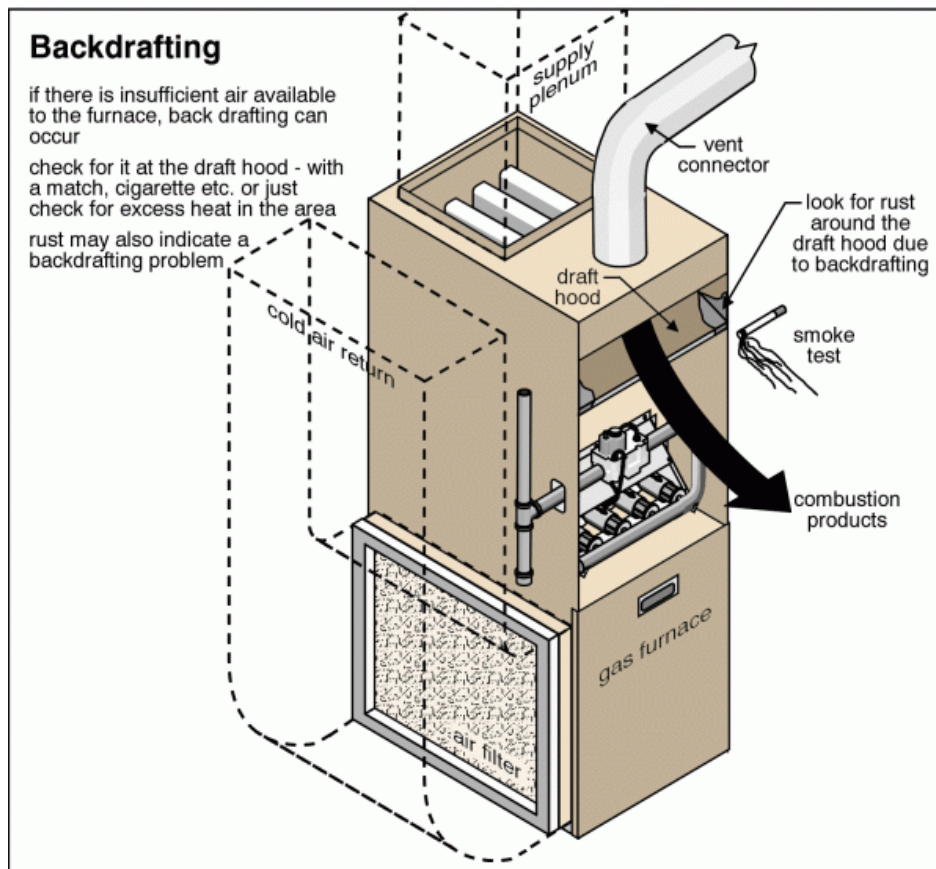
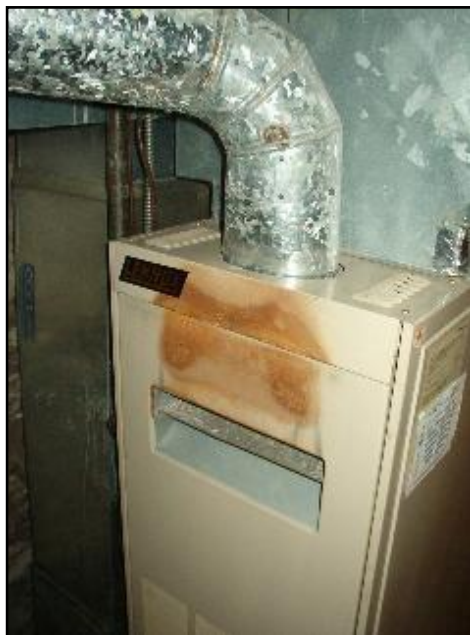
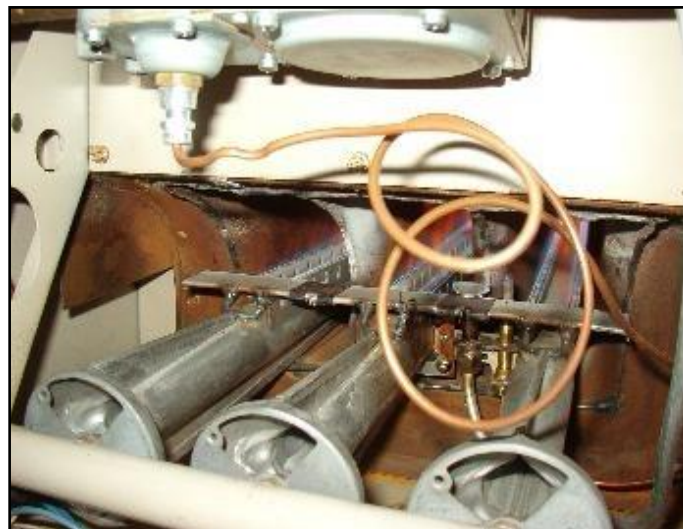
16. Condition: • [Draft hood spillage or backdraft](#)

A considerable amount of rust was noted on the front of the furnace.

This suggests a back-drafting problem, with combustion products entering the home.

This is a safety issue that should be addressed without delay.

Implication(s): Equipment not operating properly | Hazardous combustion products entering home

Draft hood spillage or backdraft

Task: Correct

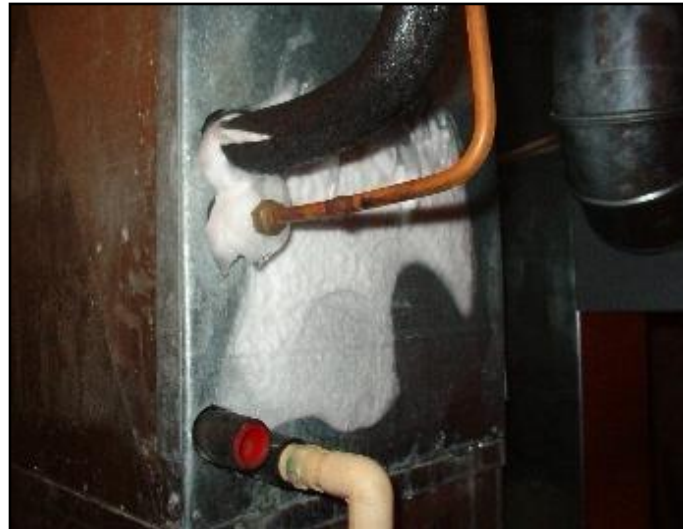
17. Condition: • [Frost](#)

Implication(s): Increased cooling costs | Reduced comfort

Location: West Basement

Frost

Task: Repair

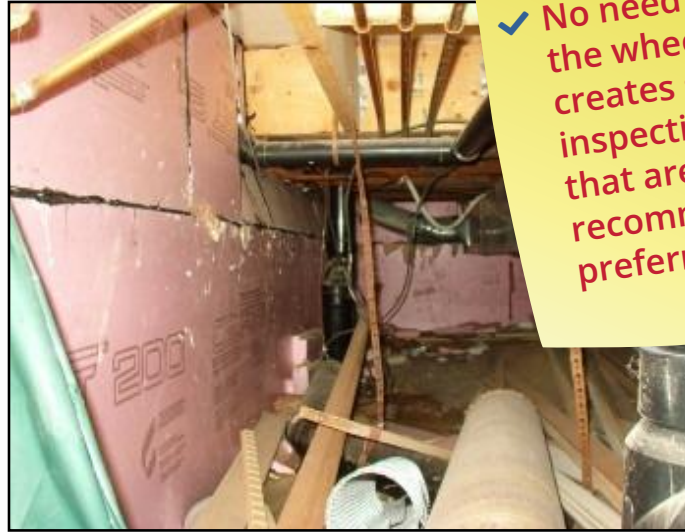
18. Condition: • [Exposed combustible insulation](#)

Implication(s): Fire hazard

Location: West Crawl Space

Exposed combustible insulation

Task: Remove or cover with drywall

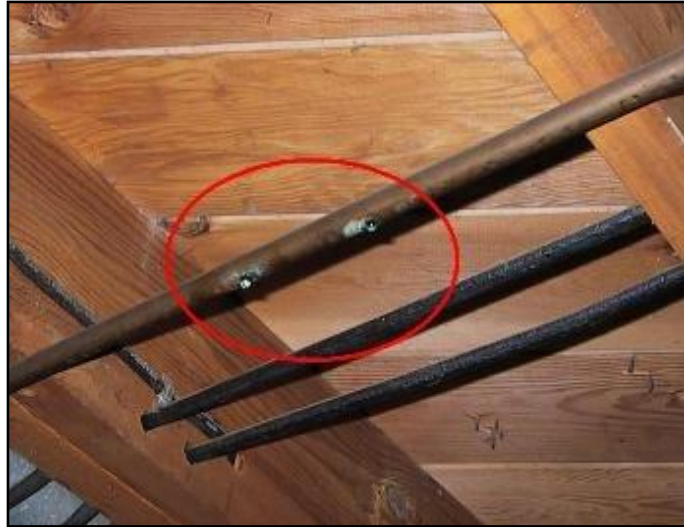
19. Condition: • [Leak](#)

Implication(s): Chance of water damage to contents, finishes and/or structure | System inoperative

Location: Northeast Basement

Leak

Task: Replace

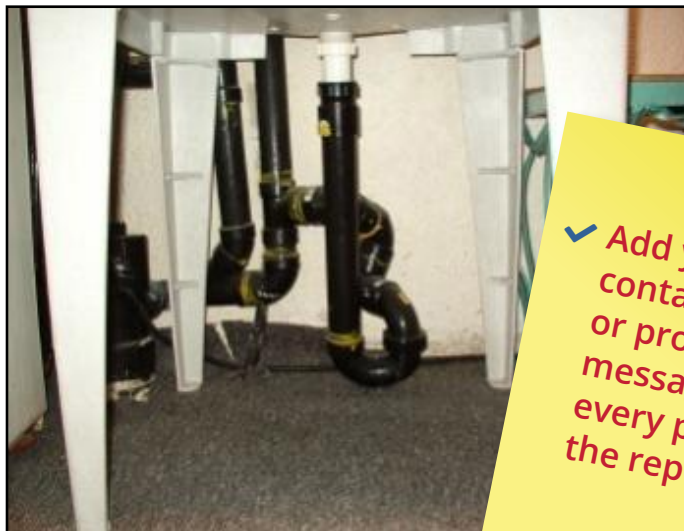
20. Condition: • [Nonstandard shape or material](#)

Implication(s): Reduced operability | Fixtures slow to drain

Location: Basement Laundry Area

Poor trap arrangement

Task: Improve

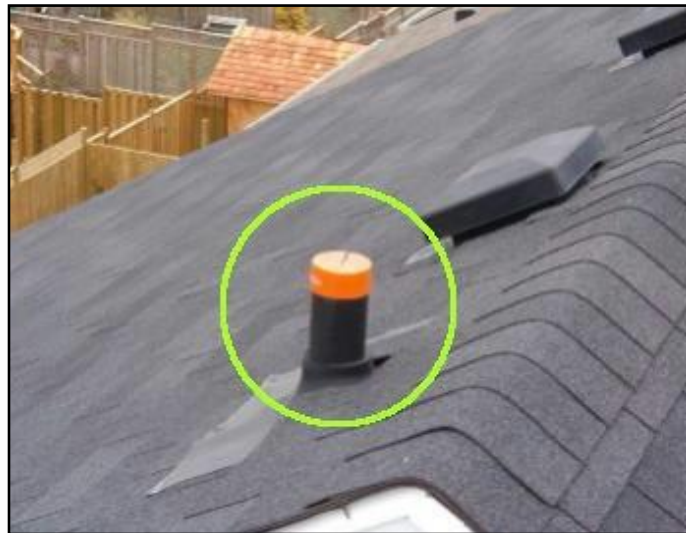
21. Condition: • [Vent termination problems](#)

Implication(s): Reduced operability | Sewer gases entering the building

Location: West central part of roof

Plumbing stack is capped

Task: Remove cap

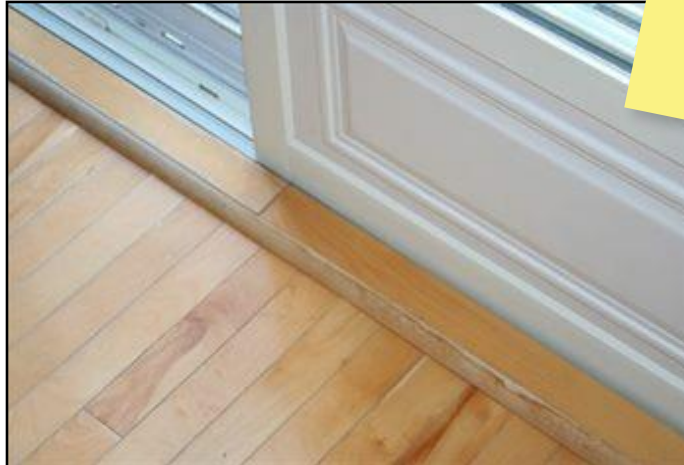
22. Condition: • [Stained](#)

Implication(s): Chance of water damage to contents, finishes and/or structure

Location: North First Floor Family Room

Stained

Task: Replace

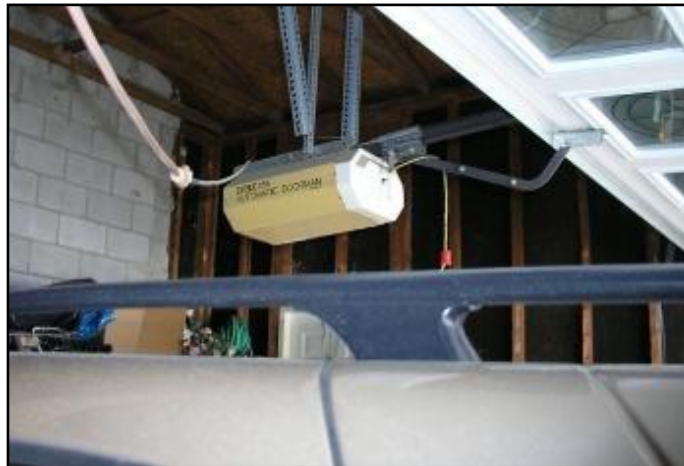
23. Condition: • [Extension cord for opener](#)

Implication(s): Electric shock

Extension cord for opener
