INSPECTION REPORT

443 Madison St.
Chicago, IL

INSPECTION DATE:
Thursday, March 1, 2018

RE: Report No. 3284
443 Madison
Chicago, IL

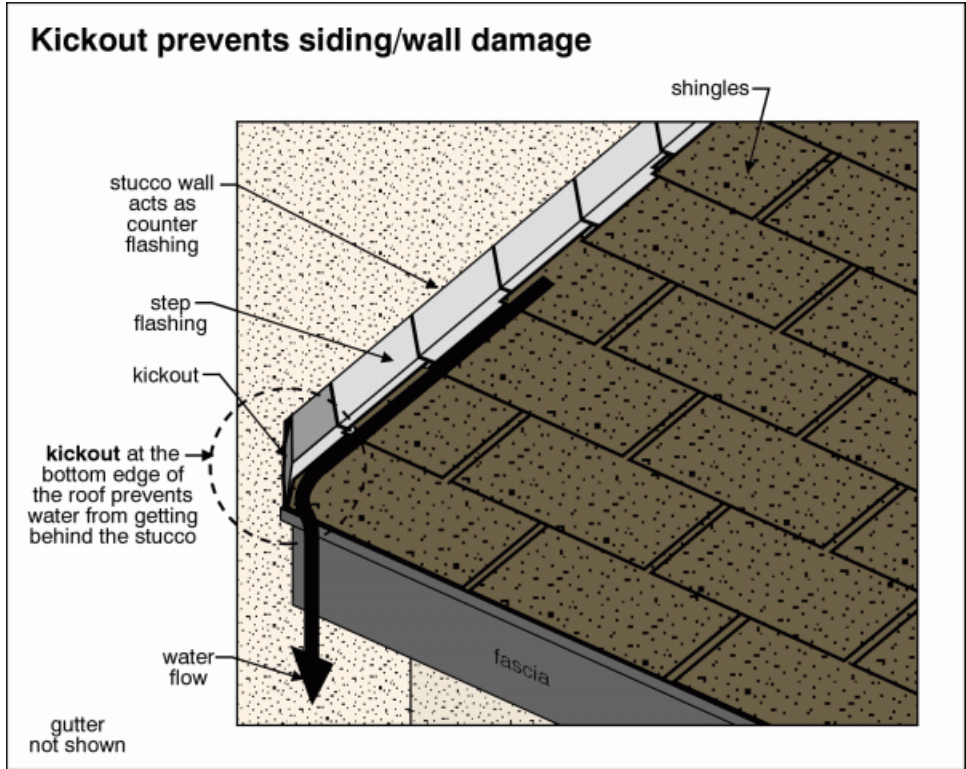
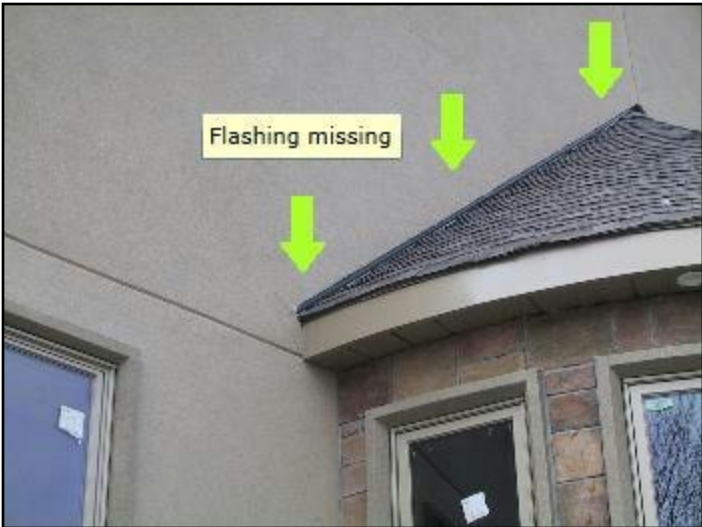
1. Condition: • No kickout flashing

Implication(s): Chance of water damage to contents, finishes and/or structure

Location: North First Floor

No kickout flashing at roof/sidewall junction

Task: Improve

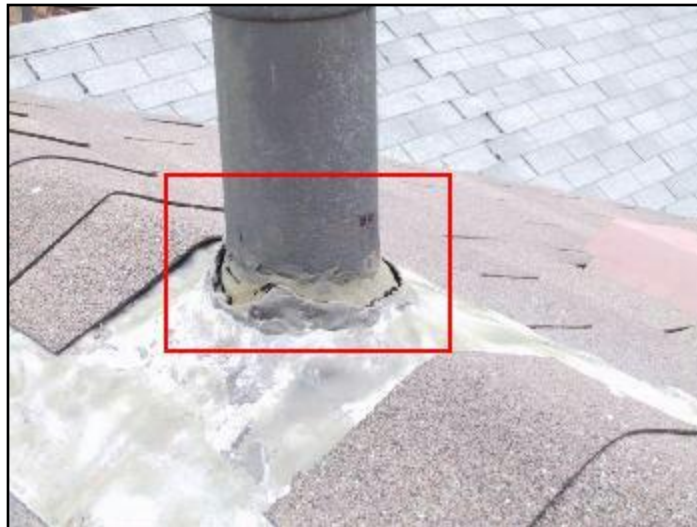
2. **Condition:** • [Leak](#)

Implication(s): Chance of water damage to contents, finishes and/or structure

Location: North

Leak

Task: Repair

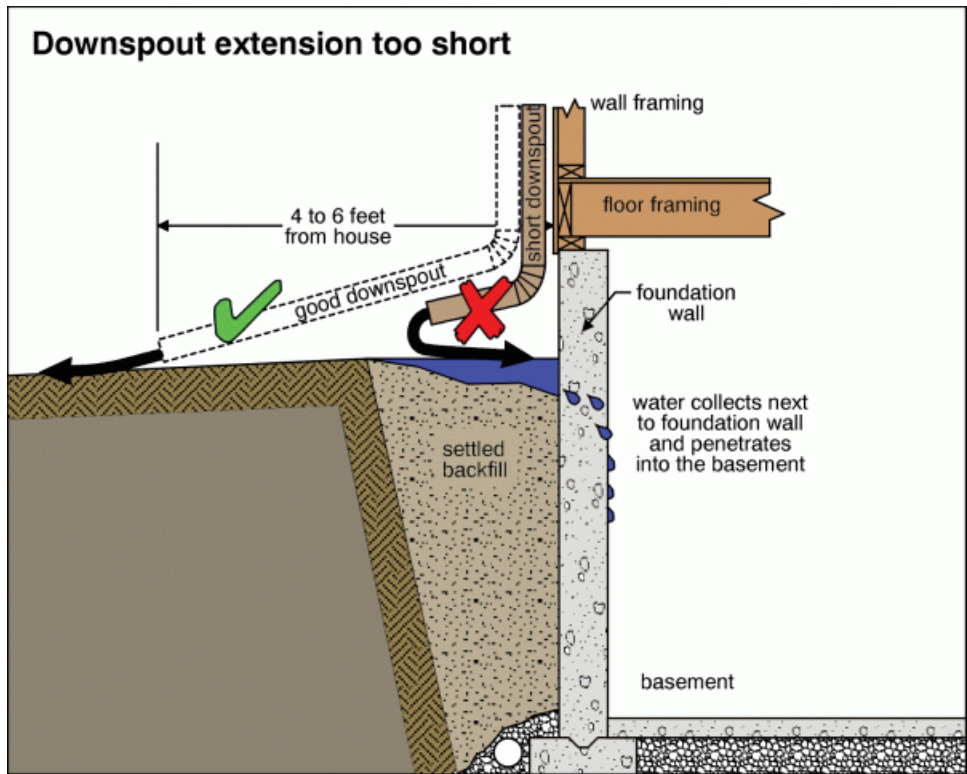
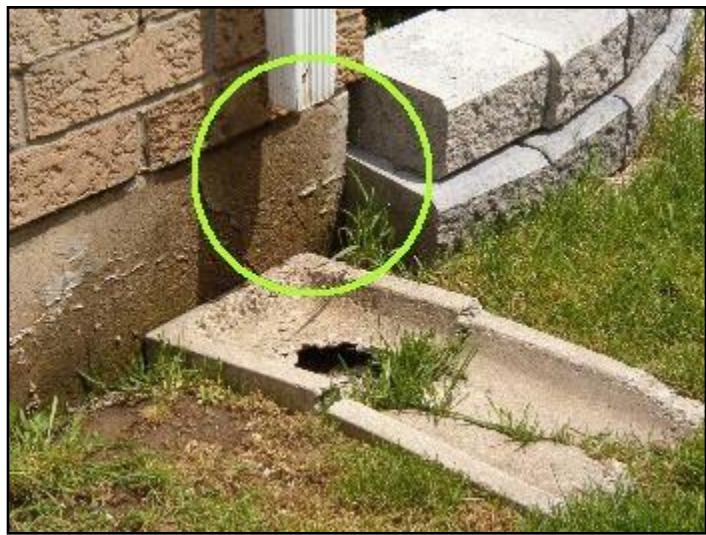
4. Condition: • Downspouts discharge too close to building

Implication(s): Chance of water damage to contents, finishes and/or structure

Location: East Exterior Wall

Downspouts discharge too close to building

The downspout should be extended to discharge at least 6 feet from the home. The splash block can be discarded.

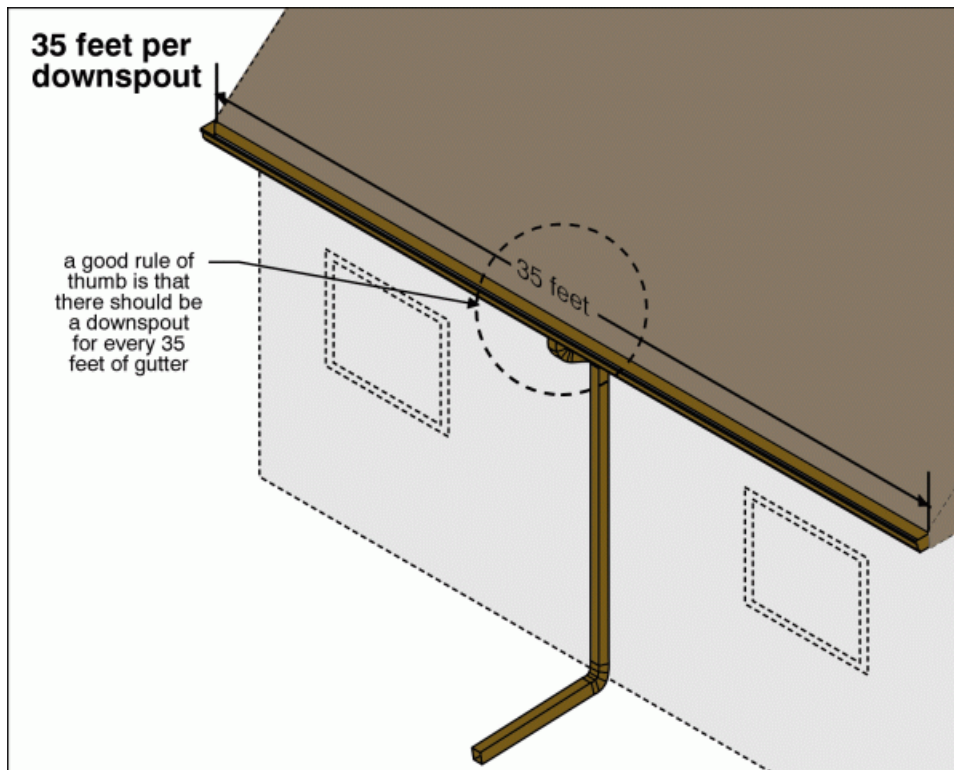
5. Condition: • [Too few](#)

Implication(s): Chance of water damage to contents, finishes and/or structure

Location: Various

Task: Provide

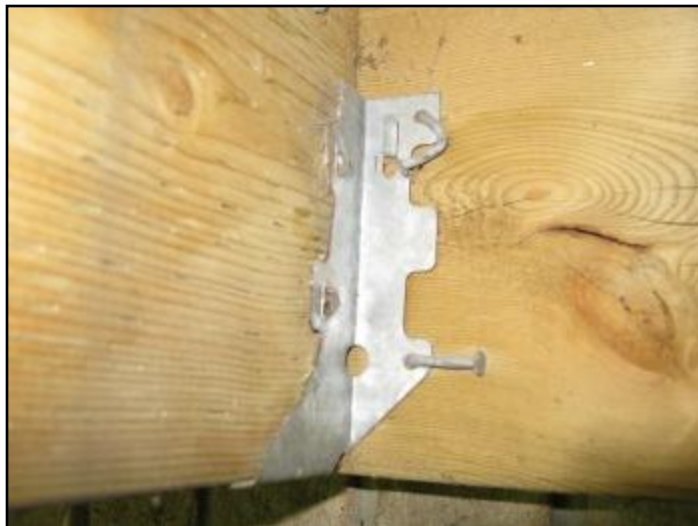
6. Condition: • [Fastener problems](#)

Joist hangers for wood deck are not properly nailed.

Implication(s): Weakened structure | Chance of movement

Location: North Exterior Wall

Poor end bearing, joist hanger connections

Task: Improve

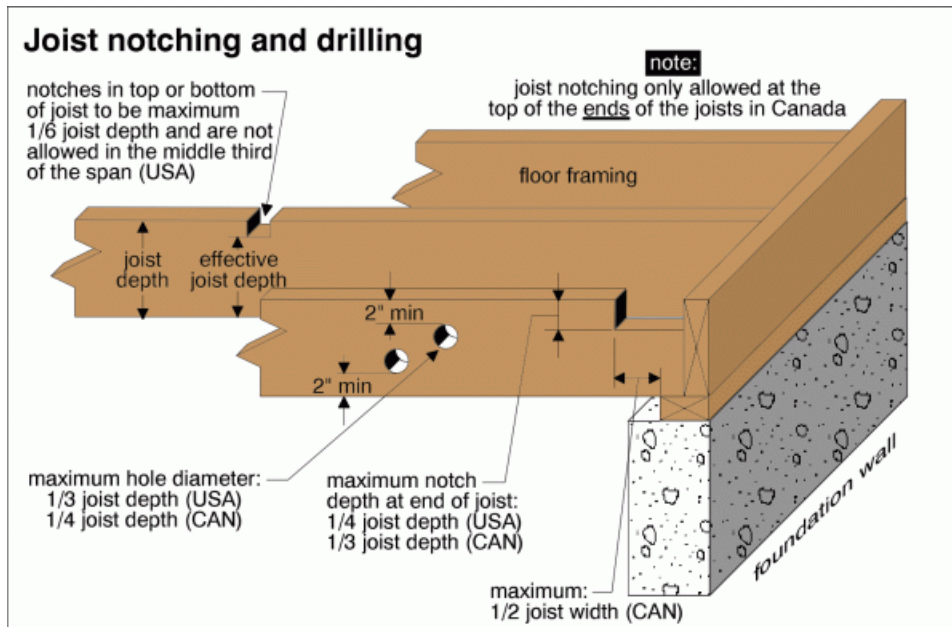
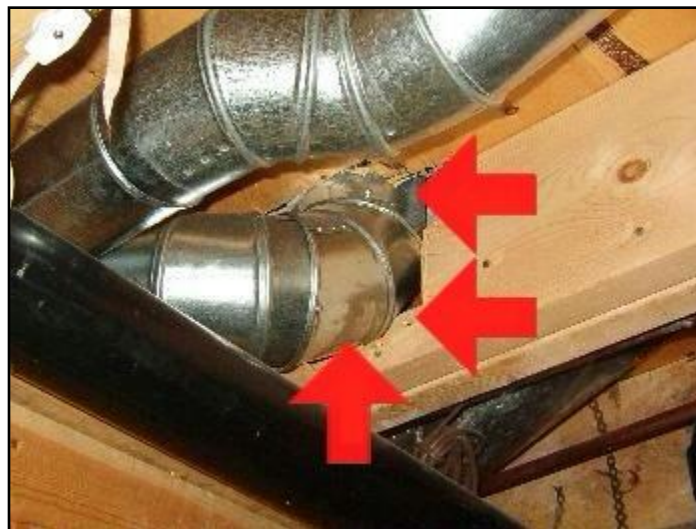
Condition: • [Notches or holes](#)

Previous repairs noted.

8. Condition: • [Notches or holes](#)

Implication(s): Weakened structure

Location: West

Joists are notched and weakened

Task: Repair

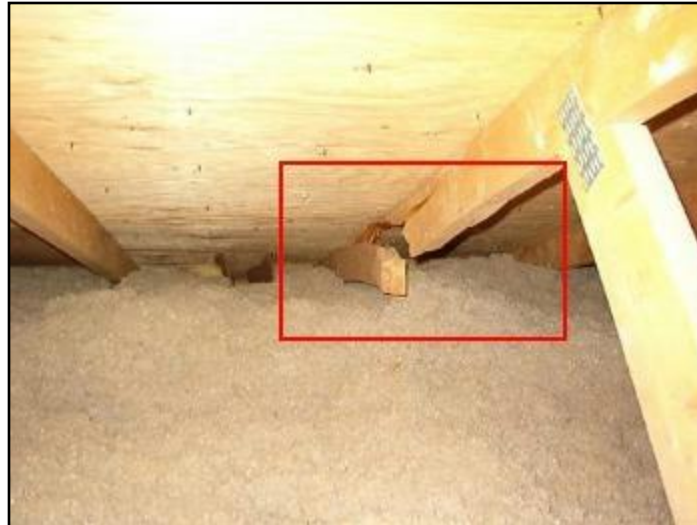
9. Condition: • [Split](#)

Implication(s): Weakened structure | Chance of structural movement

Location: North Attic

Top chord of truss is split

Task: Replace

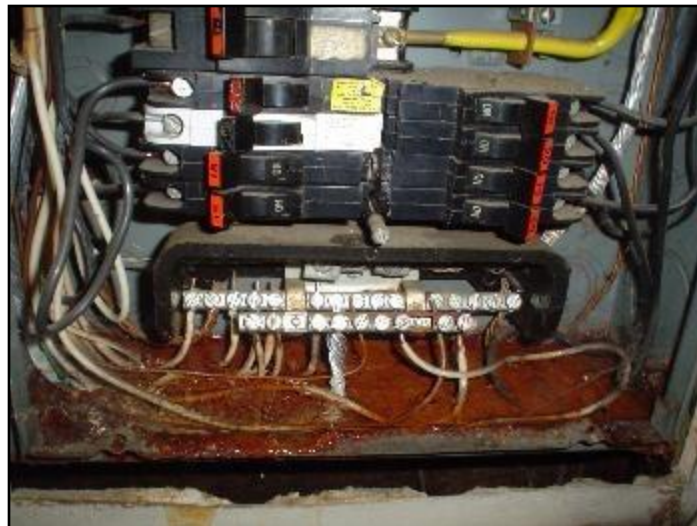
Condition: • [Rust or water in panel](#)

Implication(s): Electric shock | Fire hazard

11. Condition: • [Rust or water in panel](#)

Location: North Basement

Water and rust in bottom of panel

Task: Replace

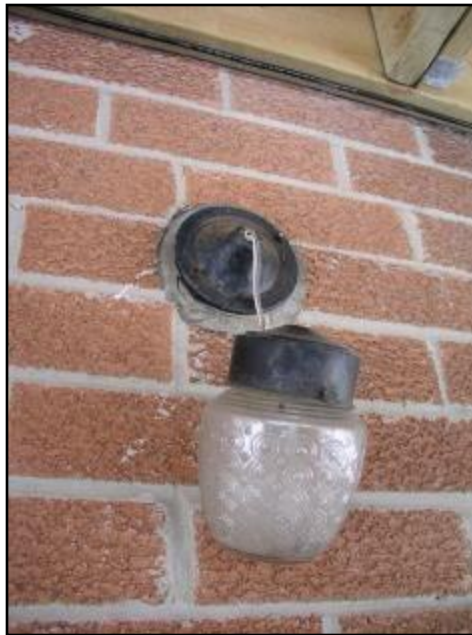
14. Condition: • [Loose](#)

Implication(s): Electric shock | Fire hazard

Location: East Exterior Wall

Light fixture is not well secured

Task: Repair or replace

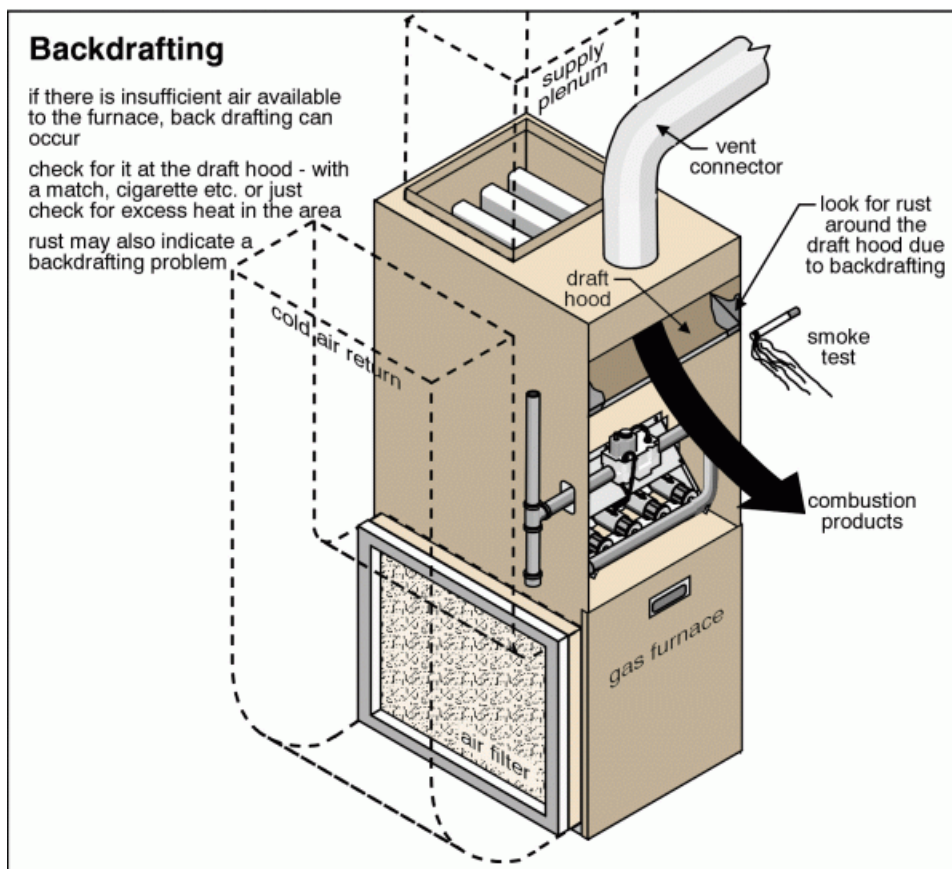
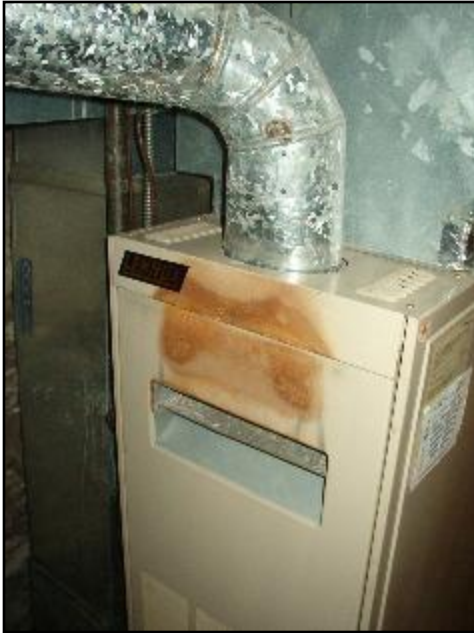
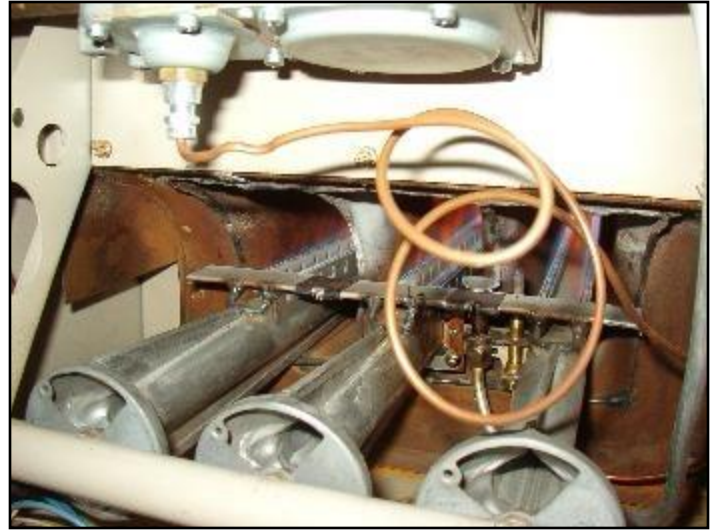
16. **Condition:** • [Draft hood spillage or backdraft](#)

A considerable amount of rust was noted on the front of the furnace.

This suggests a back-drafting problem, with combustion products entering the home.

This is a safety issue that should be addressed without delay.

Implication(s): Equipment not operating properly | Hazardous combustion products entering home

Location: Basement Furnace Room

Draft hood spillage or backdraft

Task: Correct

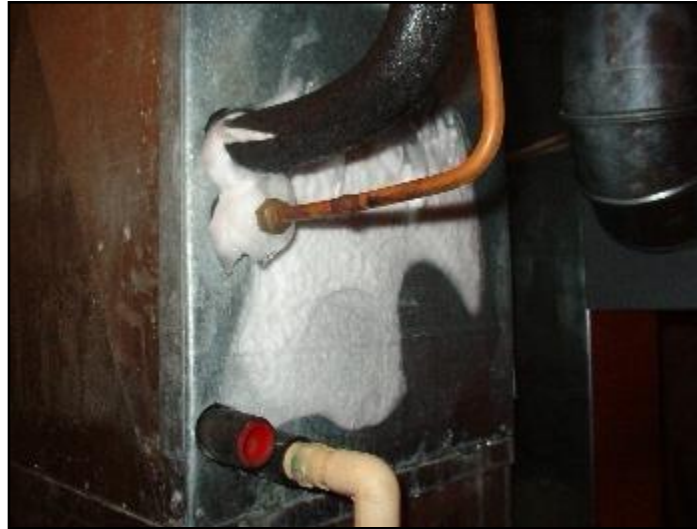
17. Condition: • [Frost](#)

Implication(s): Increased cooling costs | Reduced comfort

Location: West Basement

Frost

Task: Repair

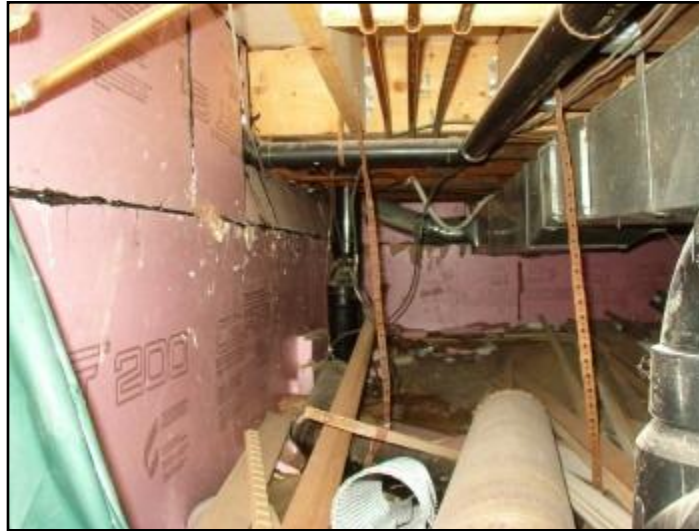
18. Condition: • [Exposed combustible insulation](#)

Implication(s): Fire hazard

Location: West Crawl Space

Exposed combustible insulation

Task: Remove or cover with drywall

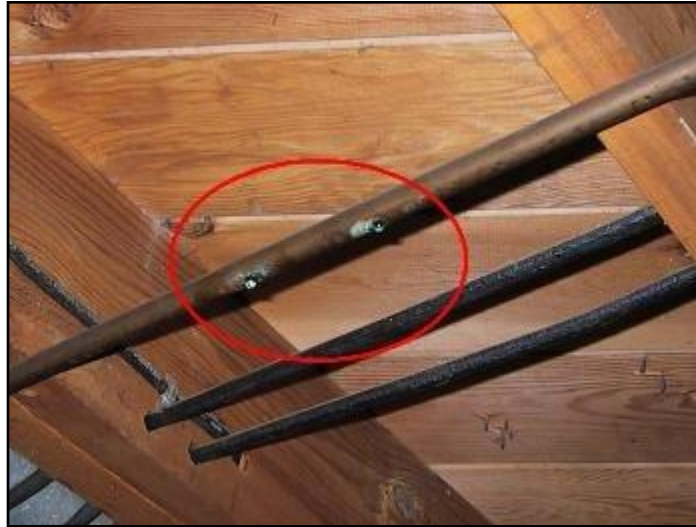
19. Condition: • [Leak](#)

Implication(s): Chance of water damage to contents, finishes and/or structure | System inoperative

Location: Northeast Basement

Leak

Task: Replace

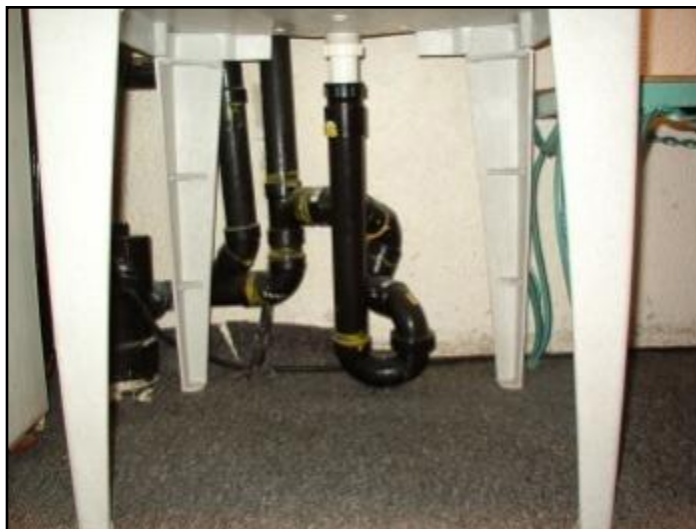
20. Condition: • [Nonstandard shape or material](#)

Implication(s): Reduced operability | Fixtures slow to drain

Location: Basement Laundry Area

Poor trap arrangement

Task: Improve

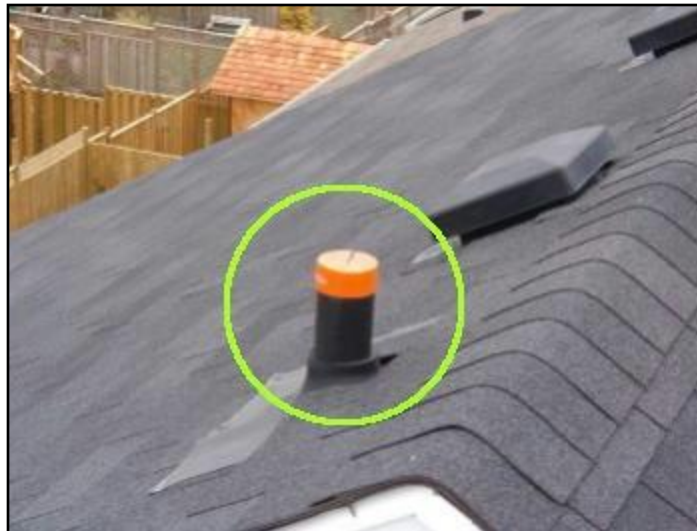
21. Condition: • [Vent termination problems](#)

Implication(s): Reduced operability | Sewer gases entering the building

Location: West central part of roof

Plumbing stack is capped

Task: Remove cap

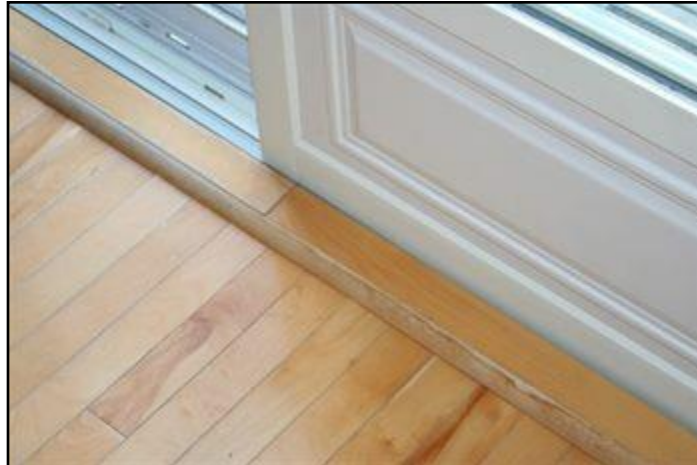
22. Condition: • [Stained](#)

Implication(s): Chance of water damage to contents, finishes and/or structure

Location: North First Floor Family Room

Stained

Task: Replace

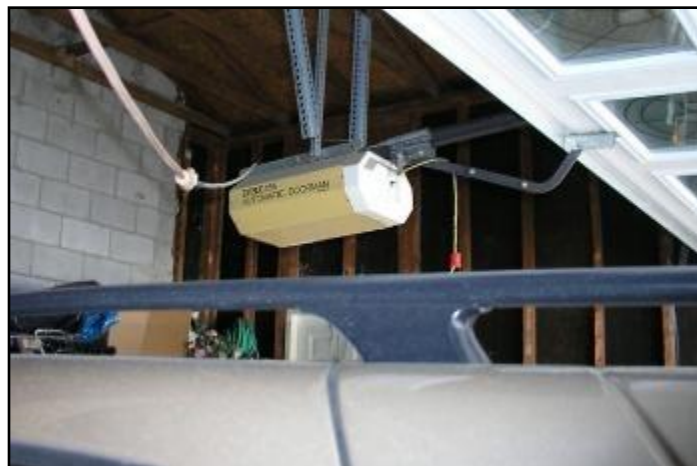
23. Condition: • [Extension cord for opener](#)

Implication(s): Electric shock

Extension cord for opener
