Inspection Report

34 West Bank Ave
Kyle, TX 78640

Thursday, February 21, 2019

John Smith of Texas Maverick
Inspections

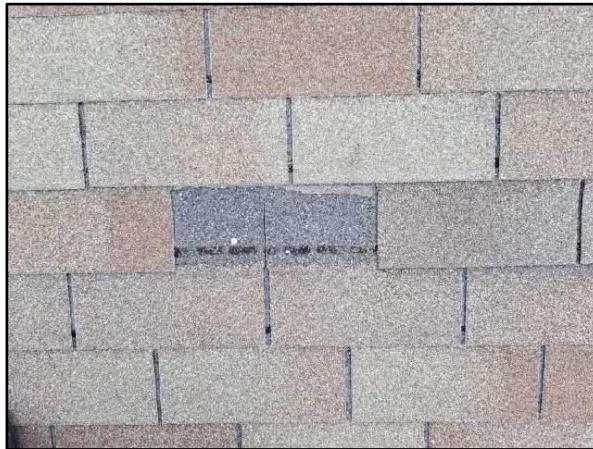
Composition shingles: Damage

Notes: Damaged shingle at rear slope.

1. Damage

Task: Deficiency- Repair

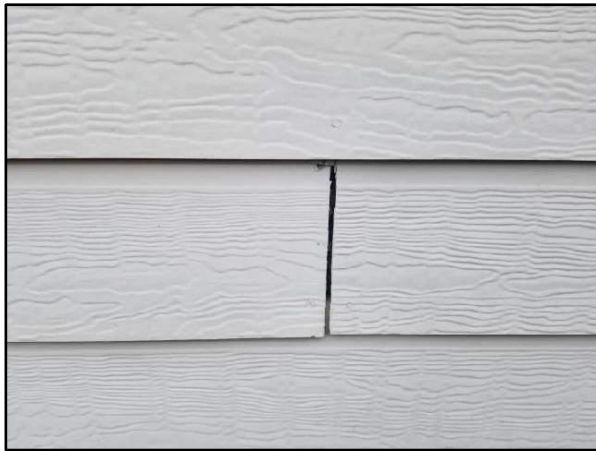
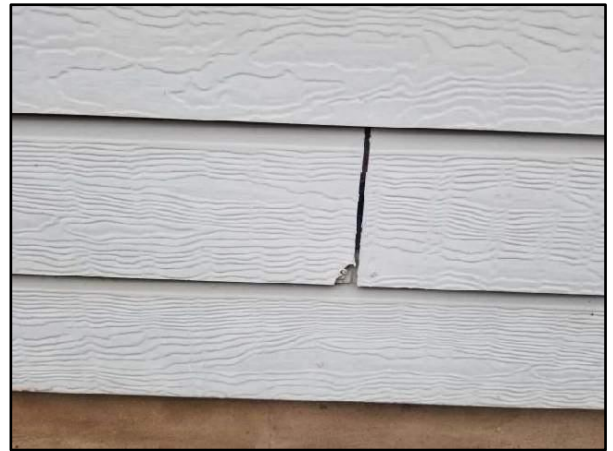
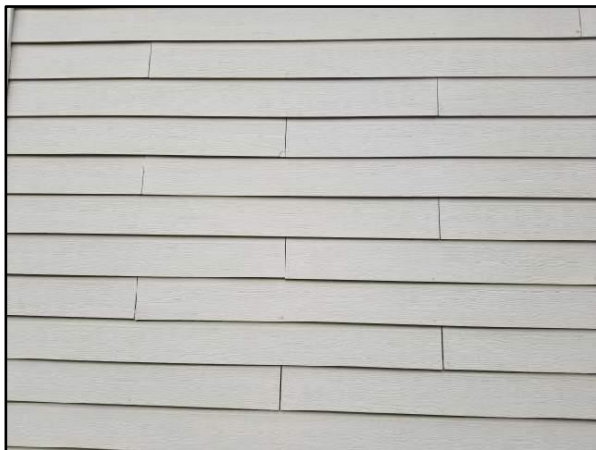
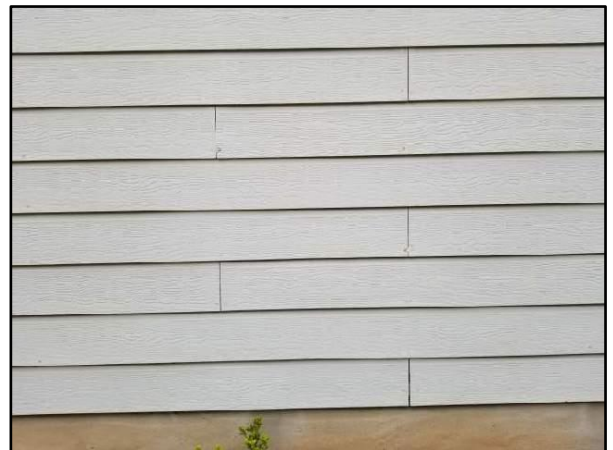
Fiber cement siding: Siding runs right to horizontal flashings—an air gap should be provided here. This is difficult to correct without causing trauma to the siding installation.

Notes: Large gaps observed at siding joints.

2. Siding runs right to horizontal flashings—a...

3. Siding runs right to horizontal flashings—a...

4. Siding runs right to horizontal flashings—a...

5. Siding runs right to horizontal flashings—a...

Task: Deficiency- Improve

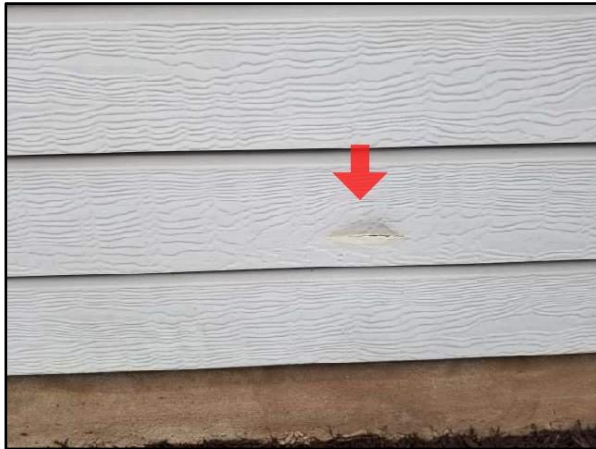
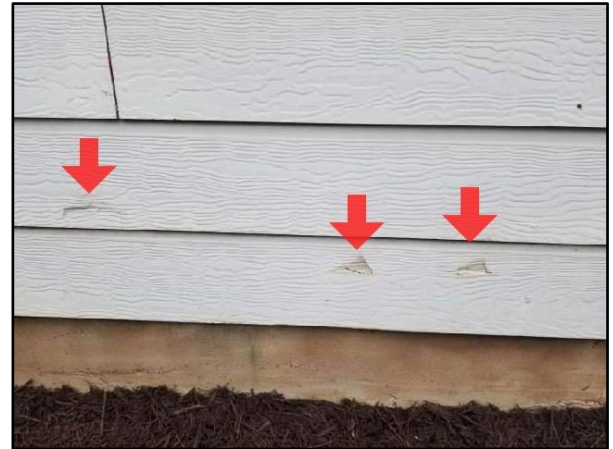
Fiber cement siding: Mechanical damage

6. Mechanical damage

7. Mechanical damage

Task: Deficiency- Repair

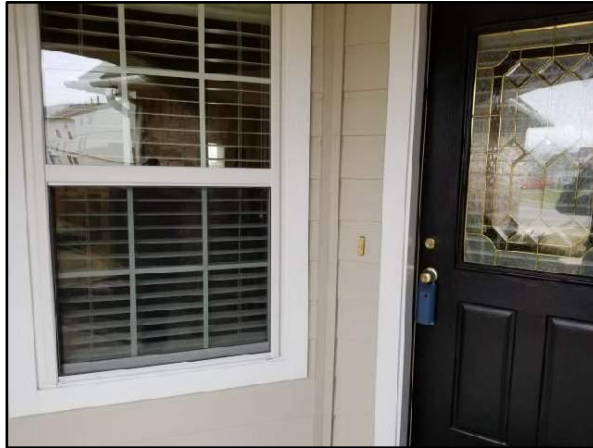
Glass (glazing): Glass is not labeled as having tempered safety glass. Under current standards the window is in an area that is required to have safety glass.

Notes: Due to being within a 2 foot radius of the front door.

8. Glass is not labeled as having tempered...

Task: Deficiency- Provide

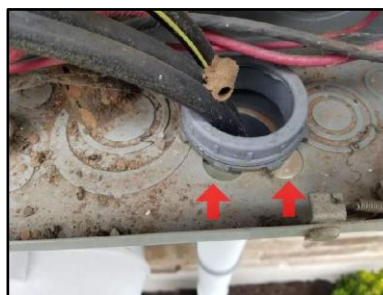
Distribution panel: Openings in panel

Notes: Gaps in panel around service entrance

9. Openings in panel

Task: Deficiency- Repair

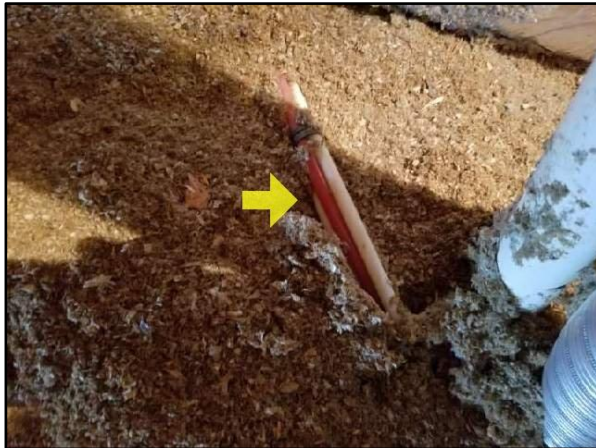
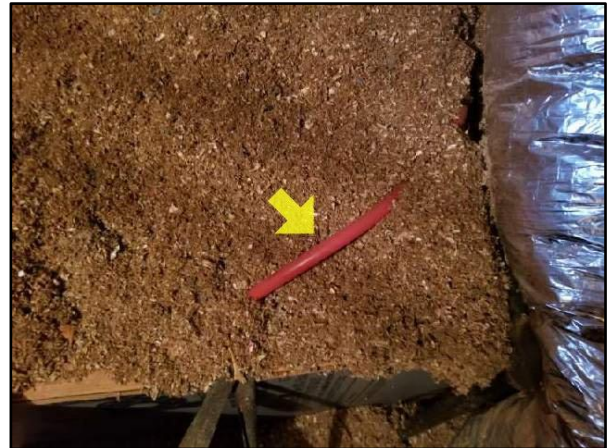
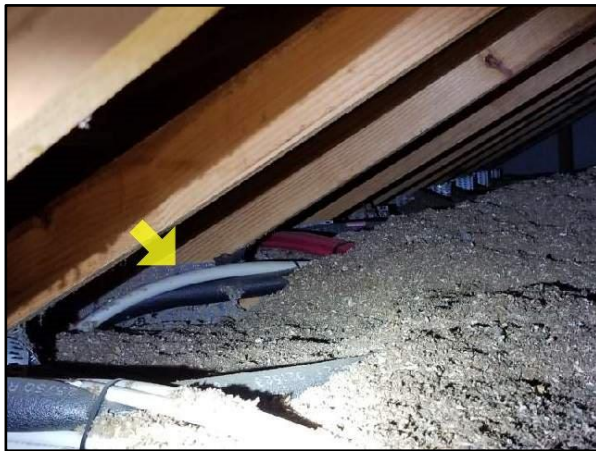
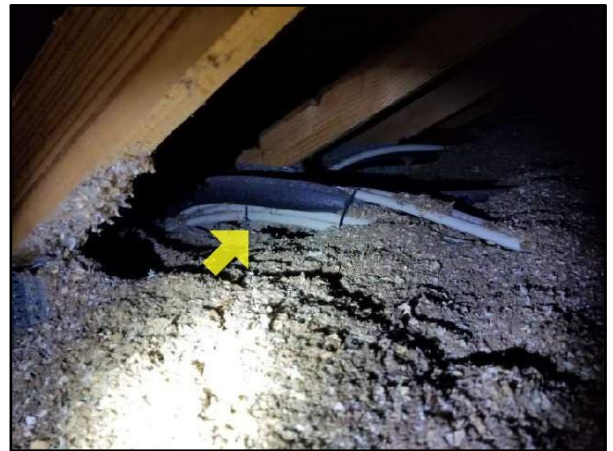
- A. Plumbing Supply, Distribution Systems and Fixtures**
Location of water meter- Front near street
Location of main water supply valve- In the yard next to the meter box/hatch.
Static water pressure reading- 60 psi
Comments:
Supply piping in building: Exposed supply plumbing in attic above living exposed without insulation.
Location: Attic
Task: Deficiency- Correct
Time: Immediate

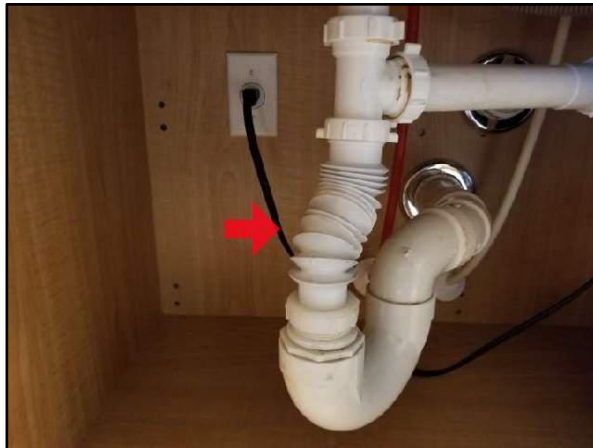
Traps - installation: Nonstandard shape or material

Notes: Flexible drain pipe at kitchen sink drain is improper and it promotes blockages

14. Nonstandard shape or material

Task: Deficiency- Replace

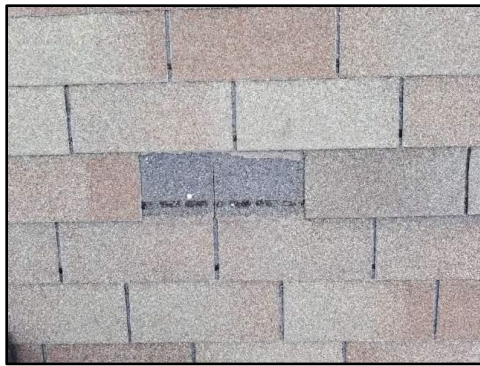
Damage

Notes: Damaged shingle at rear slope.

Implications: Chance of water damage to contents, finishes and/or structure

15. Damage

Task: Deficiency- Repair

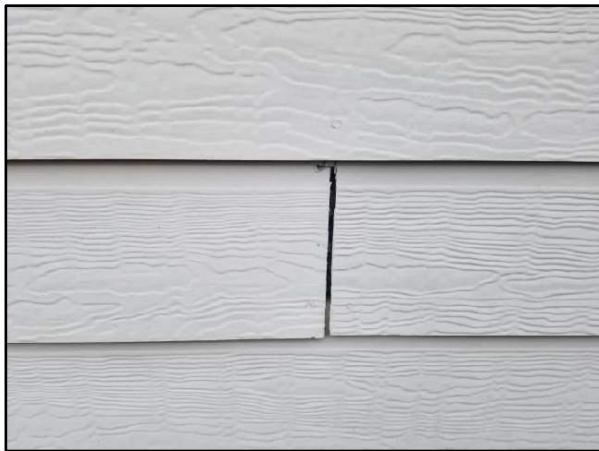
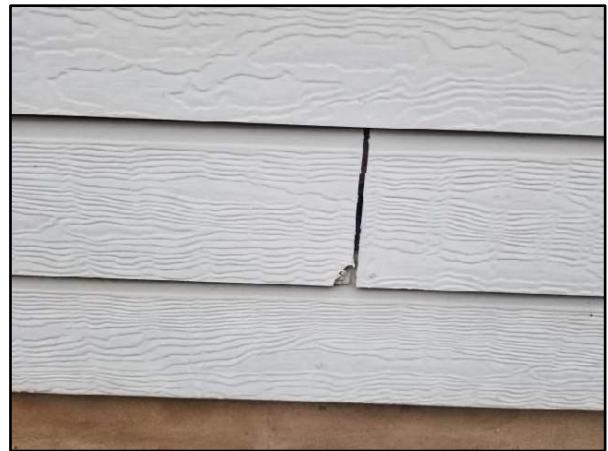
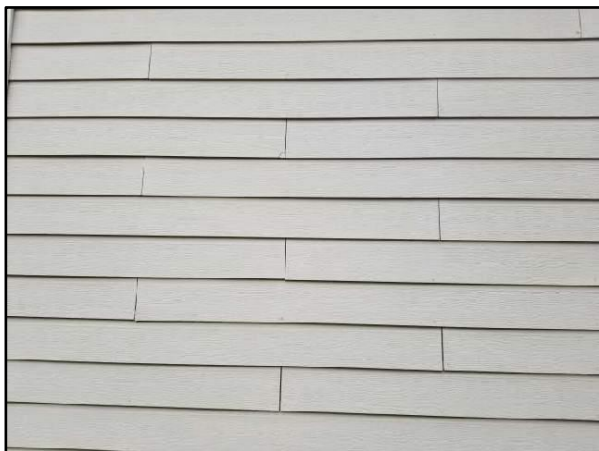
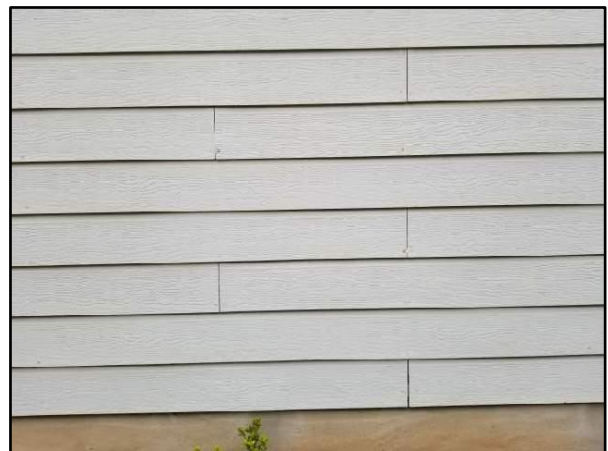
Notes: Large gaps observed at siding joints.

16. Siding runs right to horizontal flashings—a...

17. Siding runs right to horizontal flashings—a...

18. Siding runs right to horizontal flashings—a...

19. Siding runs right to horizontal flashings—a...

Task: Deficiency- Improve

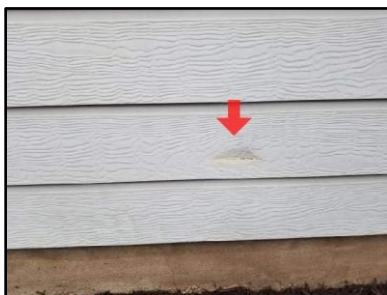
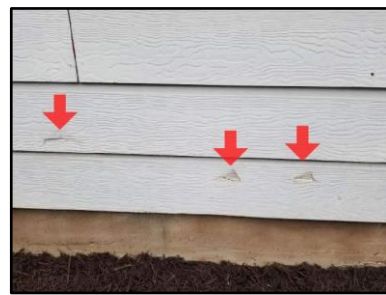
[Walls\Fiber cement siding](#)
[Mechanical damage](#)

Implications: Chance of water damage to contents, finishes and/or structure

20. Mechanical damage

21. Mechanical damage

Task: Deficiency- Repair

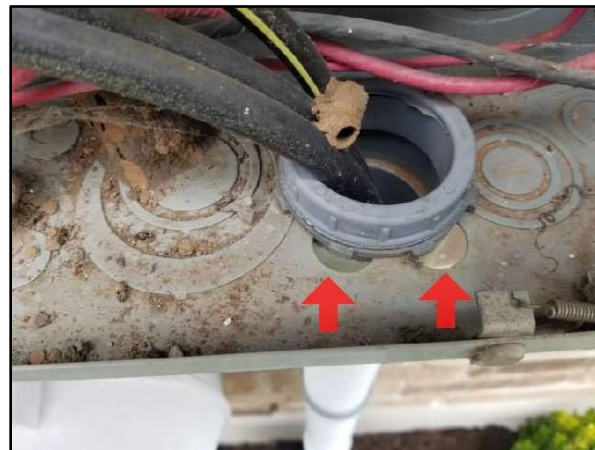
Implications: Fire hazard | Electric shock

27. Openings in panel

Task: Deficiency- Repair

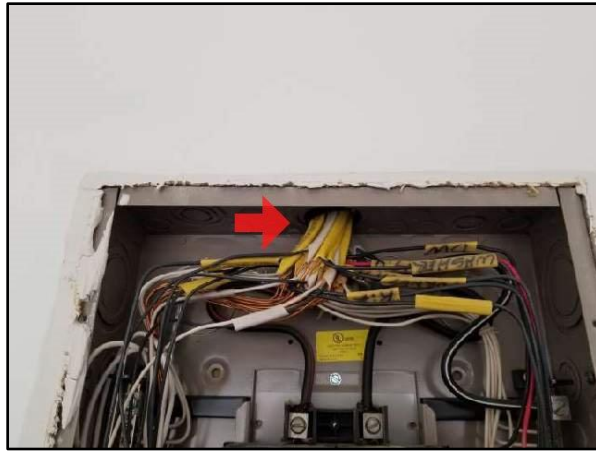
Sub panel is flush mounted and most cables are bundled and exit the panel through a large opening or two. As per current applicable standards, the individual cables should be routed through the various small "knock-out" holes at the top, bottom and/or sides of the panel box and secured with approved cable clamps, so that any smoke or fire inside the panel is confined or at least restricted from passing through the knockout openings. What was found here today was generally the method of installation in this region at the time of this home's construction. This installation would not be allowed by current

28. Sub panel is flush mounted and most cables...

Task: Deficiency- Improve

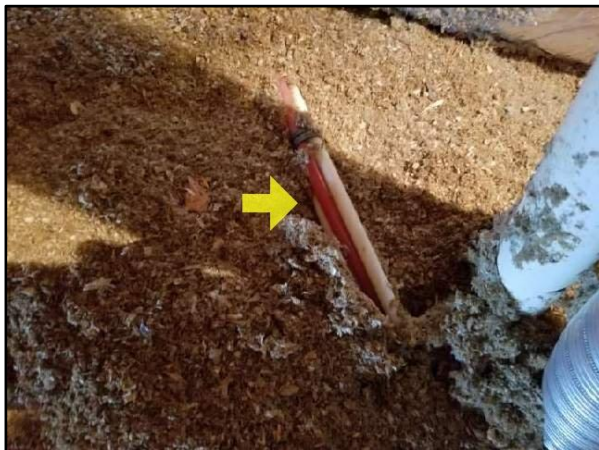
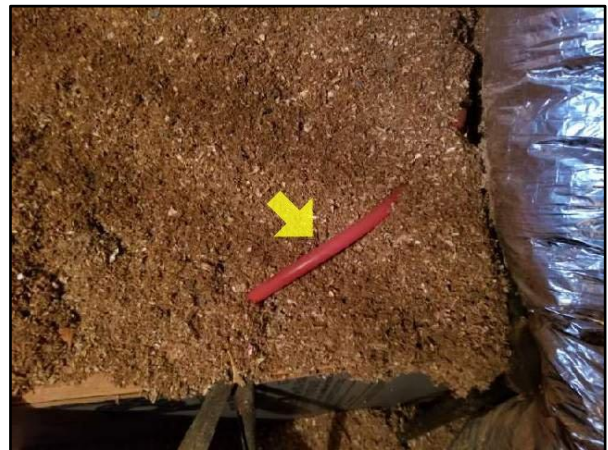
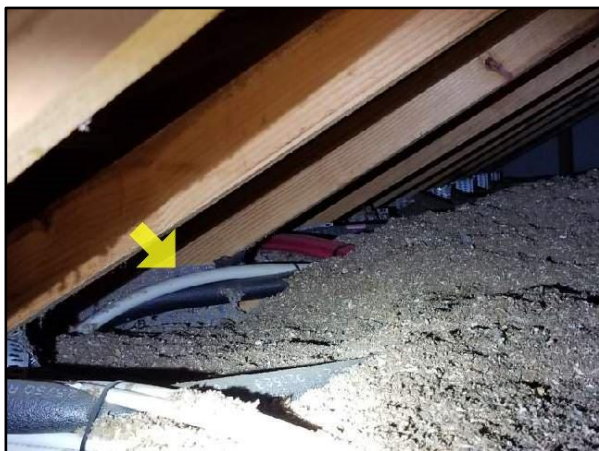
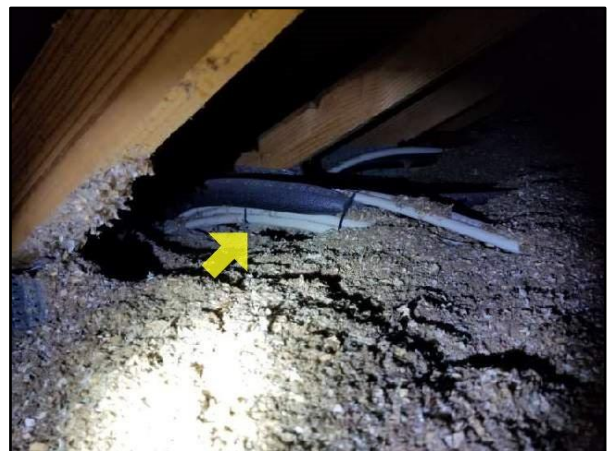
Implications: Freeze damage.

Task: Deficiency- Correct

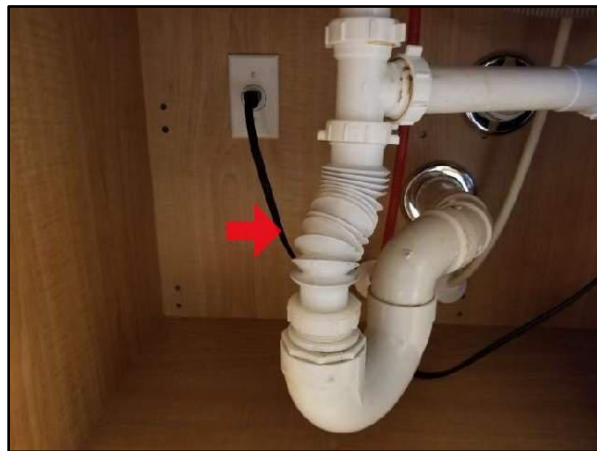
Notes: Flexible drain pipe at kitchen sink drain is improper and it promotes blockages

39. Nonstandard shape or material

Task: Deficiency- Replace

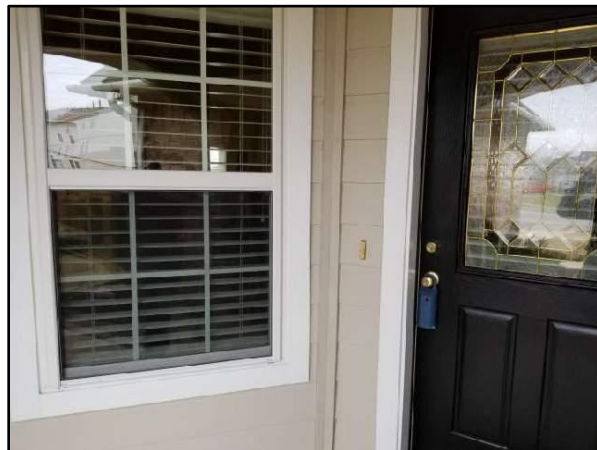
40. Glass is not labeled as having tempered...

Task: Deficiency- Provide
