YOUR Inspection Report

443 Madison St.
Chicago, IL

Monday, January 16, 2017

RE: Report No. 1366, v.39
443 Madison St.
Chicago, IL

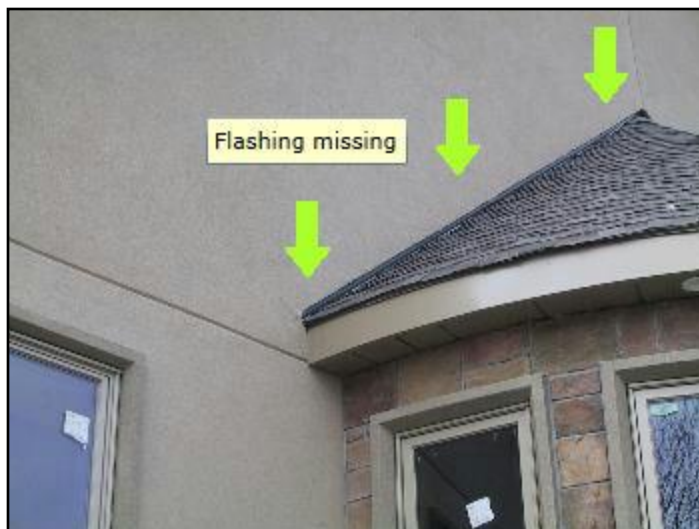
2. **Condition:** • [No kickout flashing](#)

Implication(s): Chance of water damage to contents, finishes and/or structure

Location: North First floor

1. No kickout flashing at roof/sidewall junction

Task: Improve

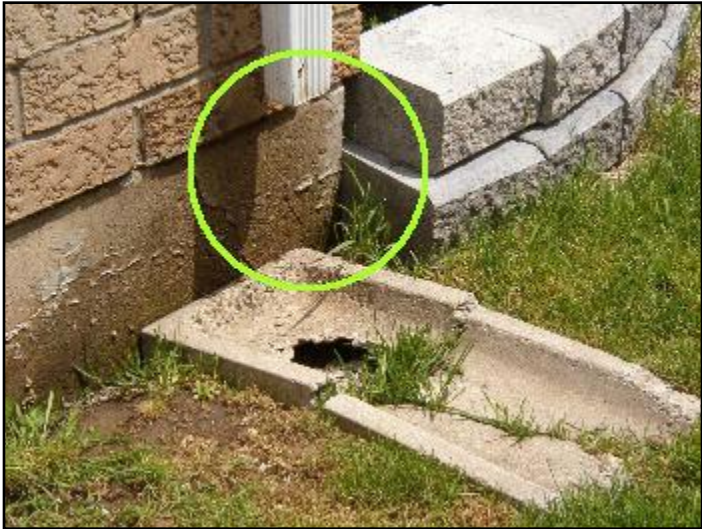
4. Condition: • [Downspouts end too close to building](#)

Implication(s): Chance of water damage to contents, finishes and/or structure

Location: East Exterior wall

3. Downspout ends too close to building

The downspout should be extended to discharge at least 6 feet from the home. The splash block can be discarded.

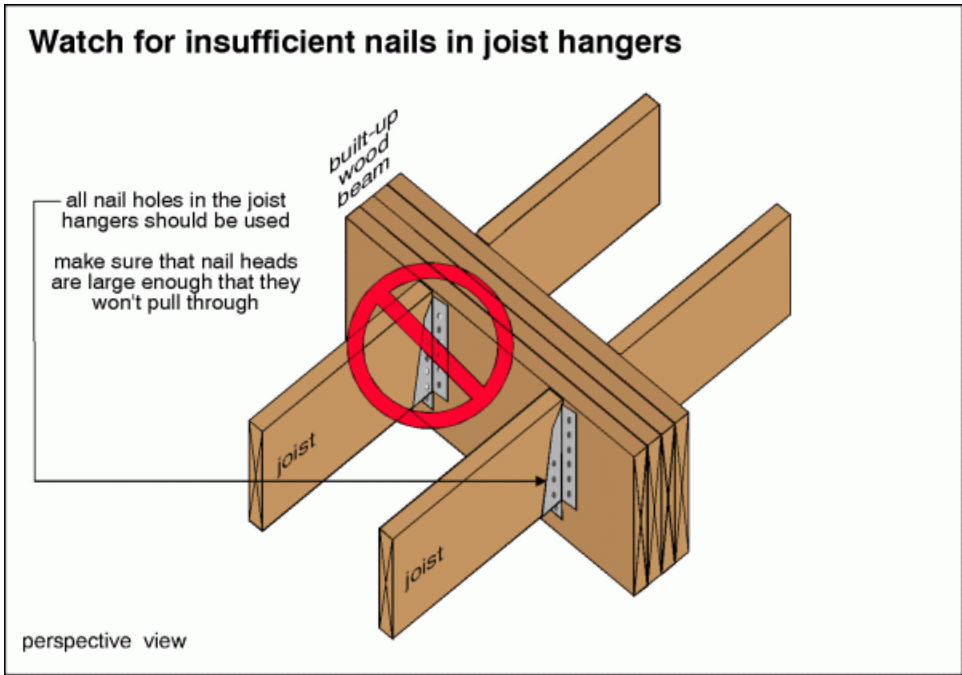
5. Condition: • [Fastener problems](#)

Joist hangers for wood deck are not properly nailed.

Implication(s): Weakened structure | Chance of movement

Location: North Exterior Wall

4. Poor end bearing, joist hanger connections

Task: Improve

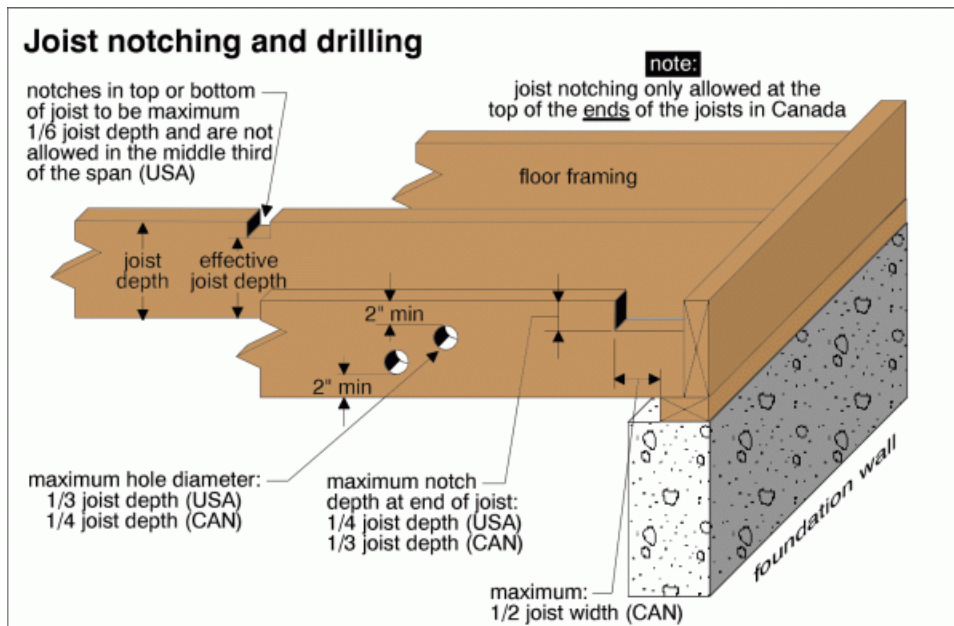
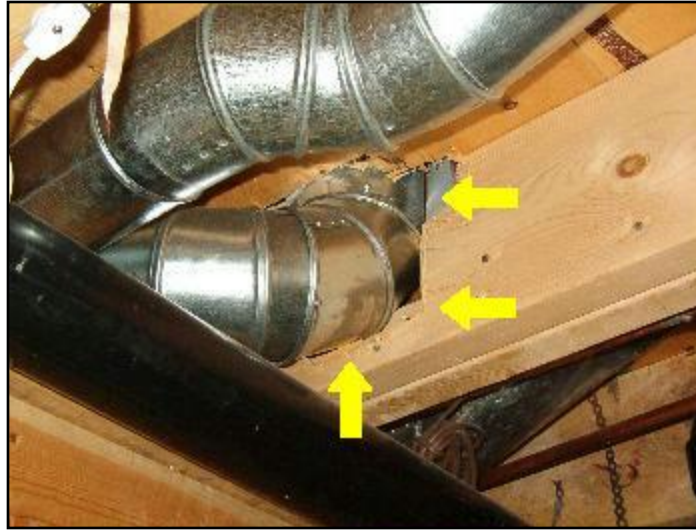
6. Condition: • [Notches or holes](#)

Implication(s): Weakened structure

Location: West

5. Joists are notched and weakened

Task: Repair

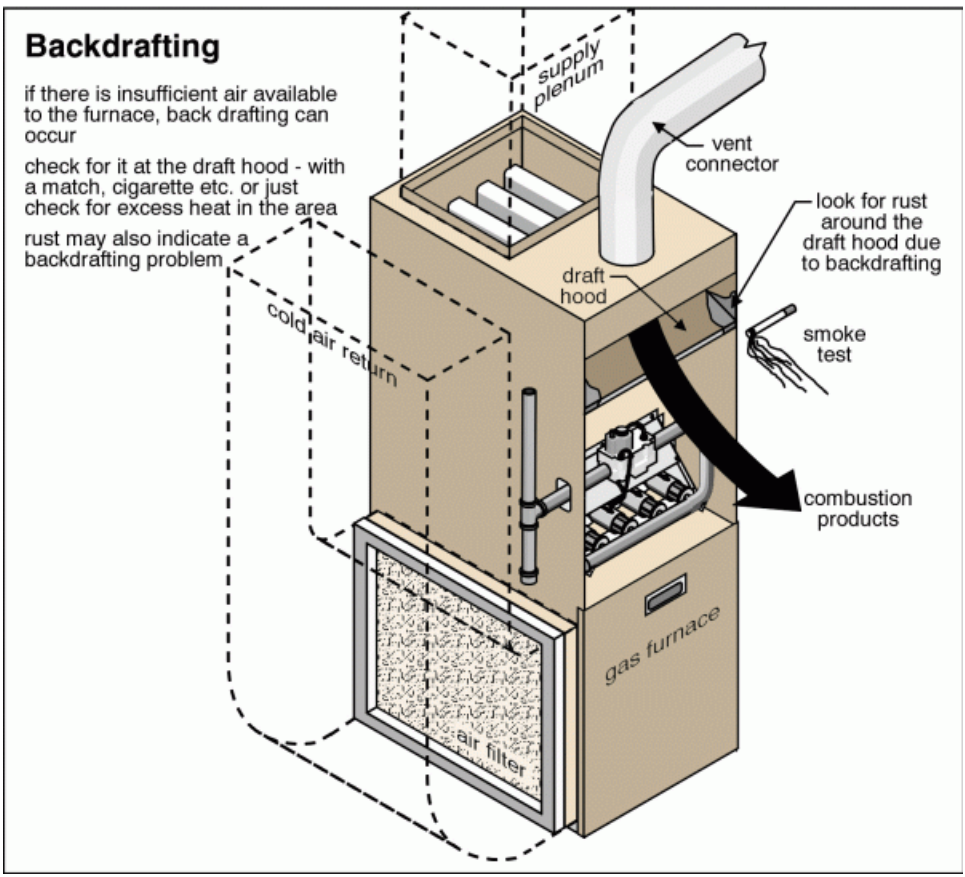
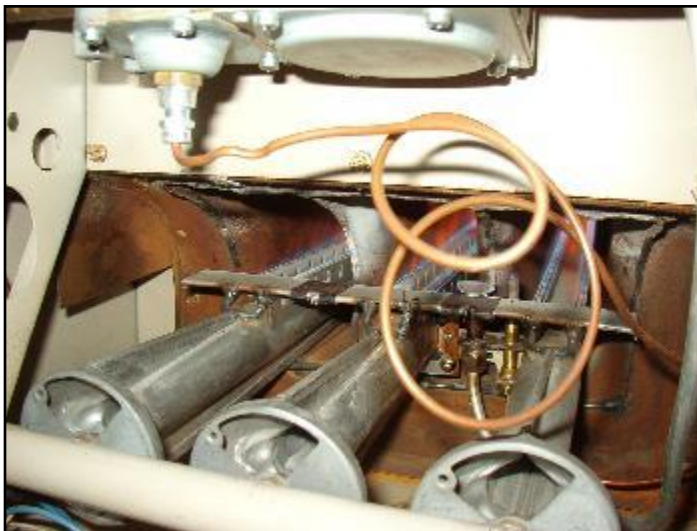
14. **Condition:** • [Draft hood spillage or backdraft](#)

A considerable amount of rust was noted on the front of the furnace.

This suggests a back-drafting problem, with combustion products entering the home.

This is a safety issue that should be addressed without delay.

Implication(s): Equipment not operating properly | Hazardous combustion products entering home

9. Rust at bottom of heat exchanger

Task: Correct

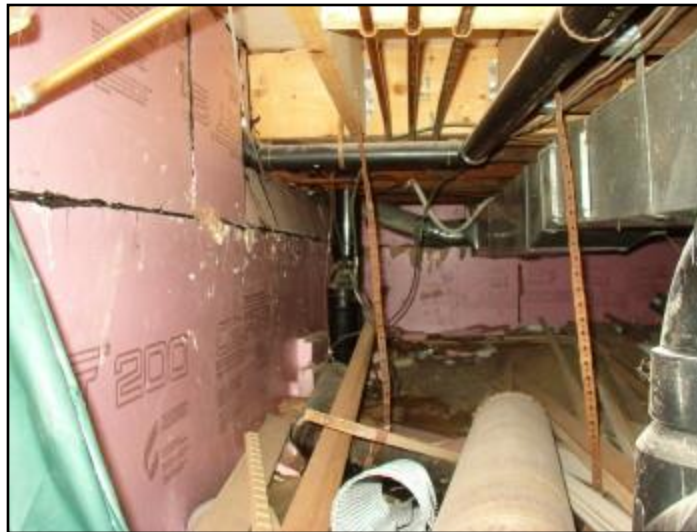
16. Condition: • [Exposed combustible insulation](#)

Implication(s): Fire hazard

Location: West Crawl space

12. Exposed polystyrene insulation is fire hazard

Task: Remove or cover with drywall

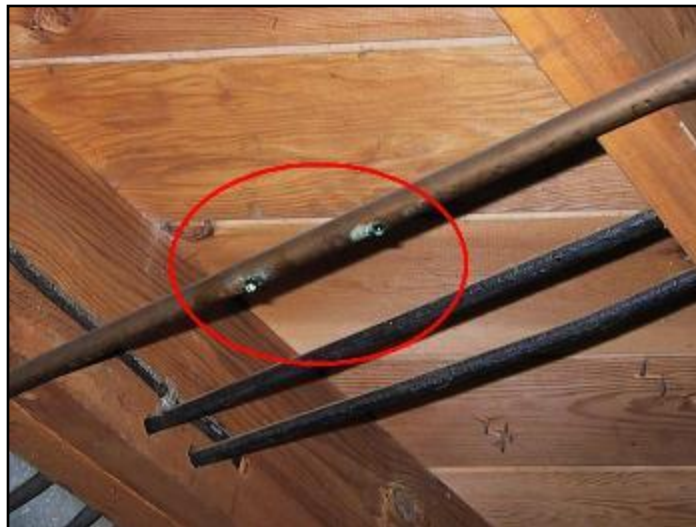
17. Condition: • [Leak](#)

Implication(s): Chance of water damage to contents, finishes and/or structure | System inoperative

Location: Northeast Basement

13. *Leaking copper supply pipe*

Task: Replace

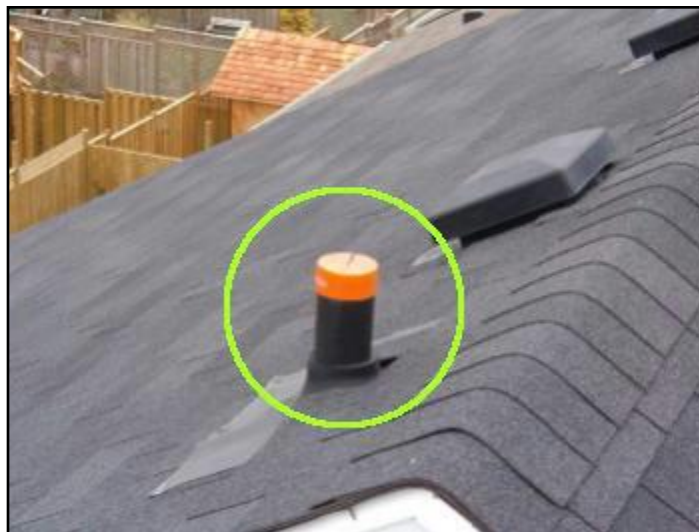
19. Condition: • [Vent termination problems](#)

Implication(s): Reduced operability | Sewer gases entering the building

Location: West central part of roof

15. Plumbing stack is capped

Task: Remove cap

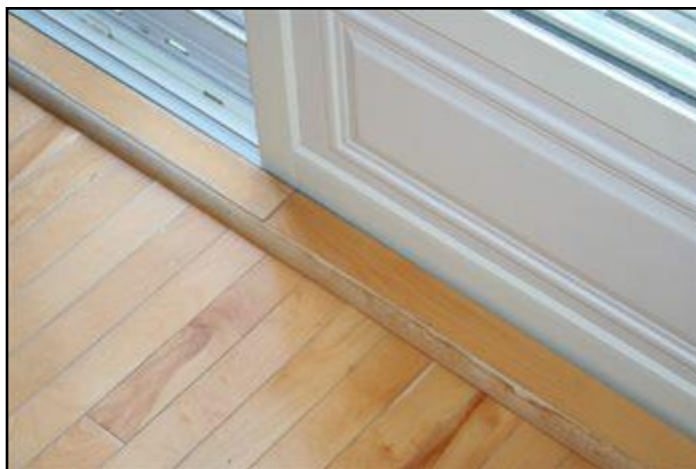
20. Condition: • [Stained](#)

Implication(s): Cosmetic defects

Location: North First Floor Family Room

16. Stained

Task: Repair

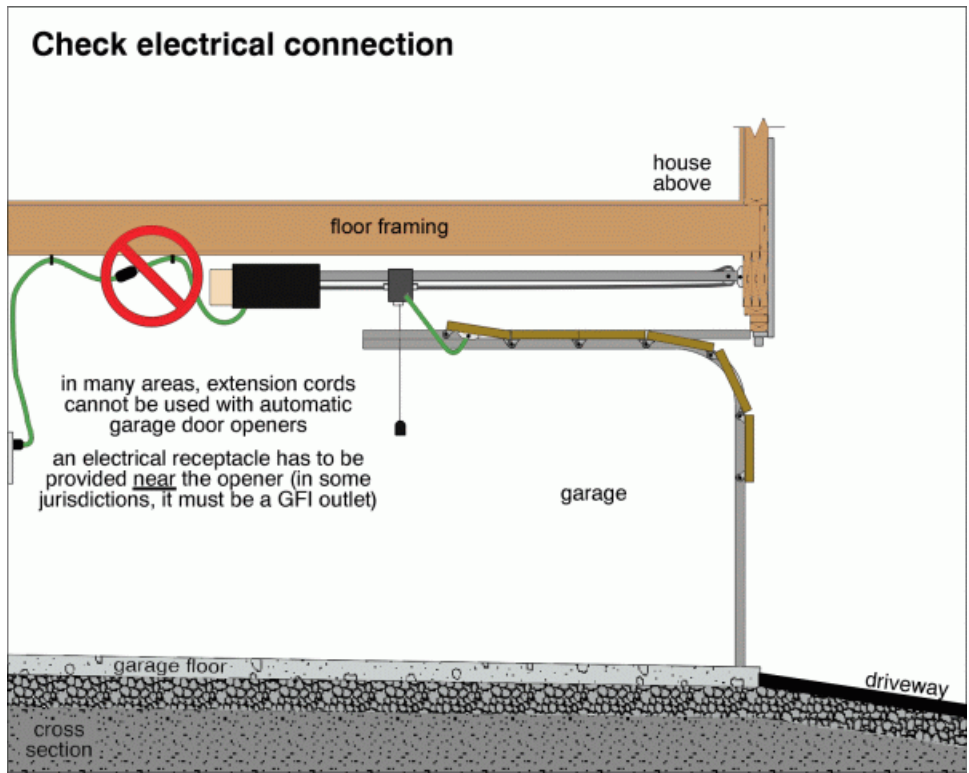
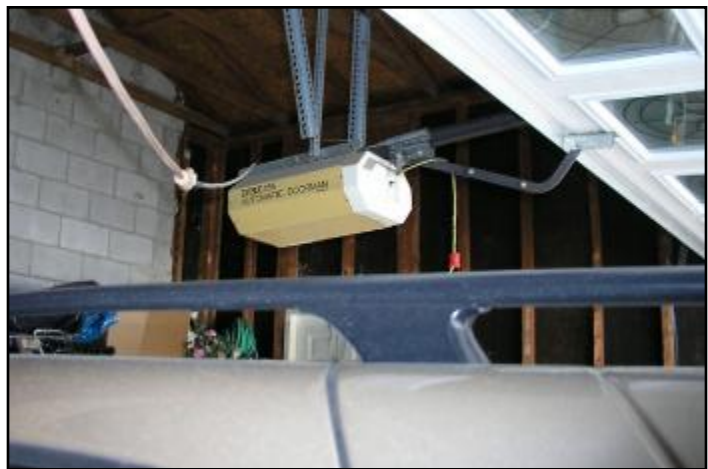
21. Condition: • [Extension cord for opener](#)

Implication(s): Electric shock

Location: Garage

17. Extension cord for west garage door opener

Task: Replace with permanent wiring
