# YOUR INSPECTION REPORT

25 Colony Ct  
Dallas, TX

John Doe <i>Name of Client</i>	Mon, Jan 17, 2022 <i>Date of Inspection</i>
25 Colony Ct, Dallas, TX <i>Address of Inspected Property</i>	
Alan Carson <i>Name of Inspector</i>	<i>TREC License #</i>
<i>Name of Sponsor (if applicable)</i>	<i>TREC License #</i>

RE: Report No. 1009, v.43  
25 Colony Ct  
Dallas, TX

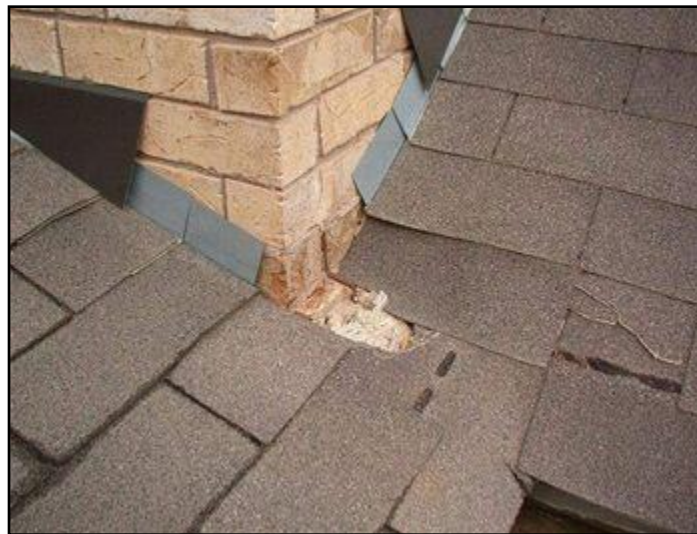
Chimney flashings: Missing top, bottom, side flashings Location(s): North Second Floor

**1. Condition:** • [Missing top, bottom, side flashings](#)

**Implication(s):** Chance of water damage to structure, finishes and contents

**Location:** North Second Floor

1. Missing top, bottom, side flashings

**Task:** Correct

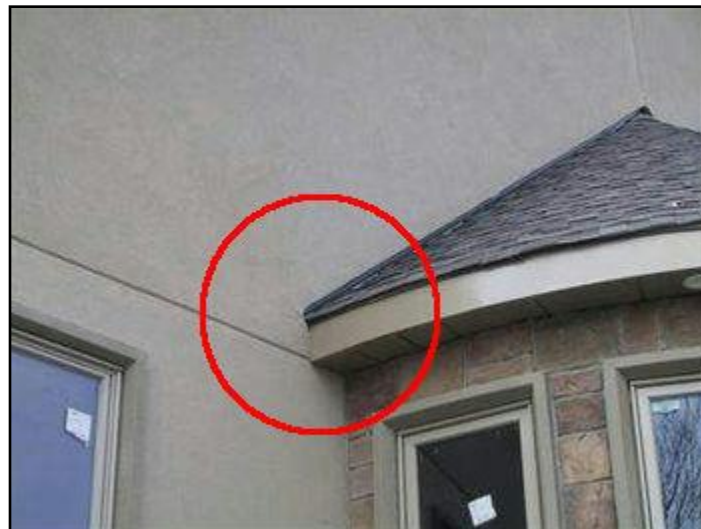
Roof/sidewall flashings: Kickout flashing - missing Location(s): North First Floor

2. Condition: • [Kickout flashing - missing](#)

**Implication(s):** Chance of water damage to structure, finishes and contents

**Location:** North First Floor

2. No kickout flashing

**Task:** Improve

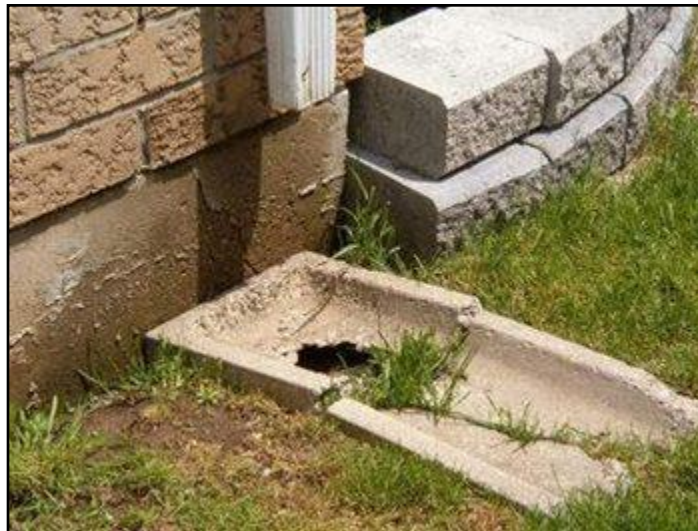
Lot grading: Downspouts to close to end of building. Location(s): Front

**3. Condition:** • Downspouts too close to end of building.

**Location:** Front

*3. Downspouts end too close to building*

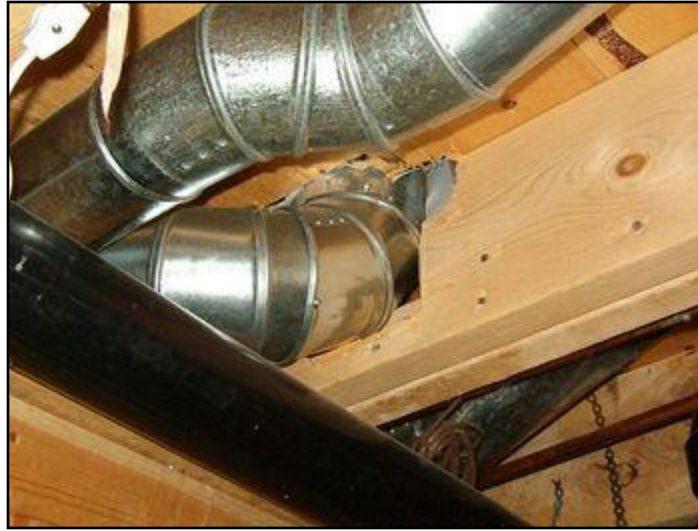
Joists: Notches or holes Location(s): West

4. Condition: • [Notches or holes](#)

Implication(s): Weakened structure

Location: West

4. Notches or holes

Task: Replace

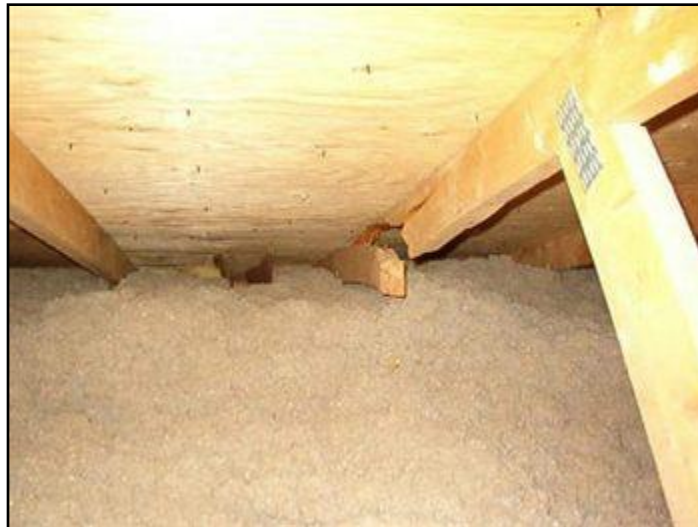
Rafters/trusses: Split Location(s): Northwest Attic

5. Condition: • [Split](#)

**Implication(s):** Weakened structure | Chance of structural movement

**Location:** Northwest Attic

5. Split

**Task:** Repair or replace

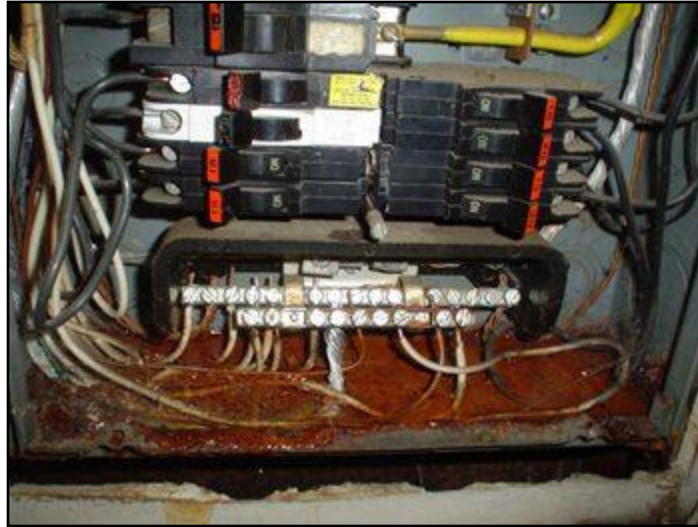
Distribution panel: Rust or water in panel Location(s): North Utility Room

**6. Condition:** • [Rust or water in panel](#)

**Implication(s):** Electric shock | Fire hazard

**Location:** North Utility Room

6. Rust or water in panel

**Task:** Replace

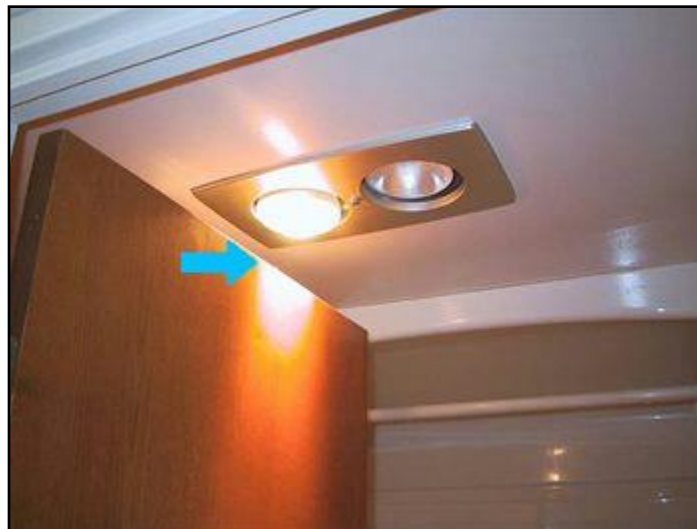
Lights: Heat lamps over doors Notes: This is my note Location(s): East Second Floor Bathroom

**7. Condition:** • [Heat lamps over doors](#)

**Implication(s):** Fire hazard

**Location:** East Second Floor Bathroom

7. Heat lamps over doors

**Task:** Correct

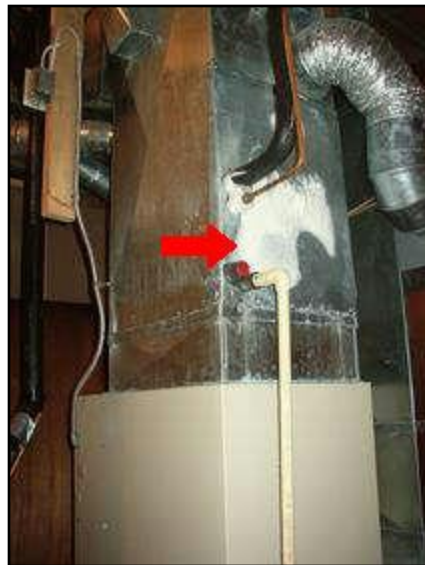
Evaporator coil: Frost Notes: This is my note Location(s): Utility Room

**9. Condition:** • [Frost](#)

8. Frost

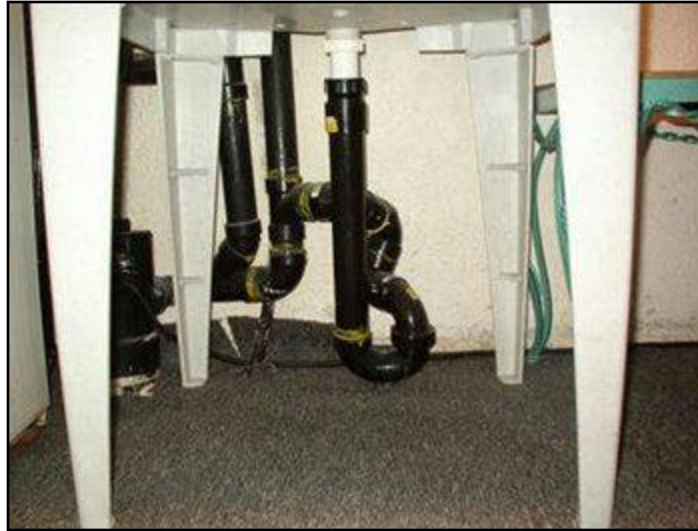
**11. Condition:** • [Nonstandard shape or material](#)

9. Nonstandard shape or material

**Task:** Improve

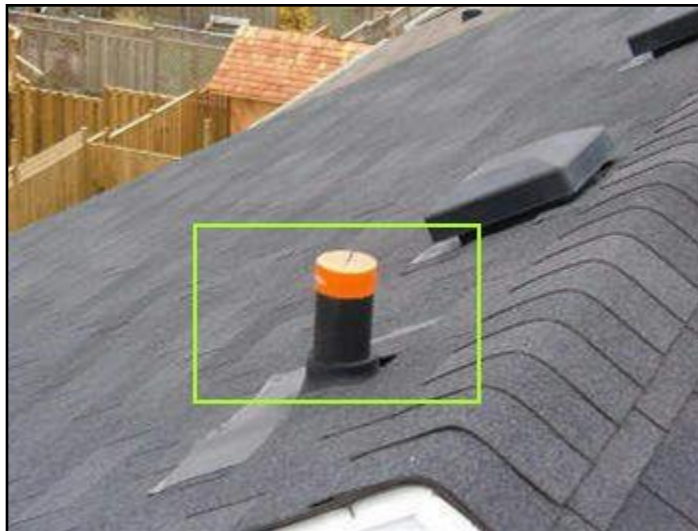
12. Condition: • [Vent termination problems](#)

10. Vent termination problems

Task: Remove cap

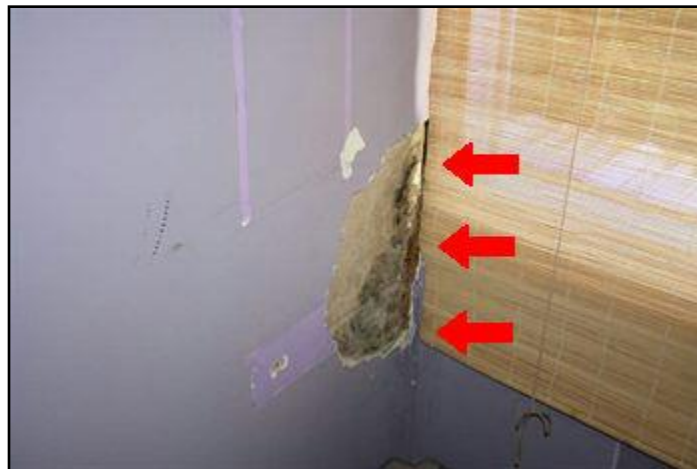
General notes: Water leaks Notes: Evidence of leakage was noted at the bottom of one window. A moisture meter indicated the area was not wet at the time of the inspection. The situation should be monitored, and repairs may be necessary if leakage occurs.

Location(s): East Second Floor Bedroom

**14. Condition:** • [Water leaks](#)

Evidence of leakage was noted at the bottom of one window. A moisture meter indicated the area was not wet at the time of the inspection. The situation should be monitored, and repairs may be necessary if leakage occurs.

**Implication(s):** Chance of damage to finishes and structure | Chance of damage to structure

11. Water leaks
