Inspection Report

4048 Robson St., Calgary IN
55555

Monday, September 30, 2023

Jacques Laplante

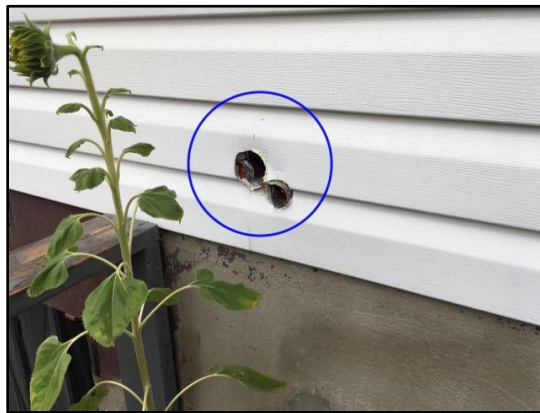
2. Seal all penetrations on exterior walls

Seal all penetrations on exterior walls

Implications: Chance of water damage to surfaces and structure below

Location: Various

Task: Provide

Time: As soon as possible

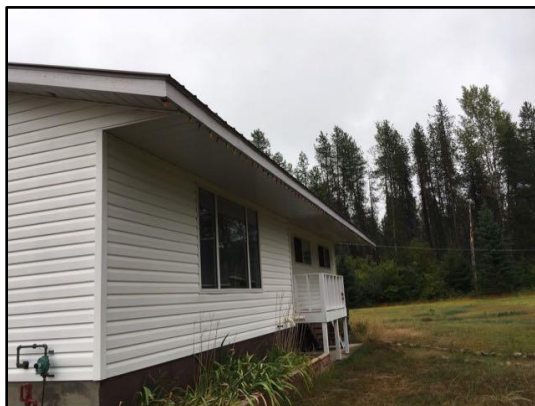
3. Missing

ROOF DRAINAGE\GUTTERS

Missing

Implications: Chance of water damage to contents, finishes and/or structure

Location: Roof edge

Task: Provide gutters and downspouts

Time: Immediate

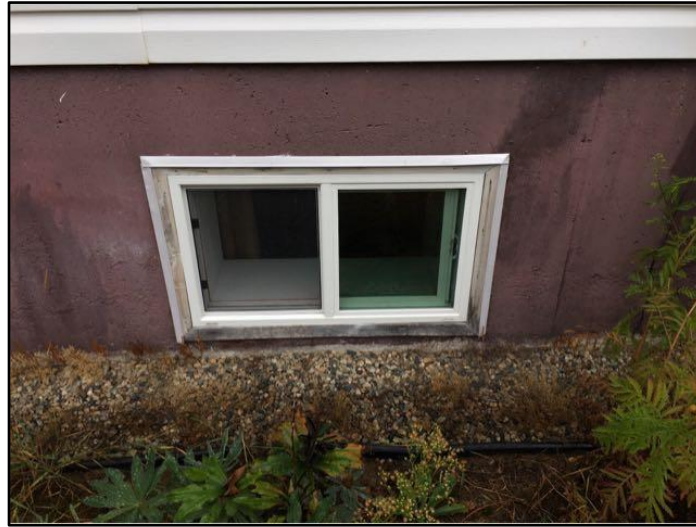
4. Damage

EXTERIOR GLASS/WINDOWS\EXTERIOR TRIM**Damage**

Implications: Chance of water damage to contents, finishes and/or structure

Location: Various basement windows

Task: Replace

Time: Less than 1 year

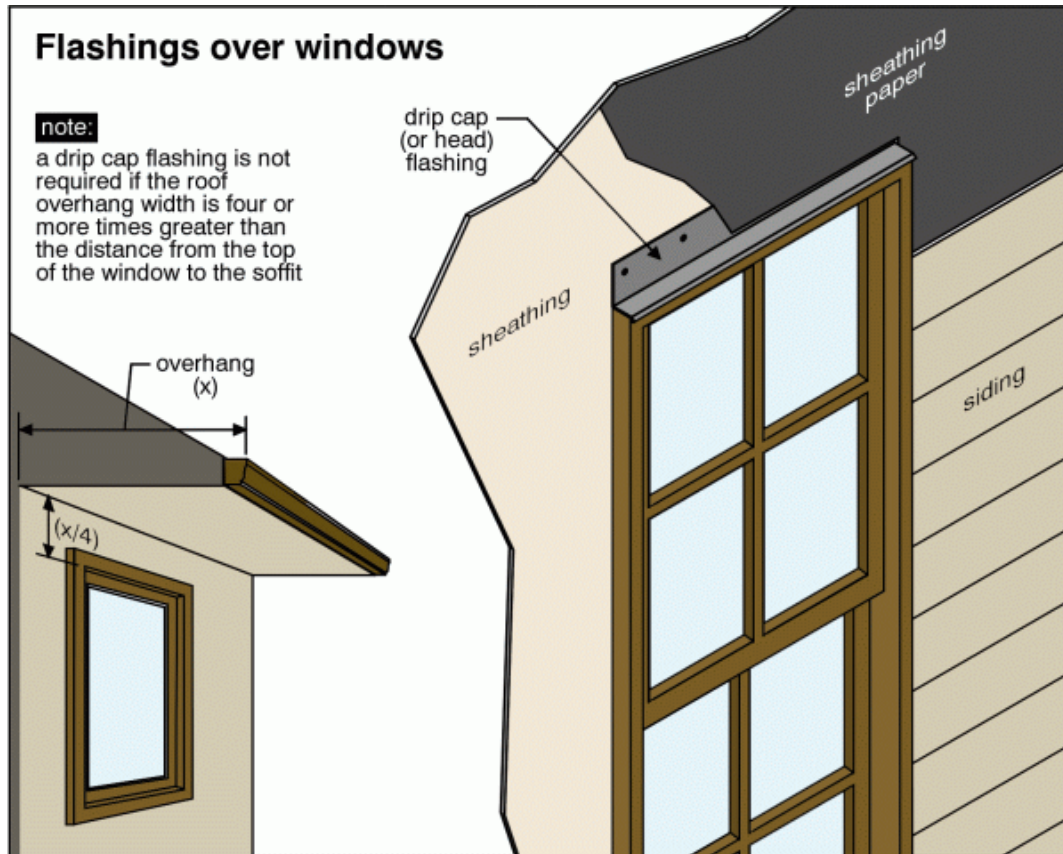
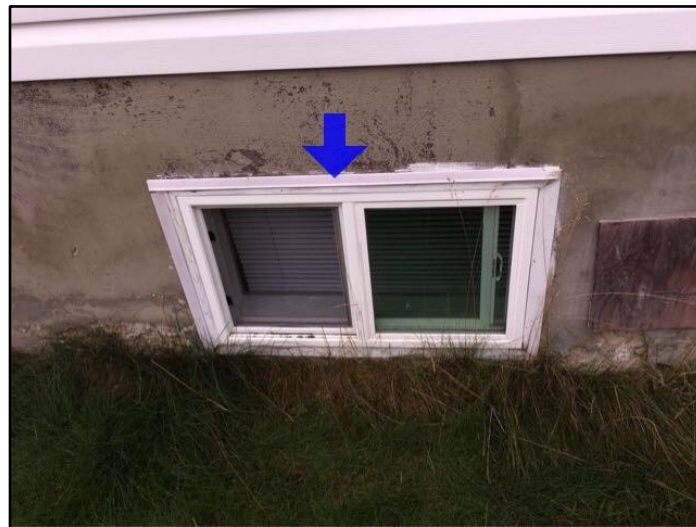
5. Ineffective

EXTERIOR GLASS/WINDOWS\EXTERIOR DRIP CAPS/DRIP CAP FLASHING/HEAD FLASHING**Ineffective**

Implications: Chance of water damage to contents, finishes and/or structure

Location: Basement North

Task: Replace

Time: As soon as possible

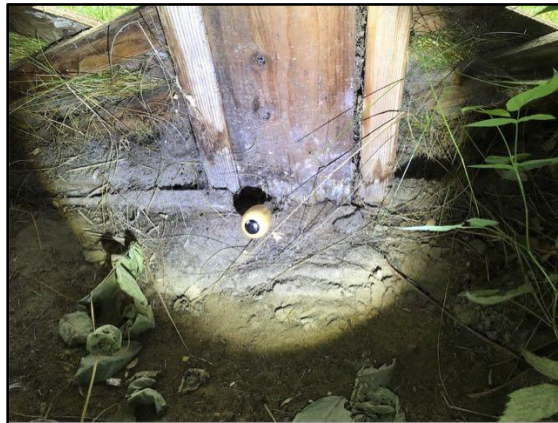
6. Rot or insect damage

PORCHES, DECKS, STAIRS, PATIOS AND BALCONIES\COLUMNS / POSTS**Rot or insect damage**

Implications: Weakened structure | Chance of movement

Location: Deck

Notes: Have certified contractor estimate replacement cost.

Task: Replace

Time: As soon as possible

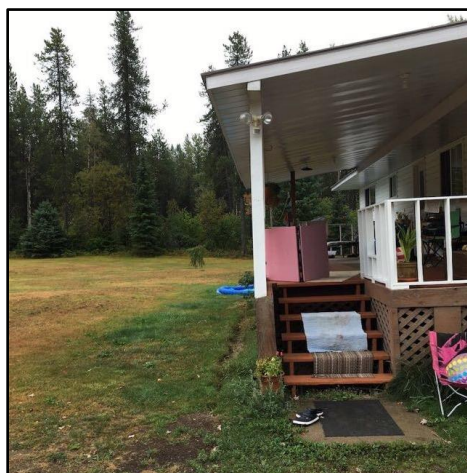
7. Leaning

PORCHES, DECKS, STAIRS, PATIOS AND BALCONIES\COLUMNS / POSTS**Leaning**

Implications: Weakened structure | Chance of movement

Location: Deck

Task: Further evaluation and repair

Time: As soon as possible

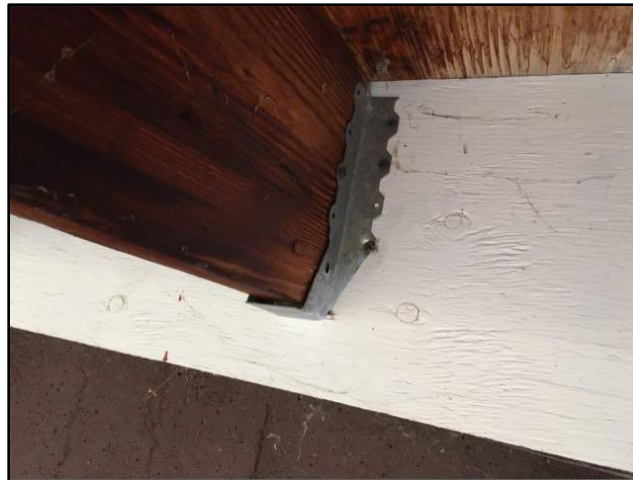
8. Improper fasteners on hangers

PORCHES, DECKS, STAIRS, PATIOS AND BALCONIES\JOISTS

Improper and missing fasteners on joist hangers

Location: Balcony

Task: Replace and provide

Time: As soon as possible

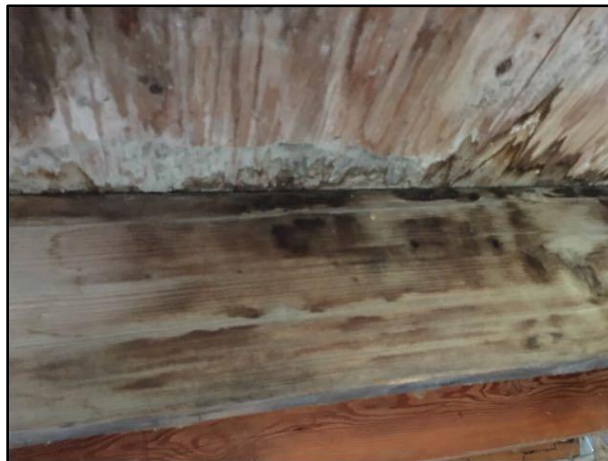
9. Damage

PORCHES, DECKS, STAIRS, PATIOS AND BALCONIES\FLOORS**Damage**

Implications: Weakened structure | Chance of movement

Location: Deck

Task: Replace/repair

Time: As soon as possible

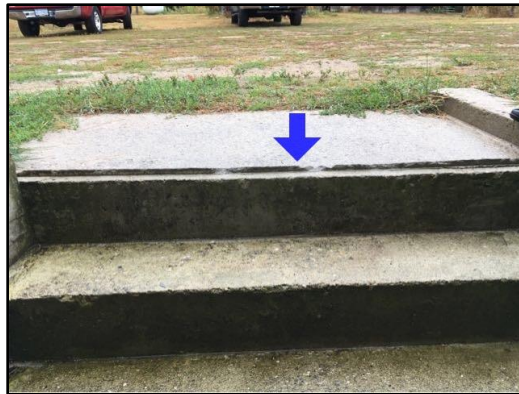
10. Trip hazard

PORCHES, DECKS, STAIRS, PATIOS AND BALCONIES\STAIRS AND LANDINGS

Trip hazard

Location: Walkout basement

Task: Improve

Time: As soon as possible

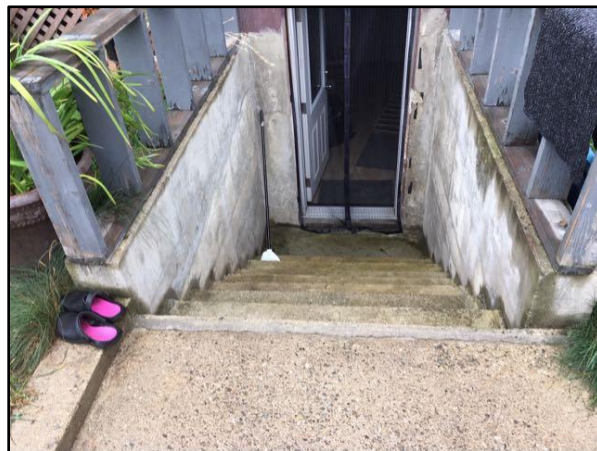
11. Missing

PORCHES, DECKS, STAIRS, PATIOS AND BALCONIES\HANDRAILS AND GUARDS

[Missing](#)

Implications: Fall hazard

Location: Walkout basement stairs

Task: Provide

Time: Immediate

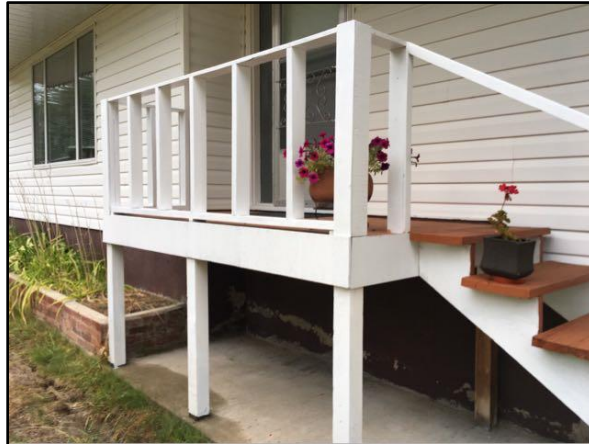
12. Openings between spindles (balusters) too...

PORCHES, DECKS, STAIRS, PATIOS AND BALCONIES\HANDRAILS AND GUARDS[Openings between spindles \(balusters\) too large](#)

Implications: Fall hazard

Location: front balcony

Task: Repair or replace

Time: As soon as possible

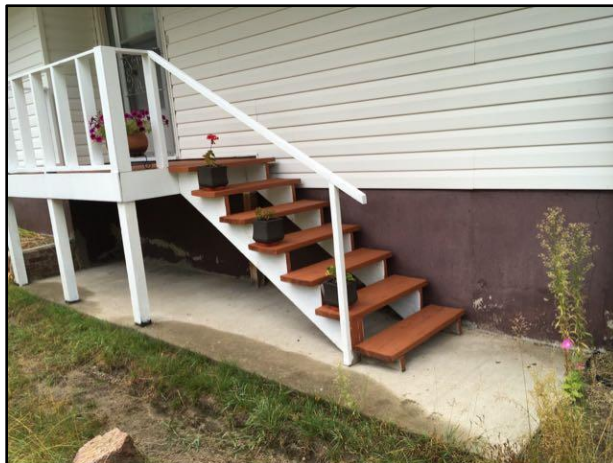
13. Spindles (balusters) missing

PORCHES, DECKS, STAIRS, PATIOS AND BALCONIES\HANDRAILS AND GUARDS[Spindles \(balusters\) missing](#)

Implications: Fall hazard

Location: Deck

Task: Repair or replace

Time: Immediate

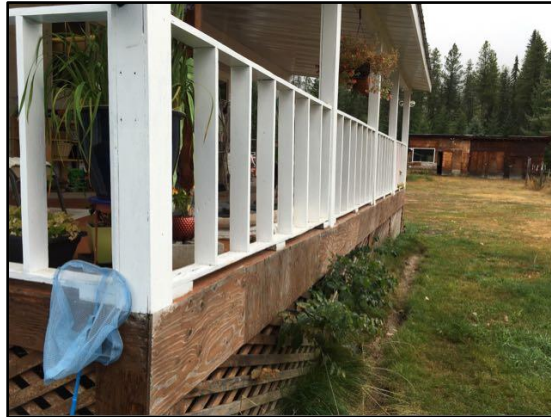
14. Spindles (balusters) too far apart

PORCHES, DECKS, STAIRS, PATIOS AND BALCONIES\HANDRAILS AND GUARDS**Spindles (balusters) too far apart****Implications:** Fall hazard**Location:** Deck**Task:** Repair or replace**Time:** As soon as possible

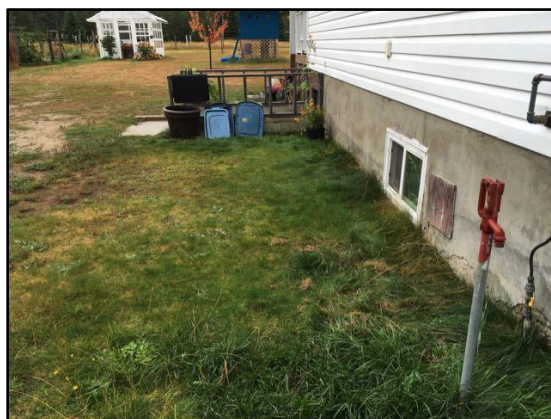
15. Improper slope or drainage

LANDSCAPING\LOT GRADING**Improper slope or drainage****Notes:** Maintain positive slope away from the building to reduce chance of water ingress into the building.**Implications:** Chance of water damage to contents, finishes and/or structure**Location:** East side (alley way)**Task:** Improve**Time:** As soon as possible

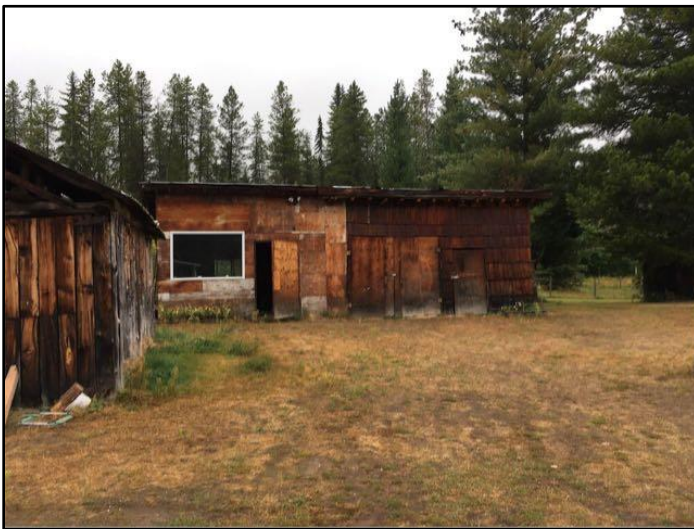
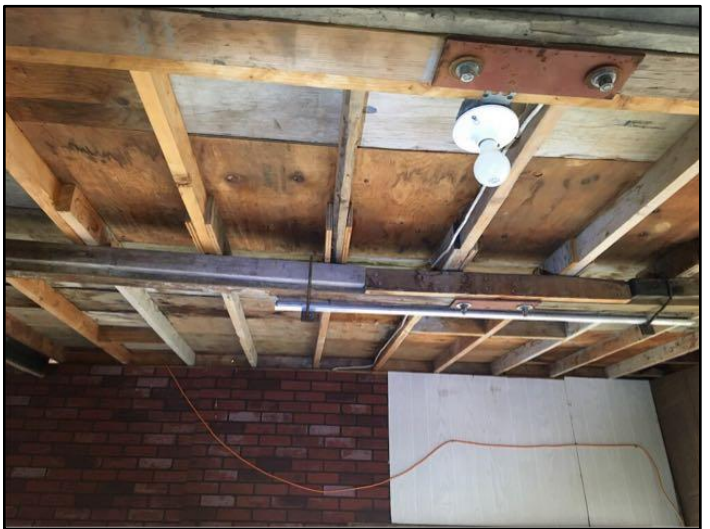
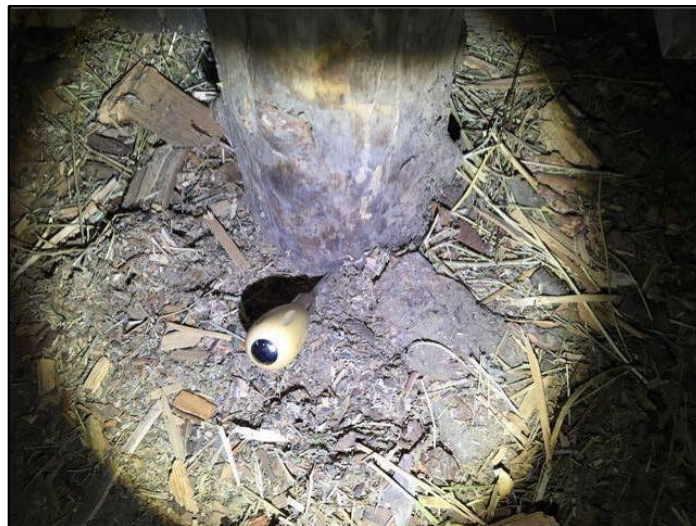
Wood shed is in need of repair. The main beam is weak. Posts are too close to grade.

Implication: Rot

Location: Garage

16. Wood shed structure is in need of repair,...

Task: Further evaluation by qualified contractor

Time: As soon as possible

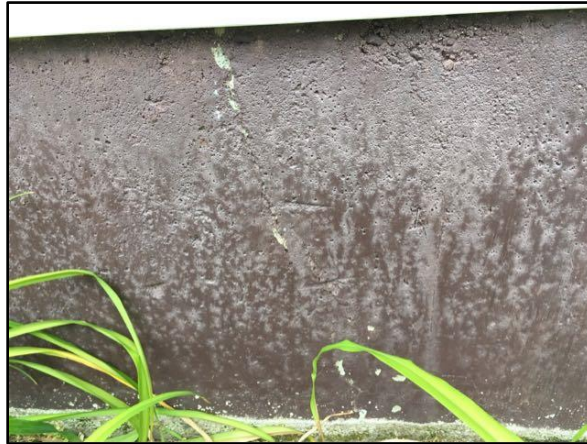
19. Typical minor cracks

FOUNDATIONS\GENERAL

Typical minor cracks

Implications: Chance of water entering building

Location: Various

Task: Repair and monitor

Time: As soon as practical

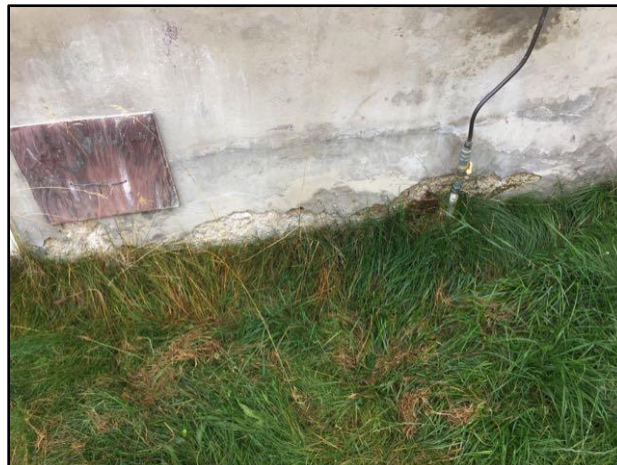
20. Parging damaged or missing

FOUNDATIONS\GENERALParging damaged or missing

Implications: Chance of damage to structure | Shortened life expectancy of material

Location: Various exterior wall

Task: Repair

Time: As soon as possible

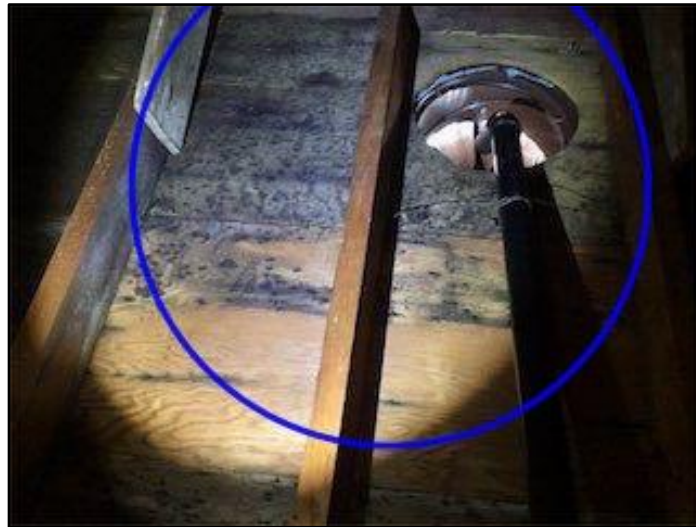
21. Attic staining on roof sheathing...

ROOF FRAMING\SHEATHING**[Attic staining on roof sheathing discoloration](#)****Implications:** Health hazard**Location:** Attic**Task:** Further evaluation by certified contractor**Time:** As soon as possible

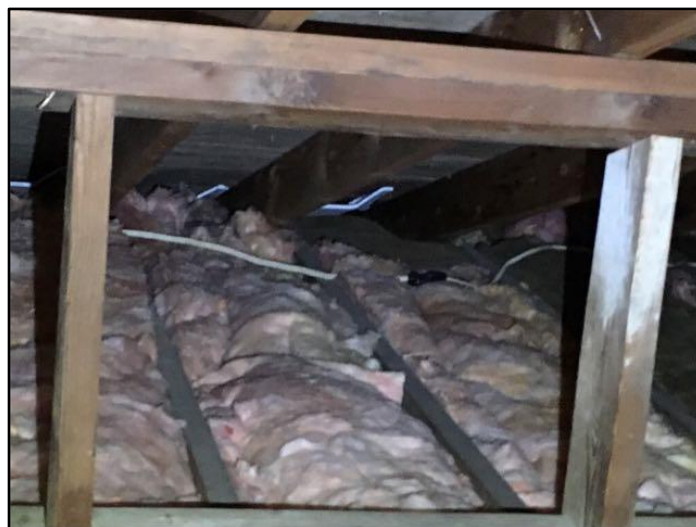
22. Open splices

DISTRIBUTION SYSTEM\WIRING - INSTALLATION

[Open splices](#)

Implications: Electric shock | Fire hazard

Location: Attic

Task: Provide junction box

Time: Immediate

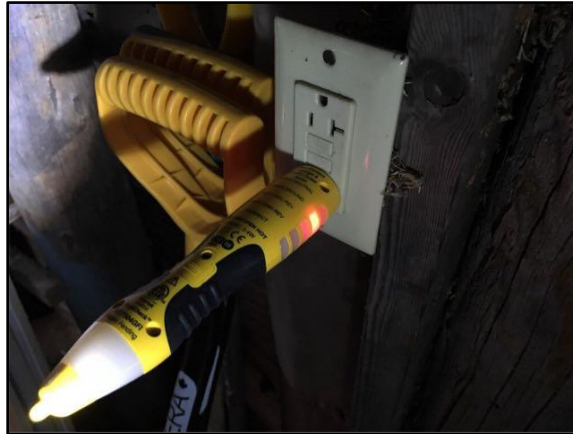
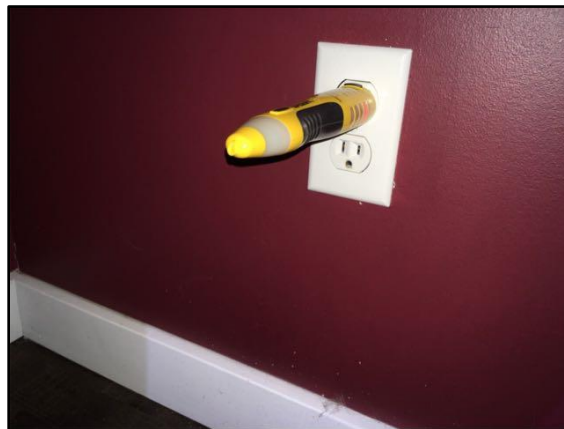
DISTRIBUTION SYSTEM\OUTLETS (RECEPTACLES)[Ungrounded](#)

Implications: Electric shock

Location: Shed and basement bedroom

23. Ungrounded

24. Ungrounded

Task: Correct

Time: As soon as possible

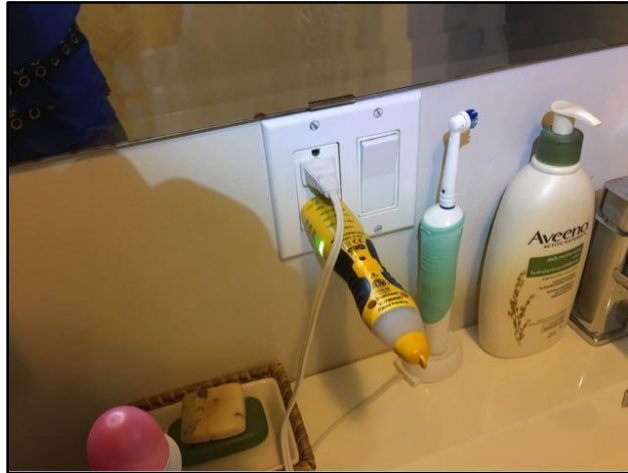
25. GFCI/GFI needed (Ground Fault Circuit...

DISTRIBUTION SYSTEM\OUTLETS (RECEPTACLES)[GFCI/GFI needed \(Ground Fault Circuit Interrupter\)](#)

Implications: Electric shock

Location: Bathroom

Task: Replace with GFCI receptacle

Time: As soon as possible

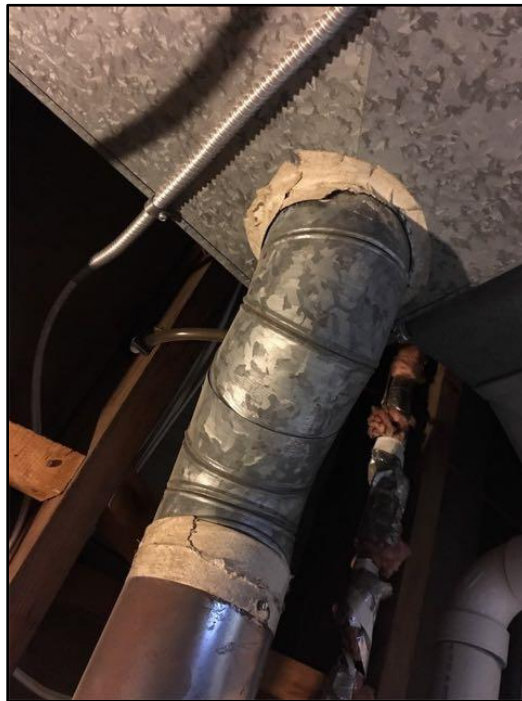
26.

FURNACE\DUCTS, REGISTERS AND GRILLES

Possible asbestos-containing tape around heating ducts

Implications: Health hazard

Location: Furnace Room

Task: Further testing

Time: As soon as possible

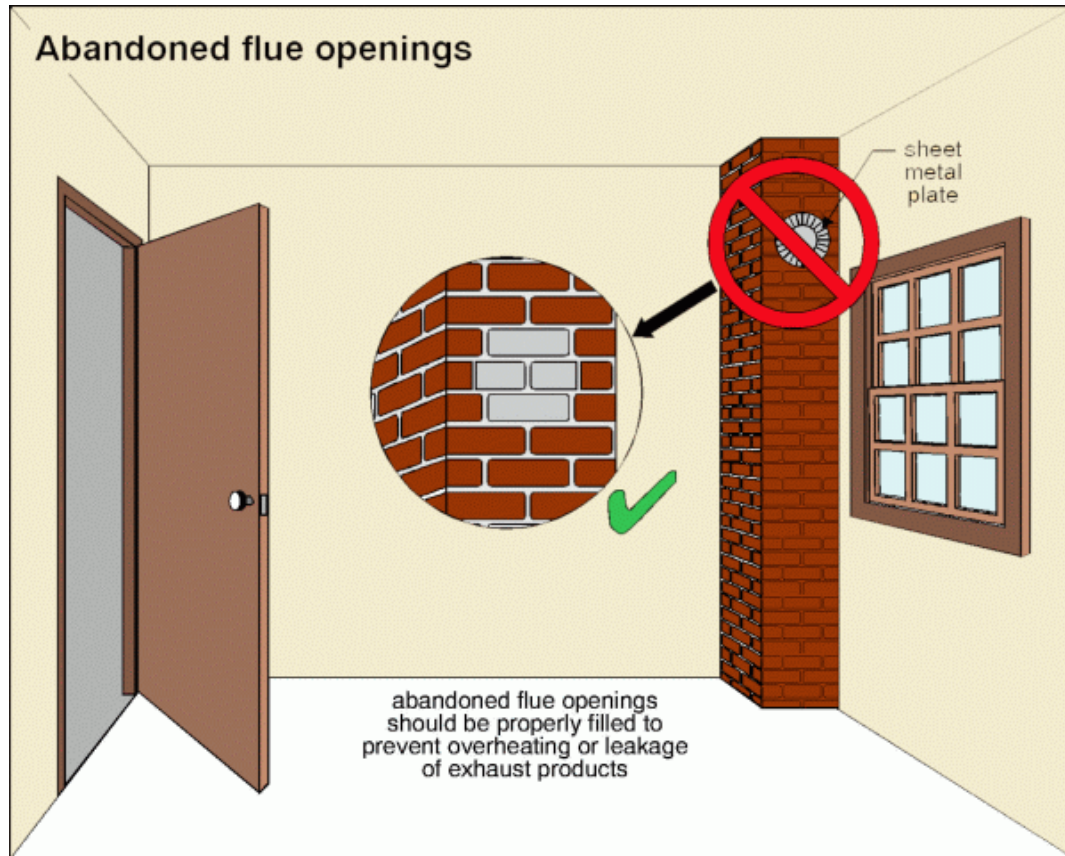
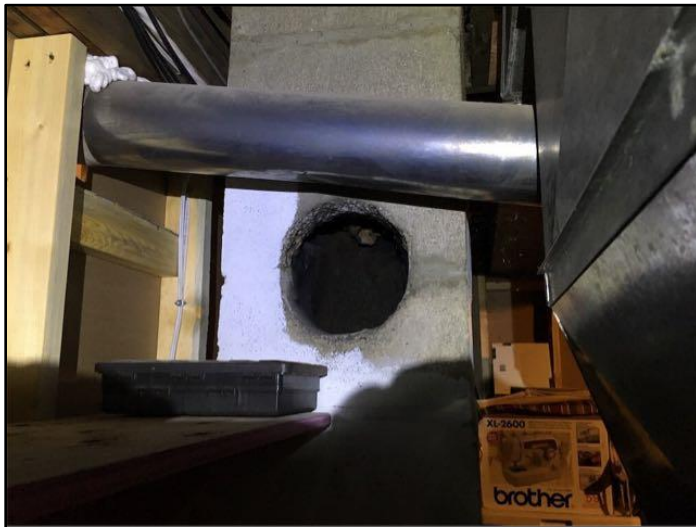
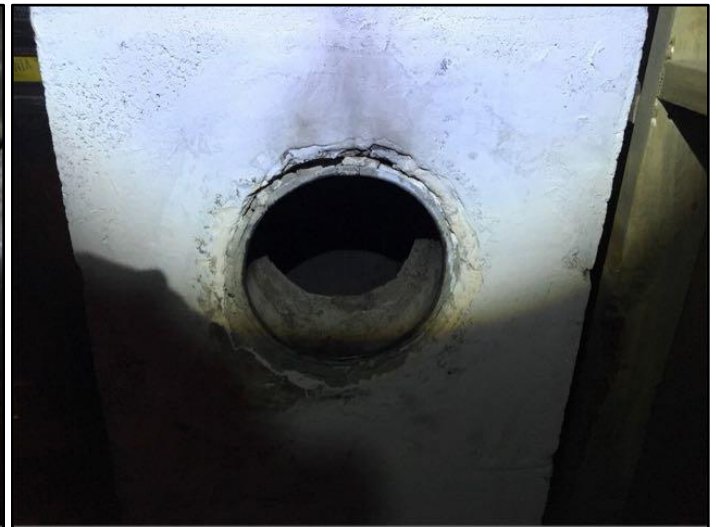
CHIMNEY AND VENT\MASONRY CHIMNEY VENT CONNECTOR

[Abandoned openings for flue connections](#)

Implications: Hazardous combustion products entering home

Location: Utility Room in Basement

27. Abandoned openings for flue connections

28. Abandoned openings for flue connections

Task: Correct

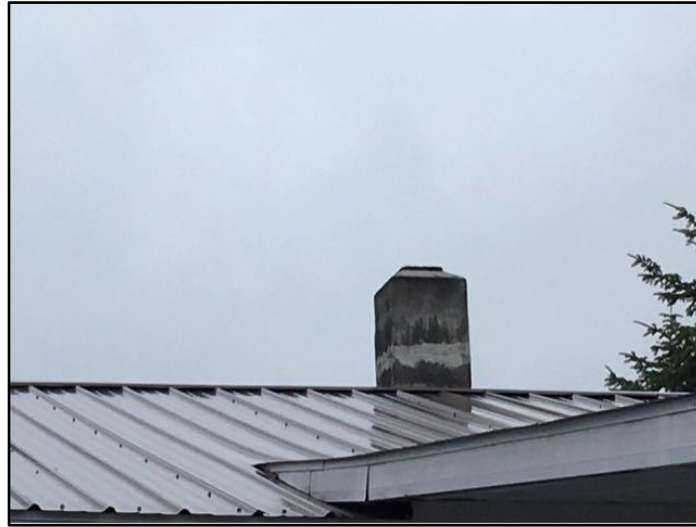
29. Cracked

CHIMNEY AND VENT\MASONRY CHIMNEY CAP**Cracked**

Implications: Chance of water damage to contents, finishes and/or structure | Shortened life expectancy of material

Task: Repair

Time: As soon as possible

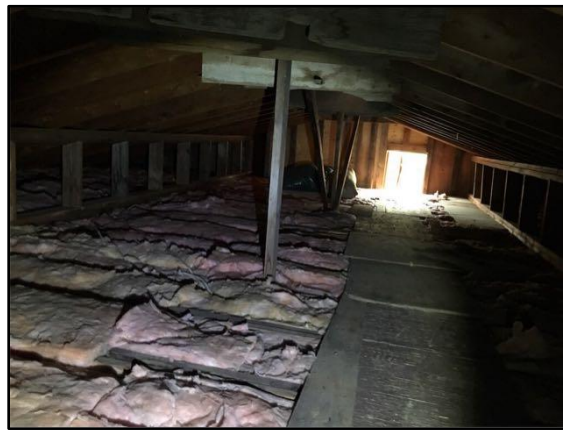
30. Amount less than current standards

ATTIC/ROOF\INSULATION

[Amount less than current standards](#)

Implications: Increased heating and cooling costs

Location: Attic

Task: Improve

Time: At your discretion

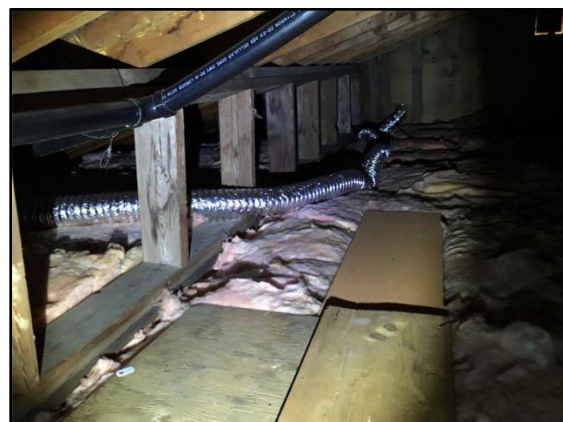
31. Not insulated in unconditioned space

ATTIC/ROOF\DUCT

[Not insulated in unconditioned space](#)

Implications: Chance of condensation damage to finishes and/or structure

Location: Attic

Task: Provide insulation

Time: As soon as possible

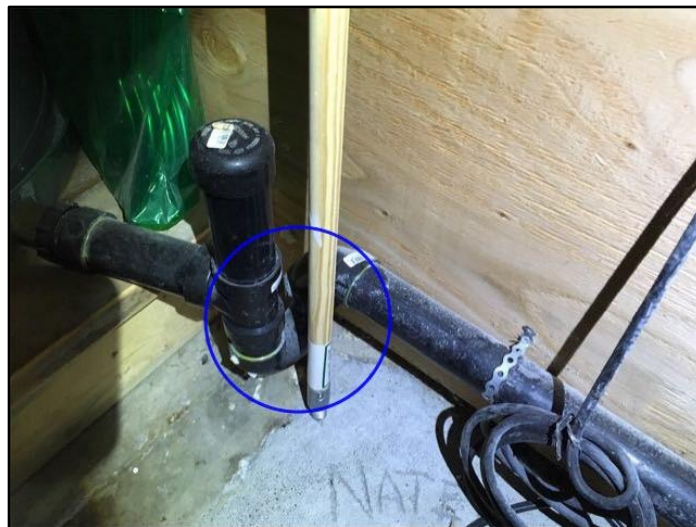
33. No primer

WASTE PLUMBING\DRAIN PIPING - INSTALLATION

No trap primer

Implications: Sewer gas entering the home

Location: Basement

Task: Add water to prime trap

Time: Regular maintenance

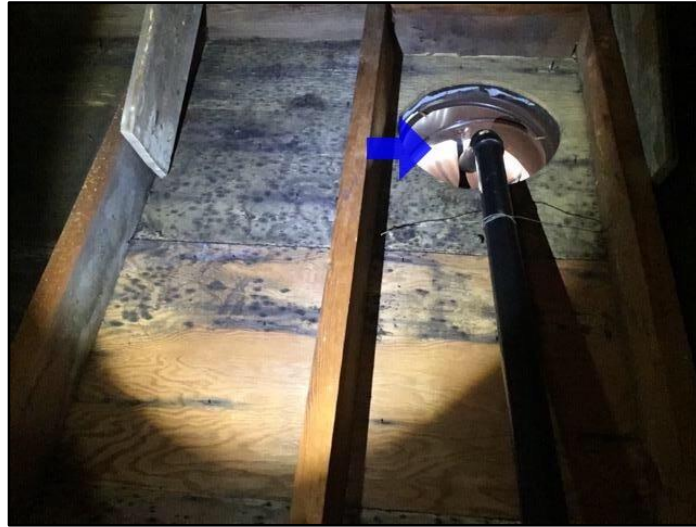
34. Vent termination problems

WASTE PLUMBING\VENTING SYSTEM[Vent termination problems](#)

Implications: Reduced operability | Sewer gases entering the building

Location: Attic

Task: Correct

Time: As soon as possible

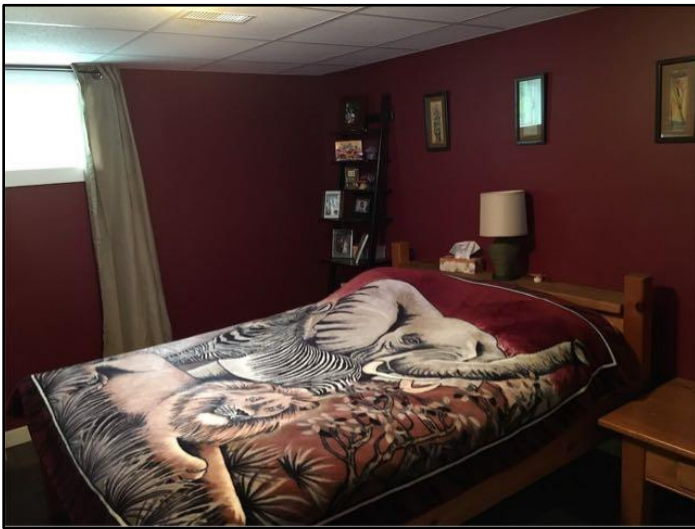
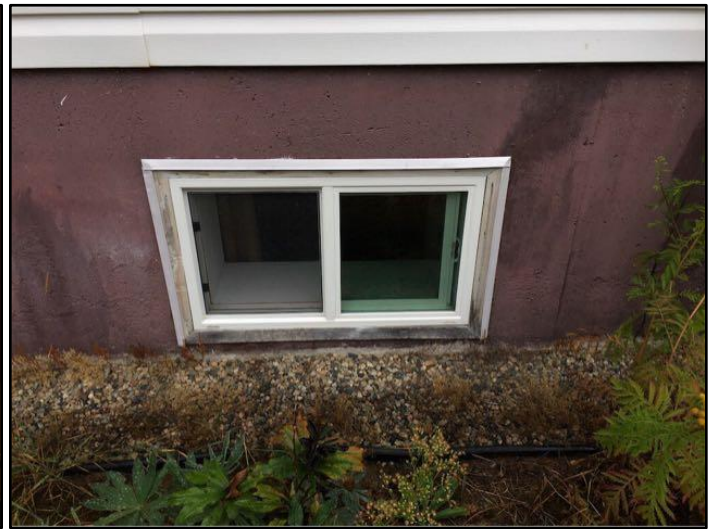
WINDOWS\MEANS OF EGRESS/ESCAPE

[Too small](#)

Implications: Restricted emergency exits

Location: Basement bedroom

35. Too small

36. Too small

Task: Improve

Time: Immediate

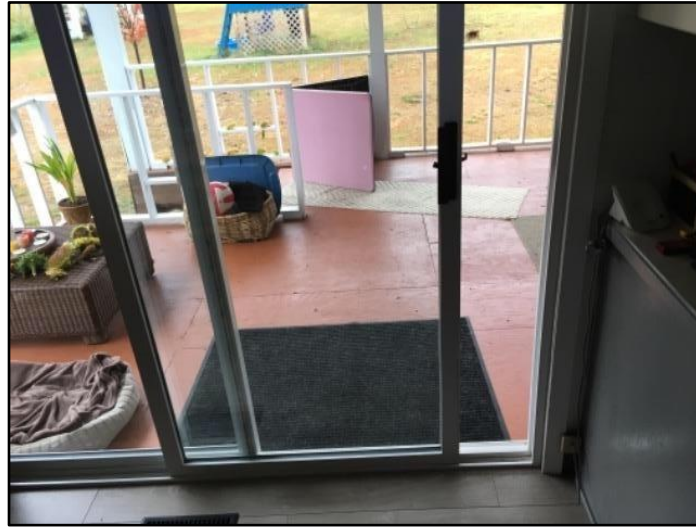
37. Sliding door

DOORS\GENERAL

Sliding door

Notes: Difficult to operate

Implications: Nuisance

Location: Dining Room

Task: Service

Time: As soon as possible

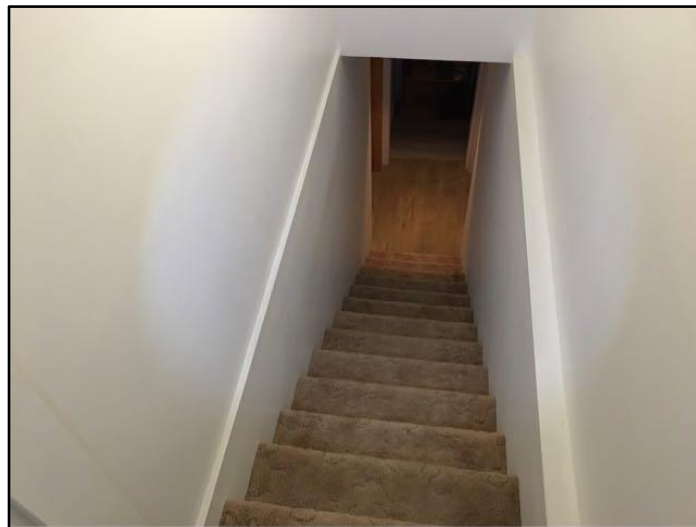
38. Missing

STAIRS\HANDRAILS AND GUARDSMissing**Implications:** Fall hazard**Location:** Staircase**Task:** Provide**Time:** As soon as possible

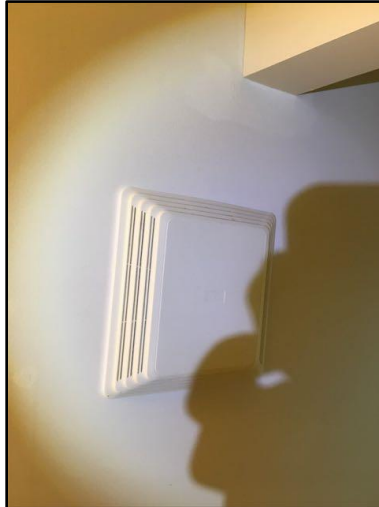
39. Inadequate air movement

EXHAUST FANS\GENERAL**Inadequate air movement**

Implications: Chance of condensation damage to finishes and/or structure

Task: Repair or replace

Time: As soon as possible

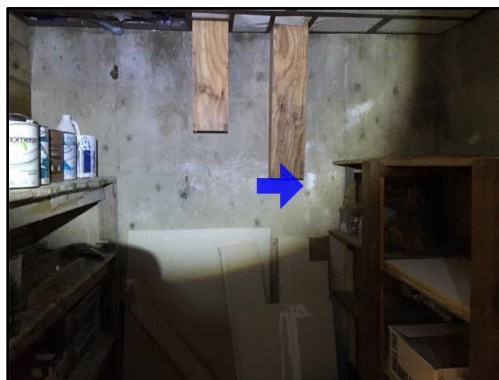
40. Efflorescence

BASEMENT\WET BASEMENT - EVIDENCE**Efflorescence**

Implications: Chance of water damage to contents, finishes and/or structure

Task: Further evaluation

Time: As soon as possible
