Your Inspection Report

100 Edenbridge Dr
Toronto, ON

INSPECTION DATE:
Thursday, May 10, 2018

RE: Report No. 62269
100 Edenbridge Dr
Toronto, ON

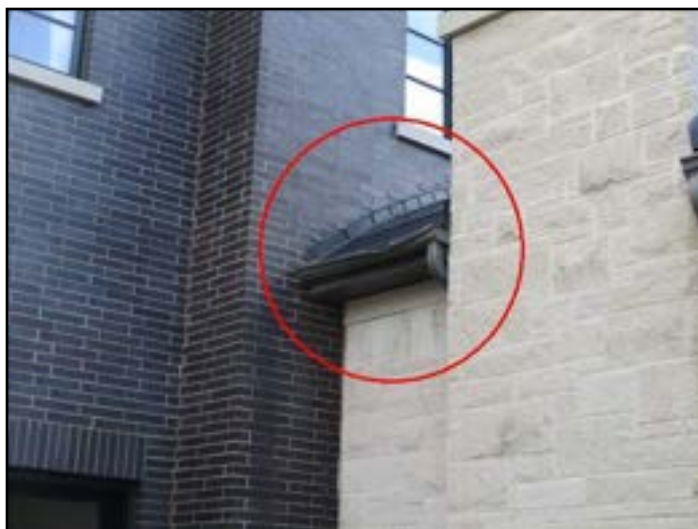
Location: East

Condition: • Damage

Damage

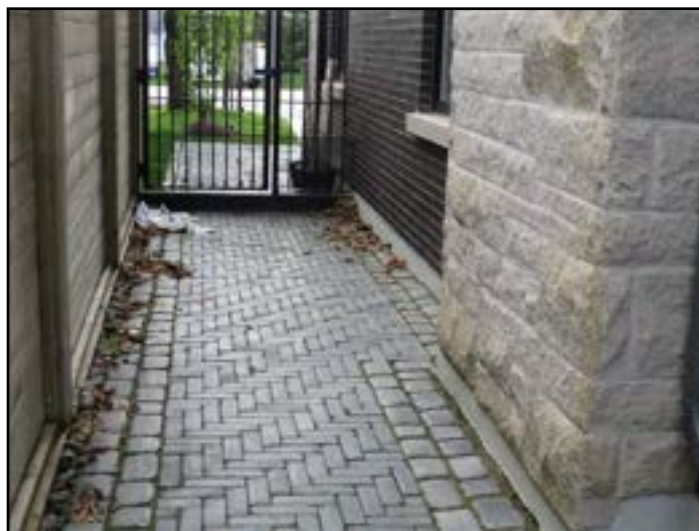
Example - east side

Condition: • [Improper slope or drainage](#)

Implication(s): Chance of water damage to contents, finishes and/or structure

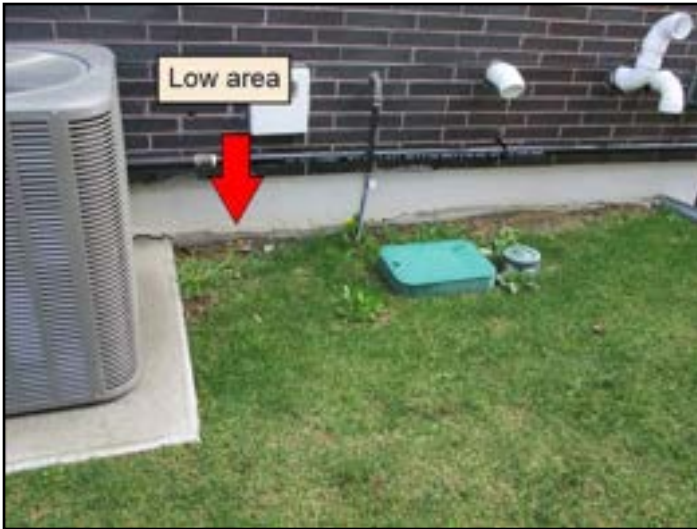
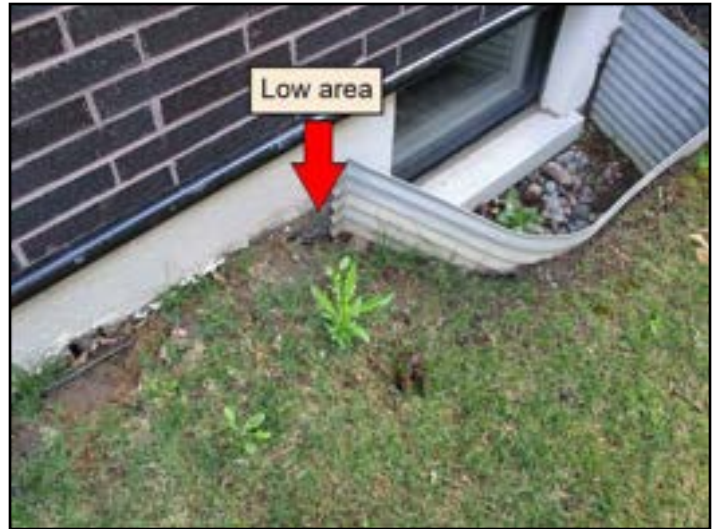
Improper slope or drainage

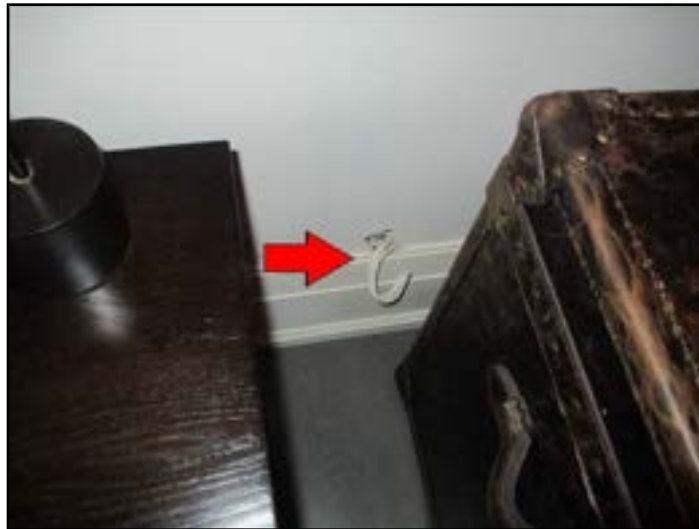
Location: Basement

Condition: • [Missing](#)

Implication(s): Fire hazard | Electric shock

Missing

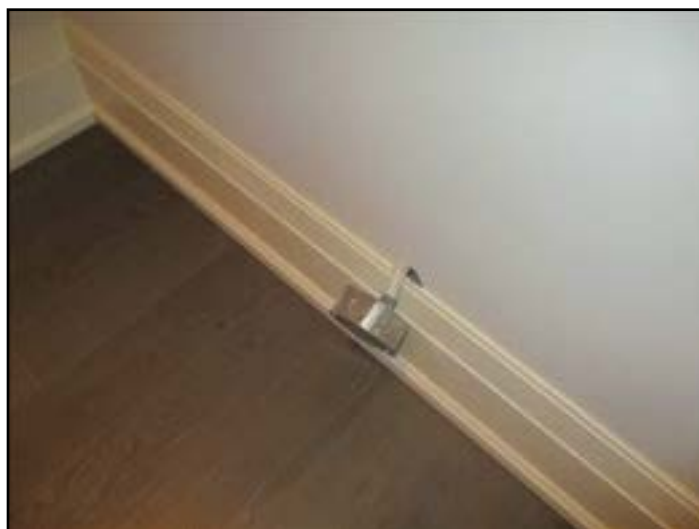
Location: Basement

Condition: • [Loose](#)

Implication(s): Fire hazard | Electric shock

Loose

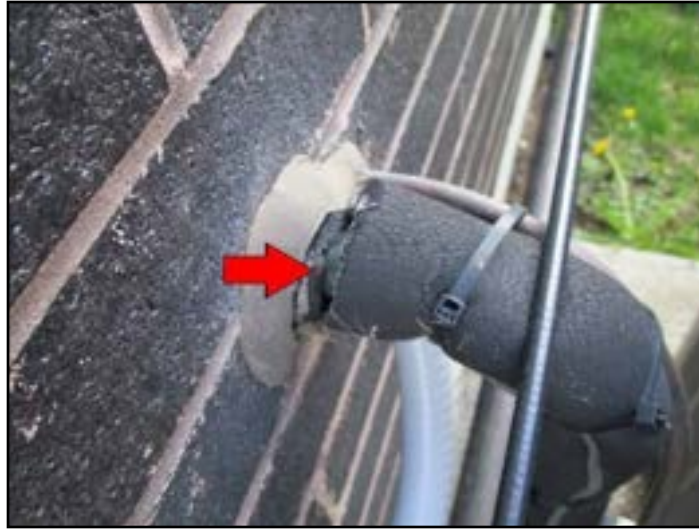
Condition: • [Insulation - missing](#)

Insulation - missing

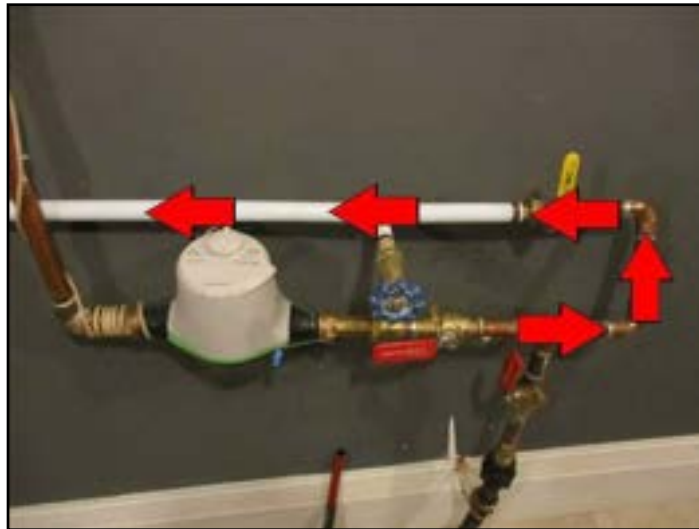
Condition: • Meter bypass should not be present.

Task: Further evaluation / Improve

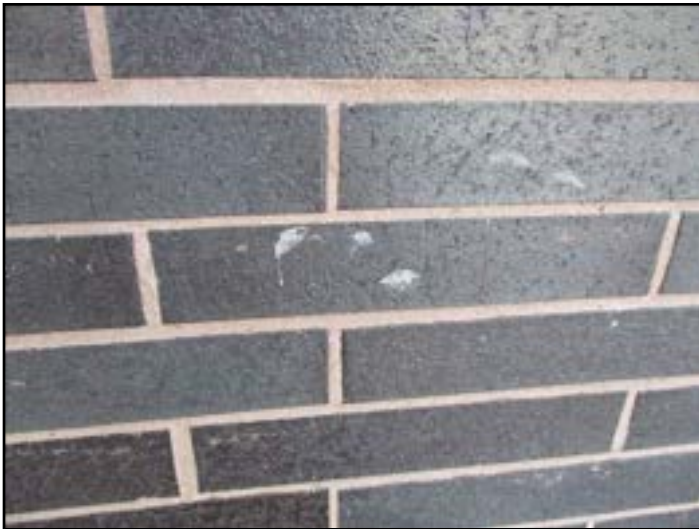
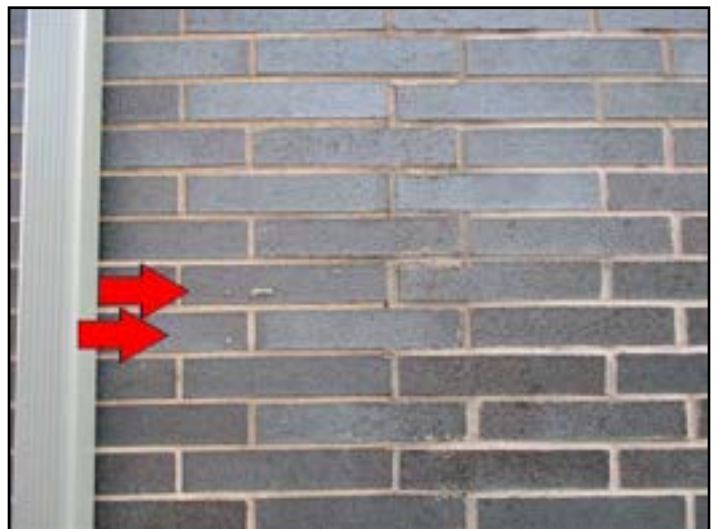
Location: Various

Condition: [4.16 Mortar splatters and stains on exterior masonry](#)

Example - rear of home

Example - northwest corner

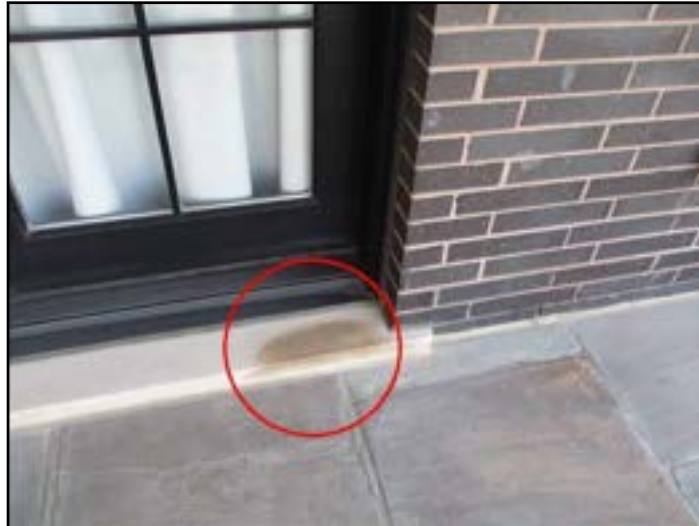
Location: Rear

Condition: • 4.0 Missing, Incomplete or Damaged Items [TARION CPG page 15 of 297]

Example - stained

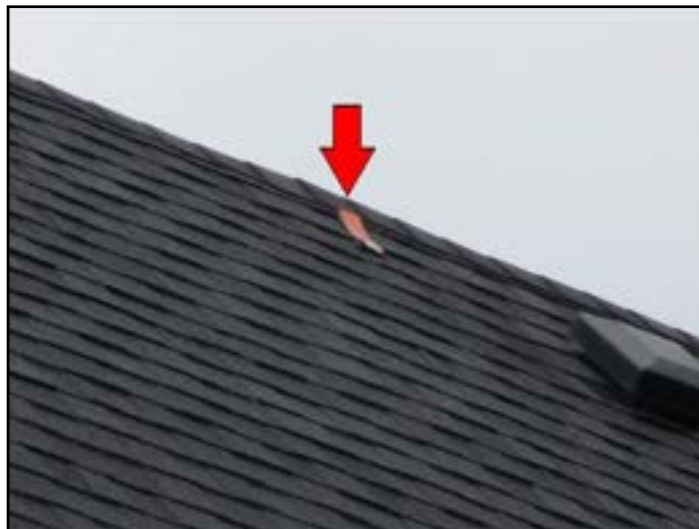
Location: Front

Condition: • [5.16 Temporary safety straps left on roof](#)

5.16 Temporary safety straps left on roof

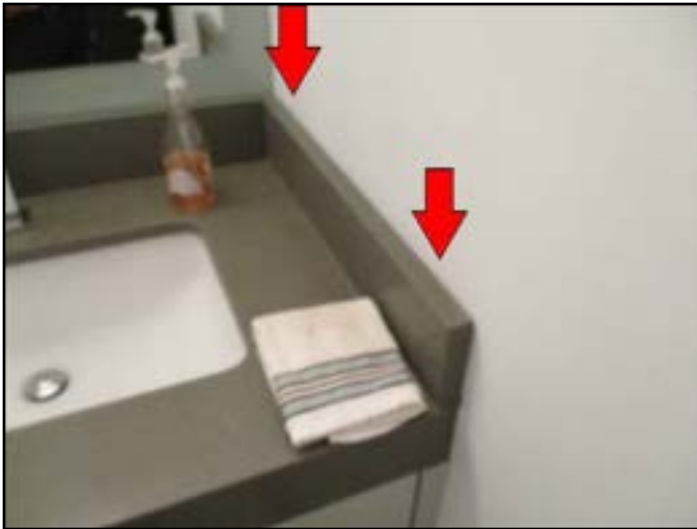
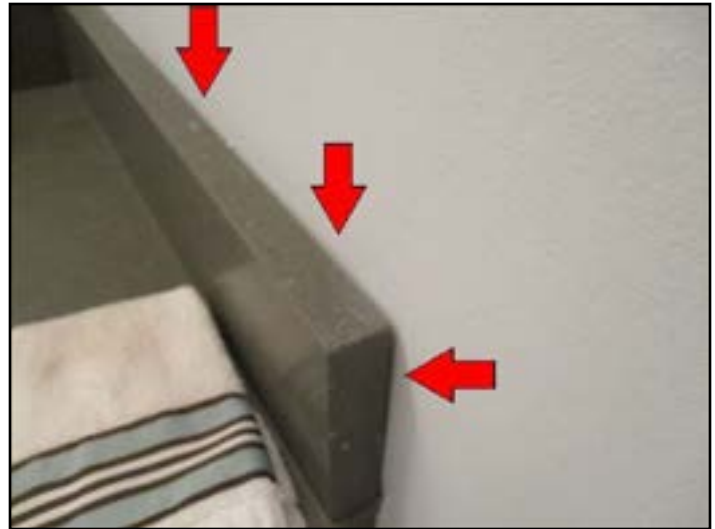
Location: West Basement Bathroom

Condition: • 6.0 Missing, Incomplete or Damaged Items [TARION CPG page 15 of 297]

Example - missing sealant

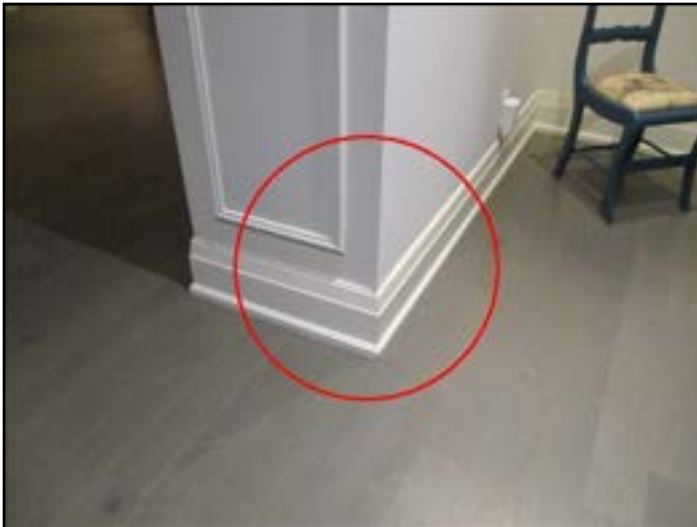
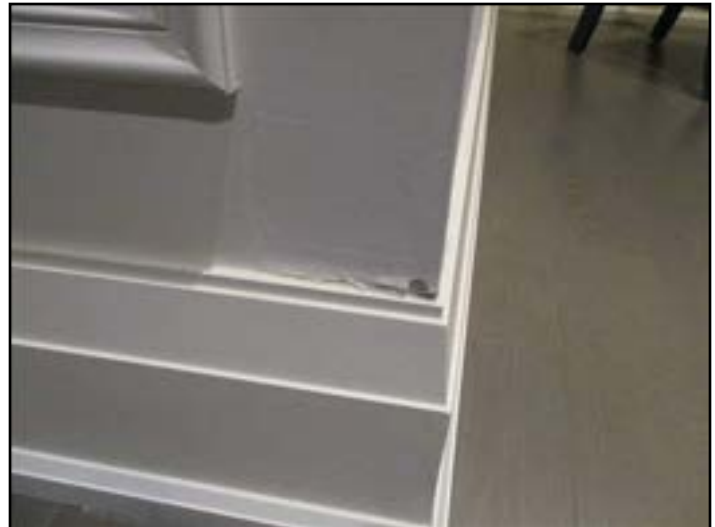
Location: Various

Condition: • [9.3 Gypsum wallboard corners are uneven](#)

Example - basement

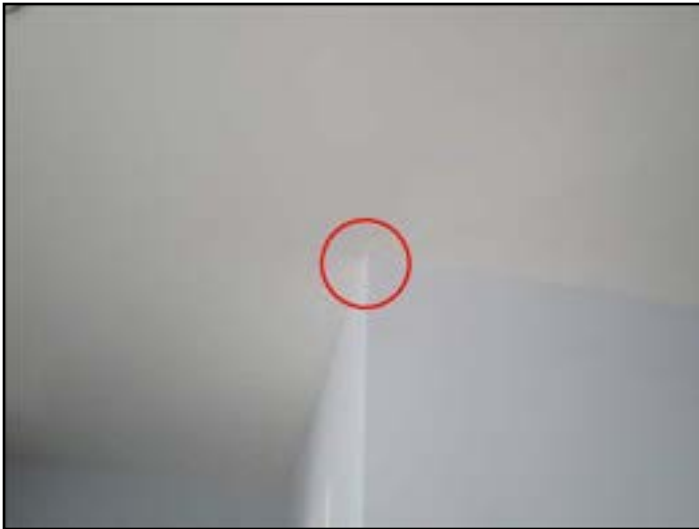
Location: Second Floor Hall

Condition: • [9.8 Finished surface is rough](#)

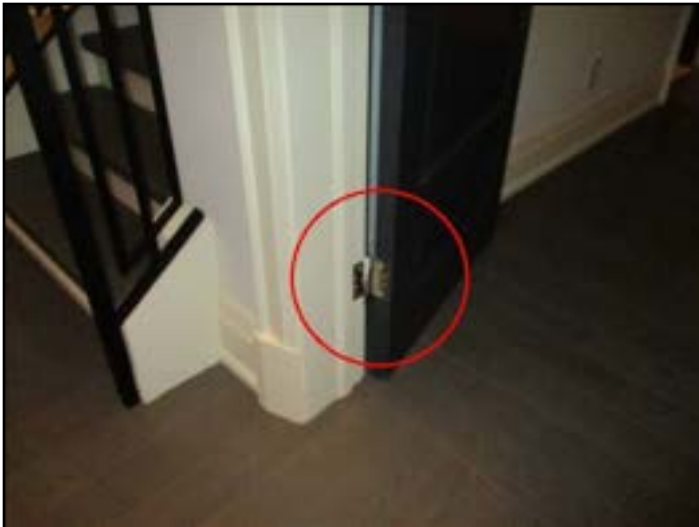
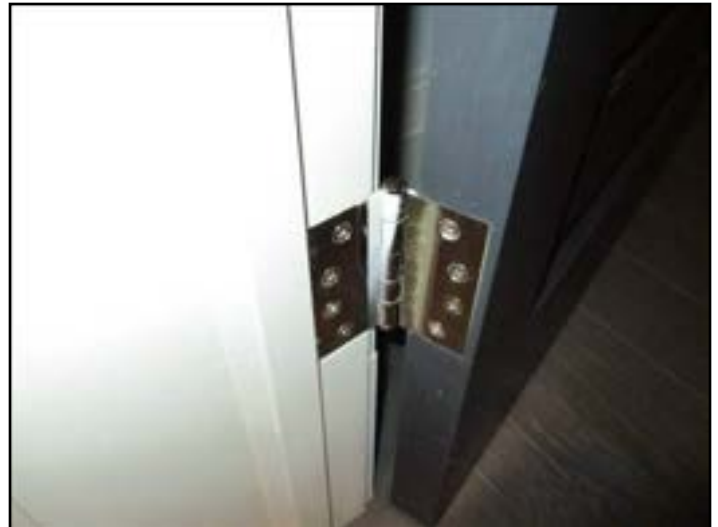
Location: Various

Condition: • [10.10 Hinges are painted](#)

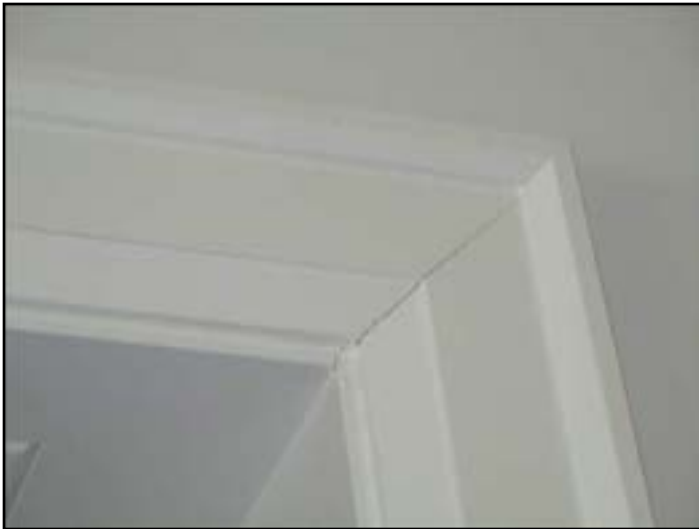
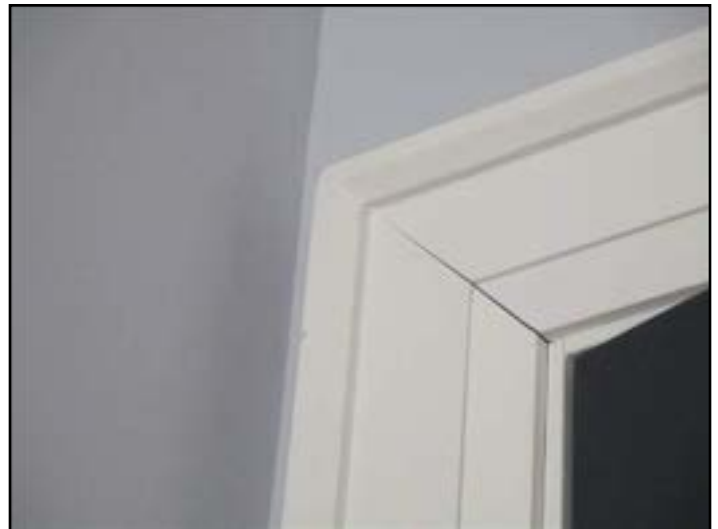
Location: Various

Condition: • [10.15 Joint quality of interior trim and moulding work](#)

Example - several doors through the home (2)

Example - several doors through the home (3)

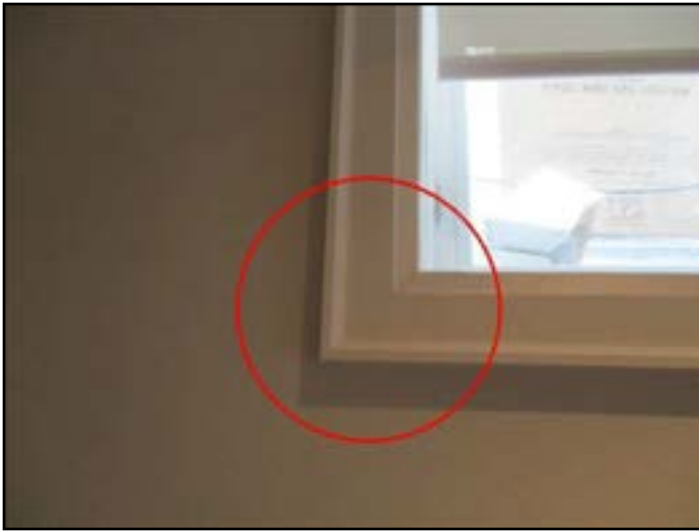
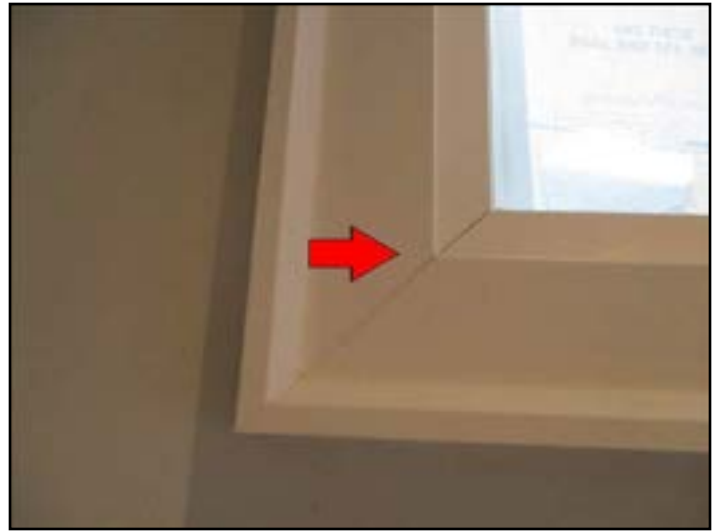
Location: Various

Condition: • [10.15 Joint quality of interior trim and moulding work](#)

Example - several windows through the home

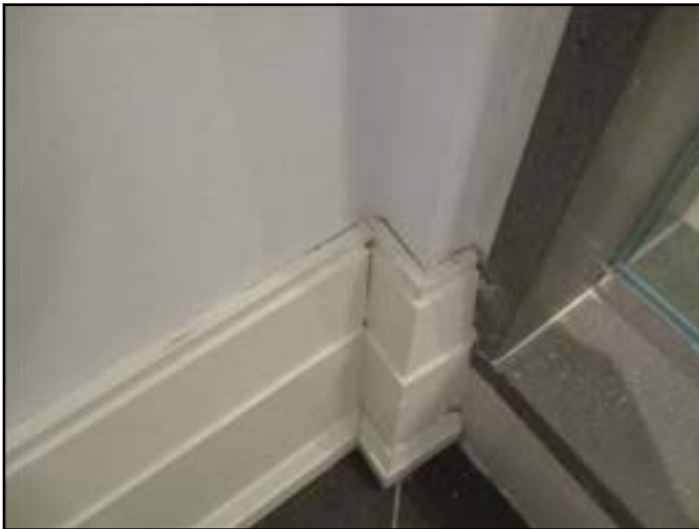
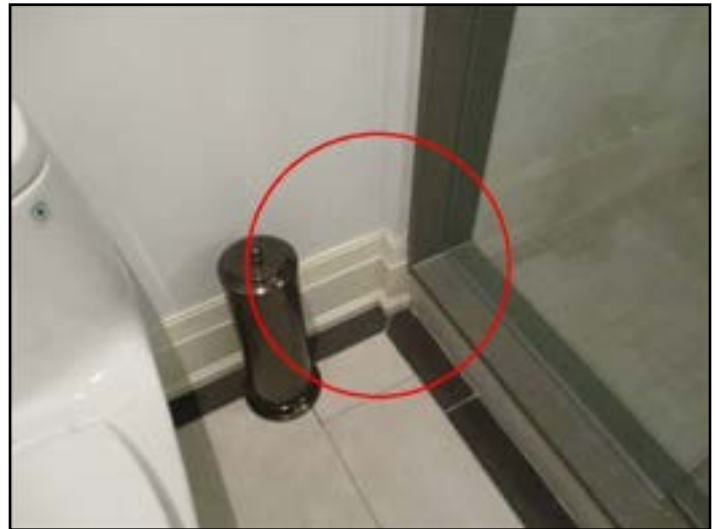
Location: Basement Bathroom

Condition: • [10.15 Joint quality of interior trim and moulding work](#)

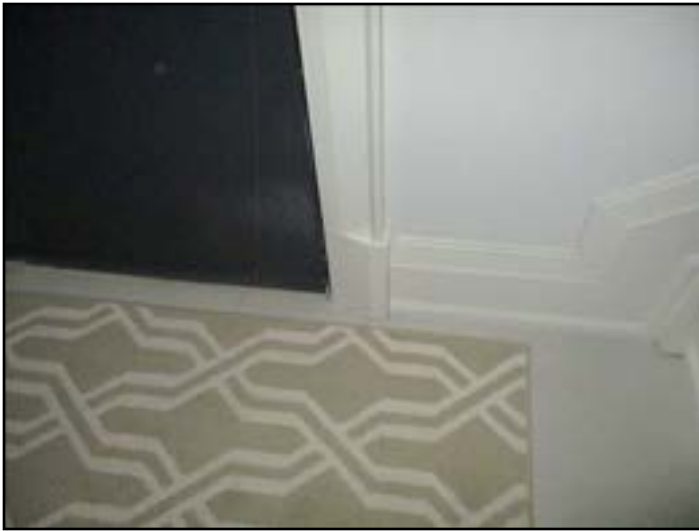
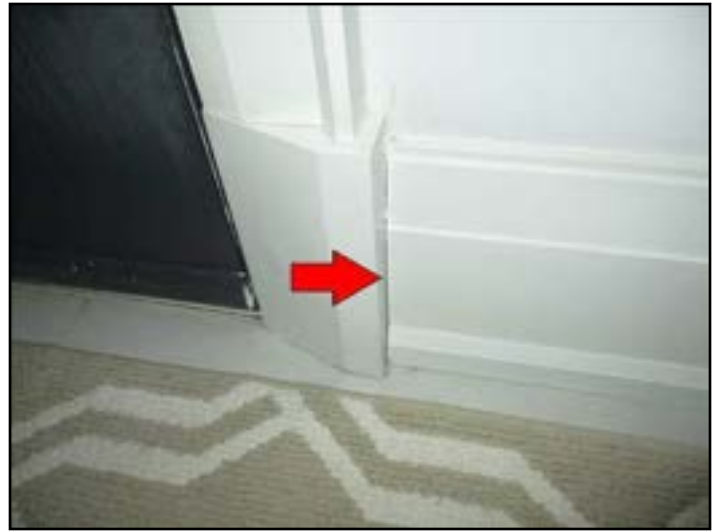
Location: Various

Condition: • [10.15 Joint quality of interior trim and moulding work](#)

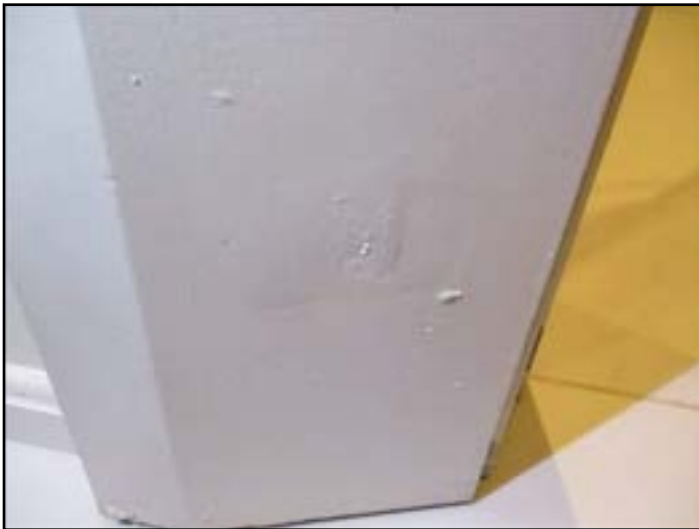
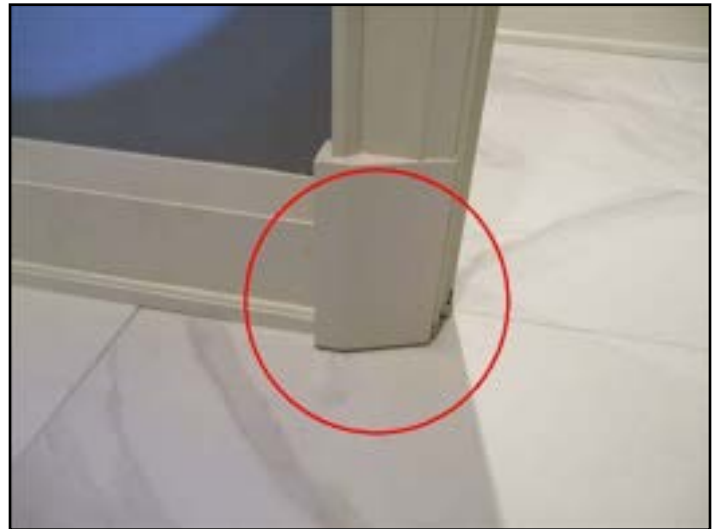
Location: Rear Basement Bathroom

Condition: • [10.16 Nailheads and fasteners are not properly set or filled](#)

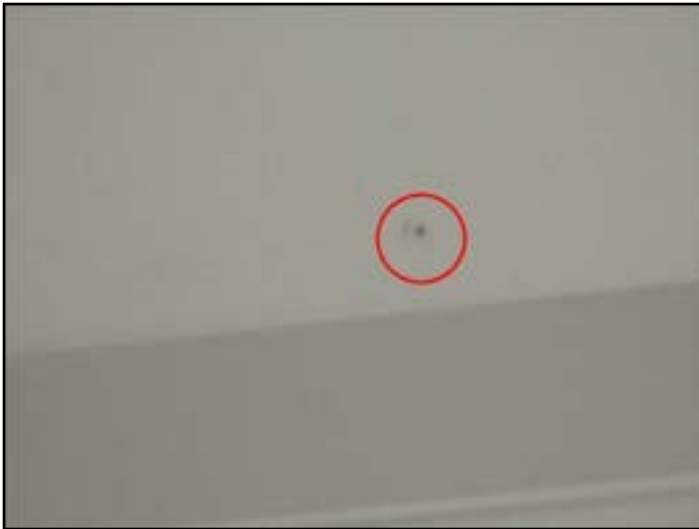
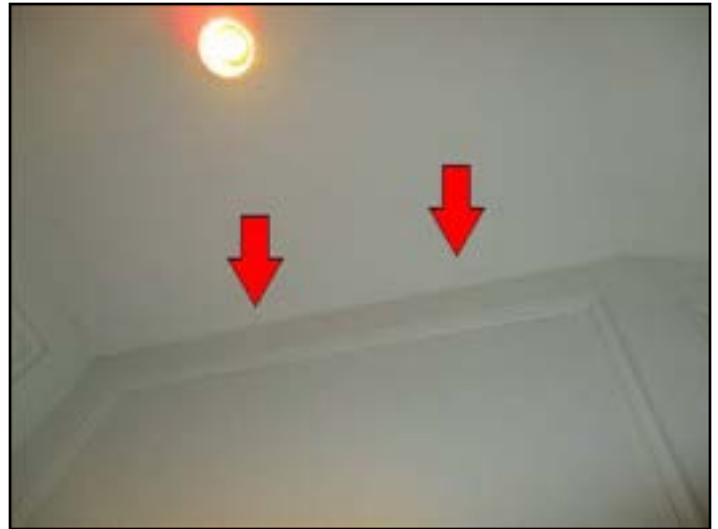
Location: Basement Stairwell

Condition: • [10.16 Nailheads and fasteners are not properly set or filled](#)

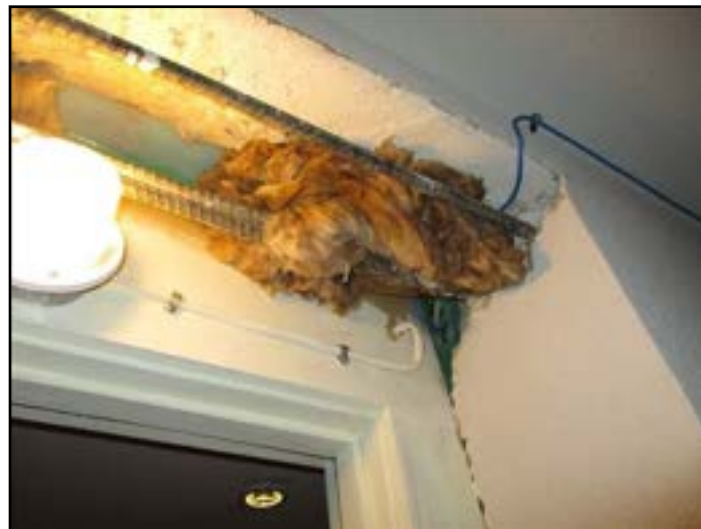
Location: Basement

Condition: • [10.20 Wall area around cold room door is unfinished](#)

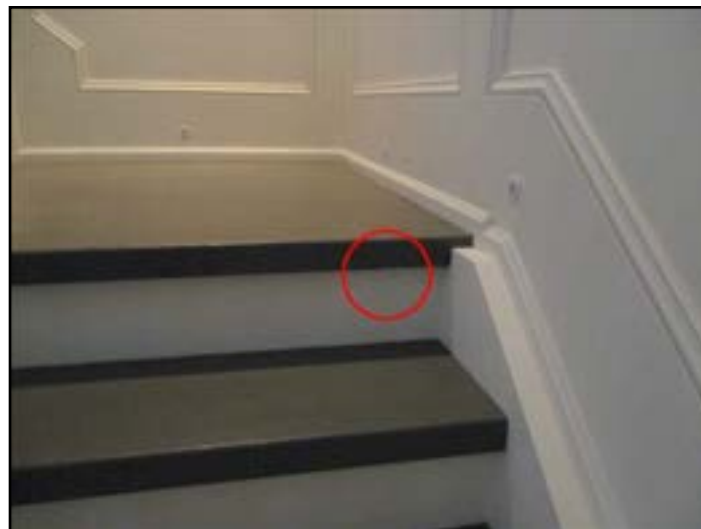
Condition: • 10.0 Missing, Incomplete or Damaged Items [TARION CPG page 15 of 297]

Example - stairs from basement

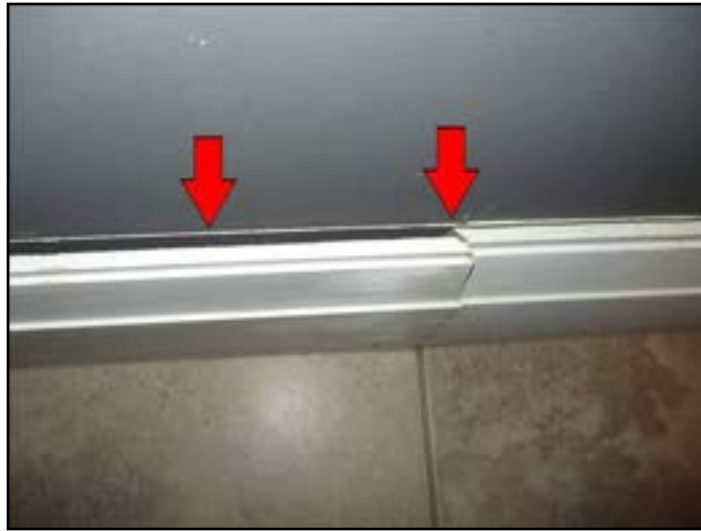
Location: Basement Utility Room

Condition: • 10.0 Missing, Incomplete or Damaged Items [TARION CPG page 15 of 297]

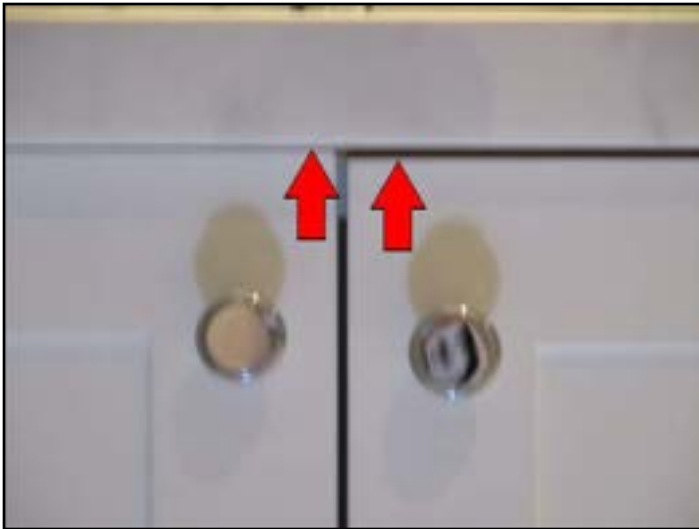
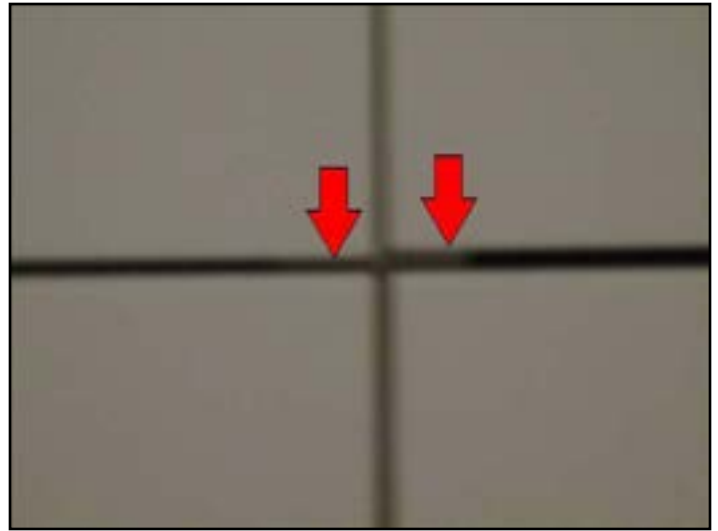
Location: Various

Condition: • [11.2 Cabinets do not line up with each other](#)

Basement bathroom - rear

Basement bathroom - west side

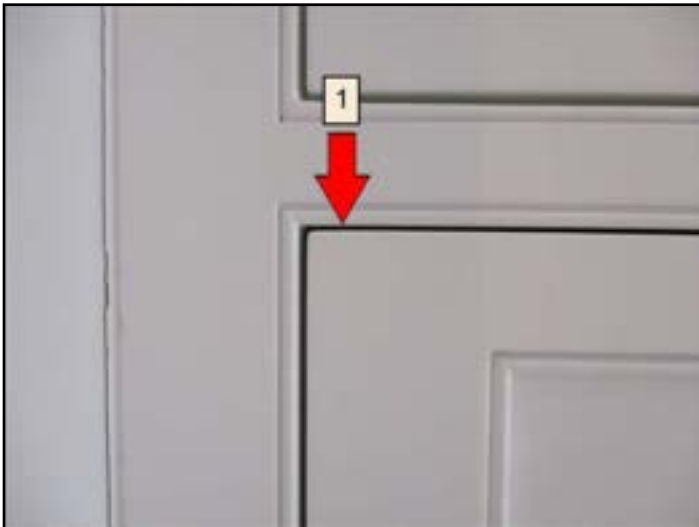
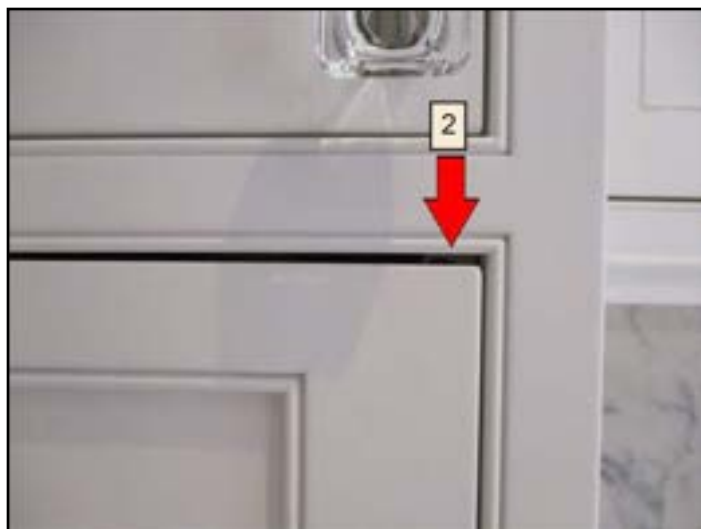
Location: First Floor Kitchen

Condition: • [11.2 Cabinets do not line up with each other](#)

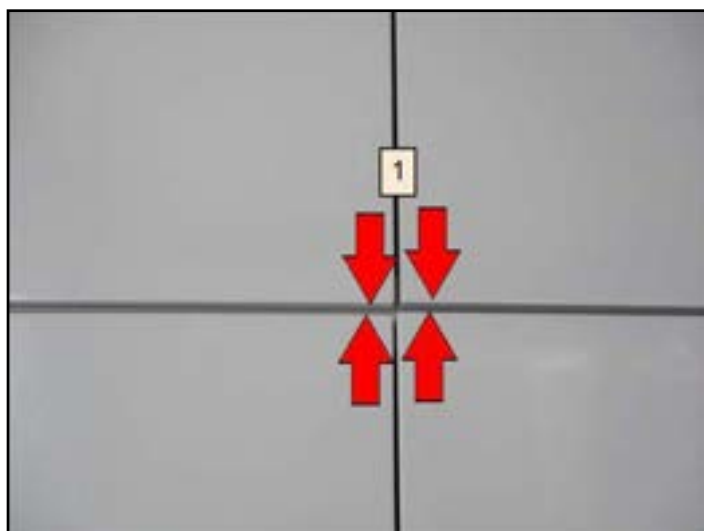
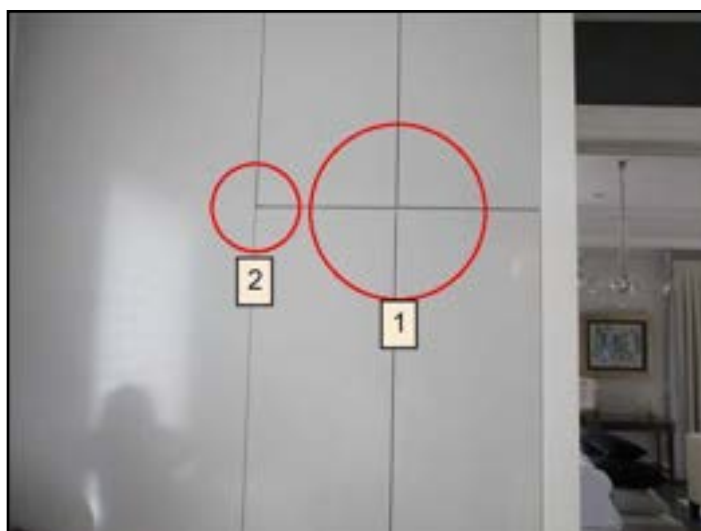
Location: Master Bathroom

Condition: • [11.2 Cabinets do not line up with each other](#)

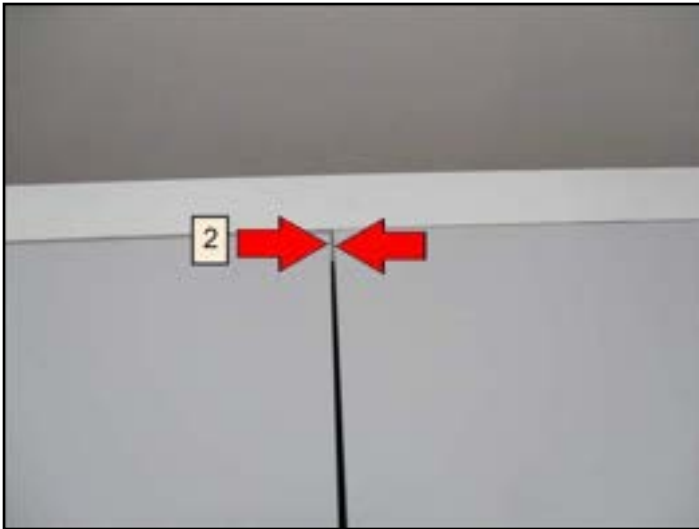
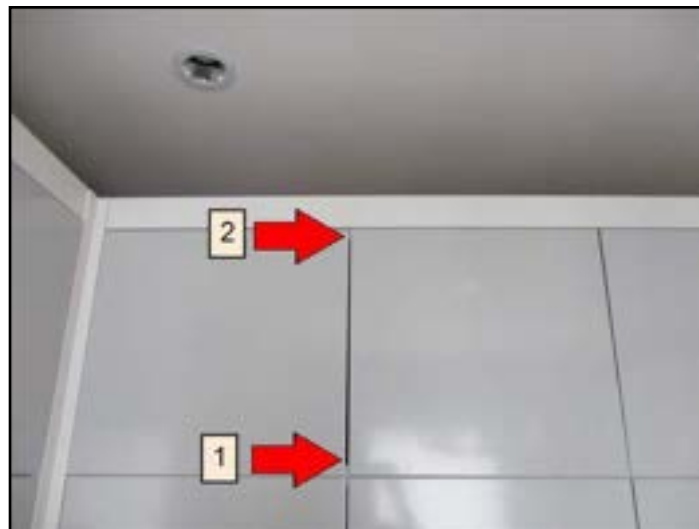
Location: Master Bathroom

Condition: • [11.2 Cabinets do not line up with each other](#)

11.2 Cabinets do not line up with each other

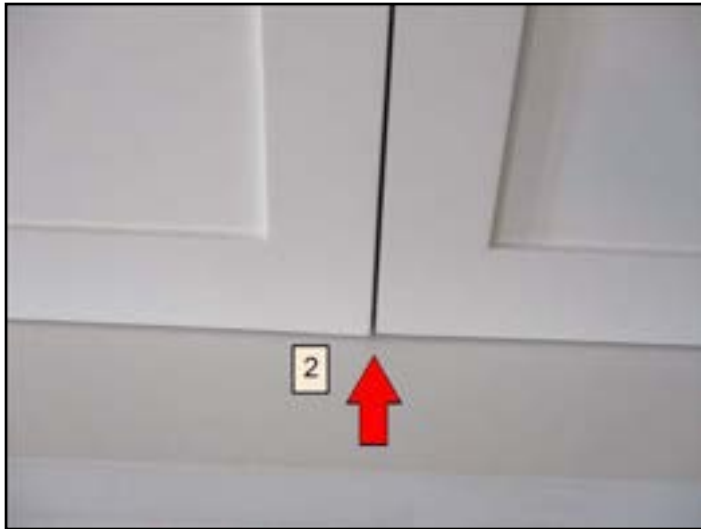
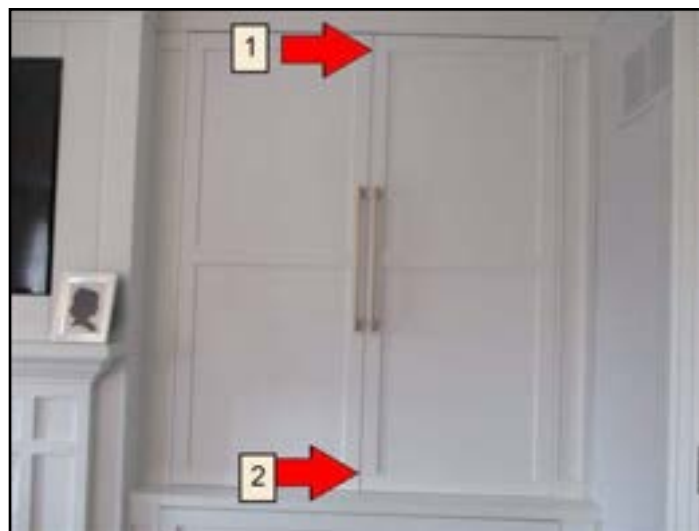
Location: Master Bedroom

Condition: • [11.2 Cabinets do not line up with each other](#)

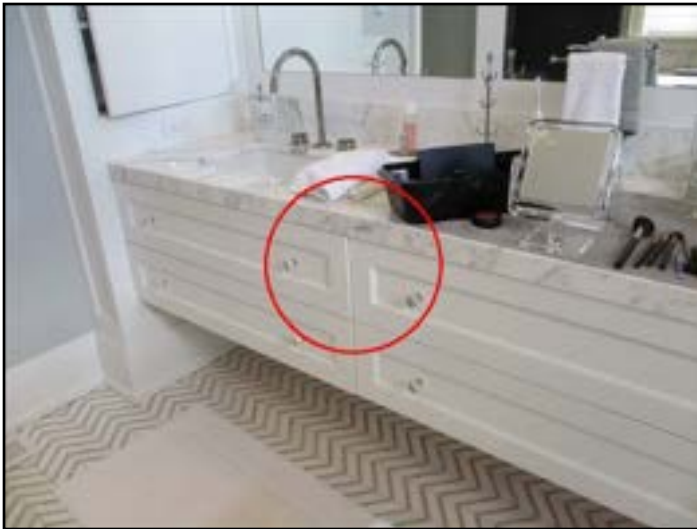
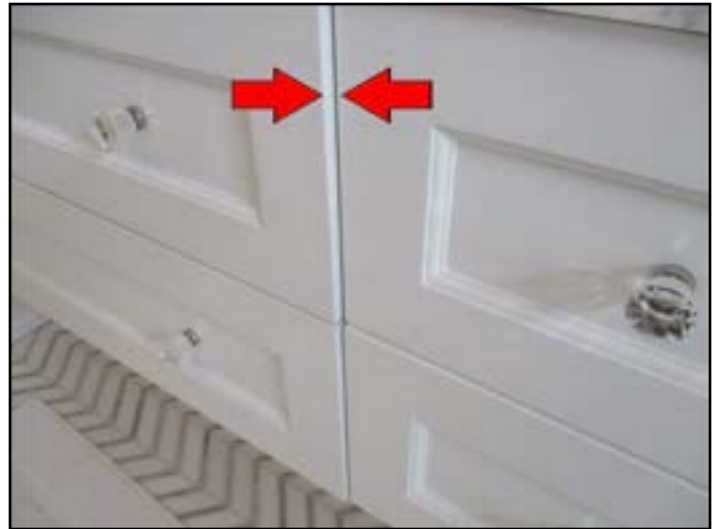
Location: Master Bathroom

Condition: • [11.3 Cabinet doors or drawer faces are warped](#)

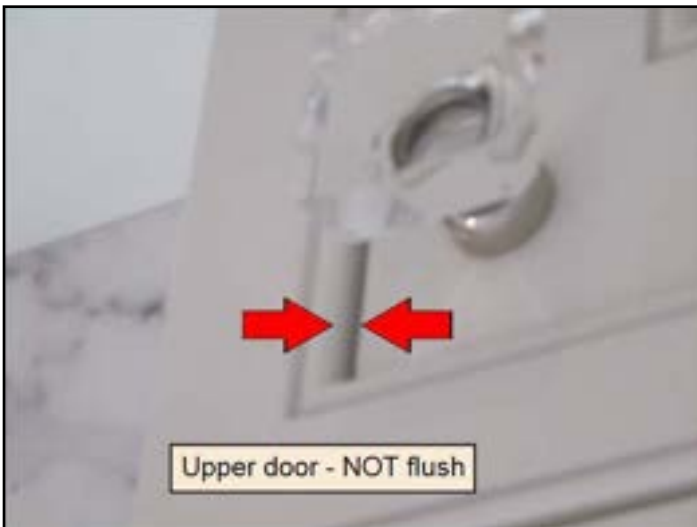
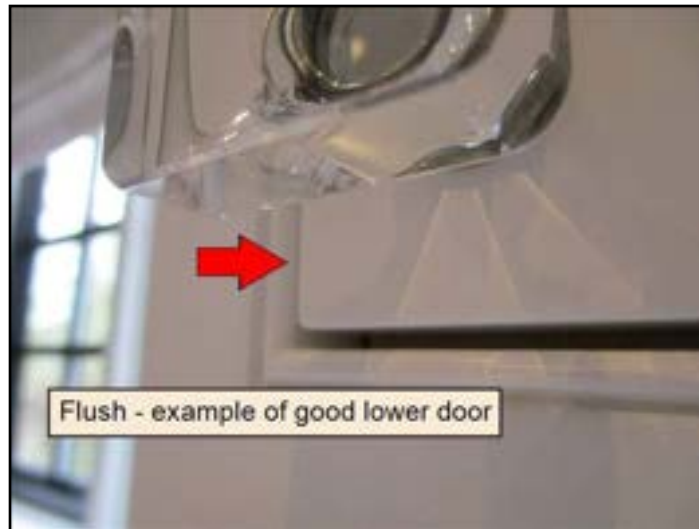
Location: First Floor Kitchen

Condition: • [11.3 Cabinet doors or drawer faces are warped](#)

11.3 Cabinet doors or drawer faces are warped

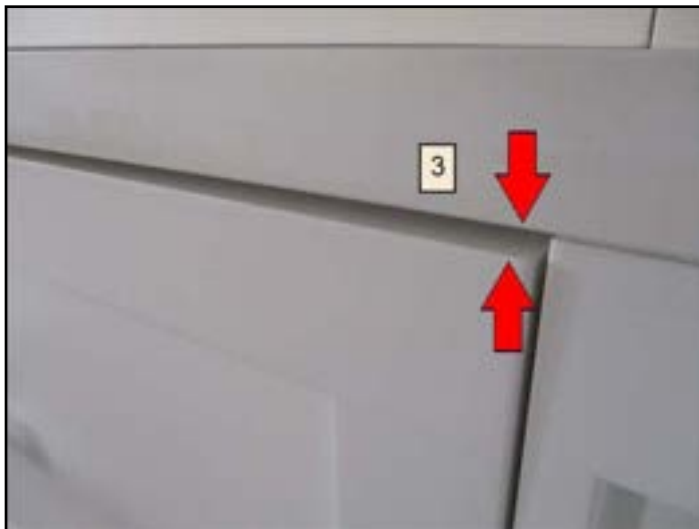
Location: Master Bedroom

Condition: • [11.3 Cabinet doors or drawer faces are warped](#)

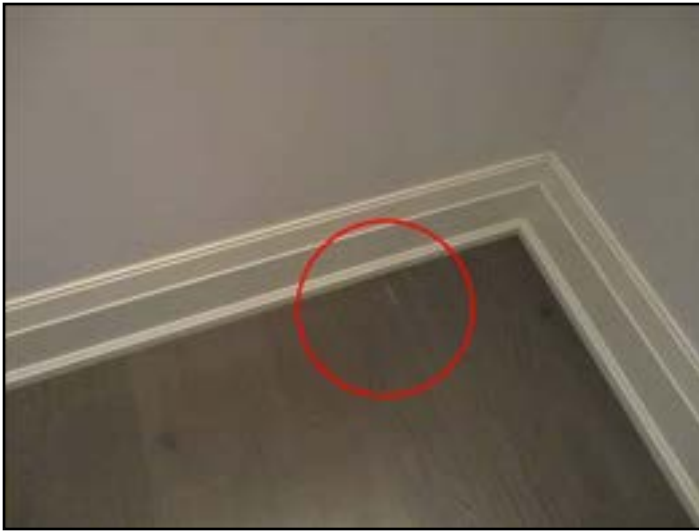
Location: Basement

Condition: • [12.23 Floor finish on wood flooring is not uniform](#)
