4-Point Inspection Form

Address Inspected: 123 Lodgeville Rd, Tampa FL 33609

Actual Year Built: 1954 Date Inspected: 6/11/2019

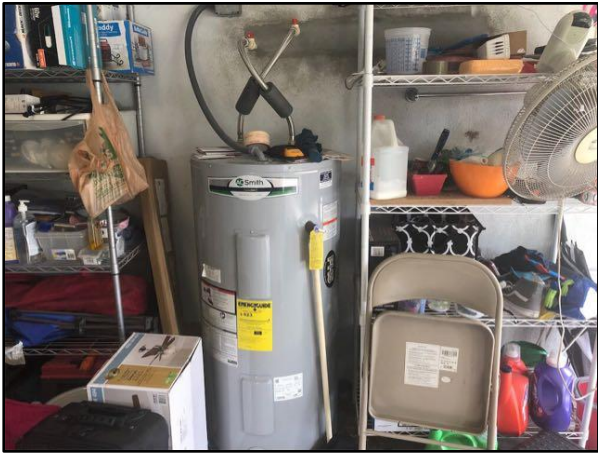
Water Heater

Water heater location- Garage

Water heater age- 2018/ 1 yr

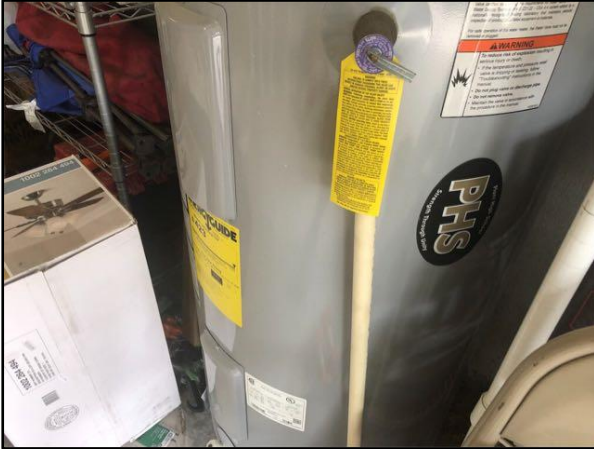
T&P Valve

Is there a temperature pressure relief valve on the water heater? ☒ Yes ☐ No

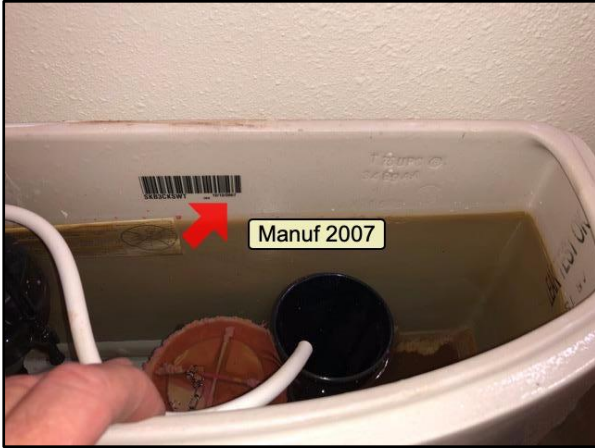
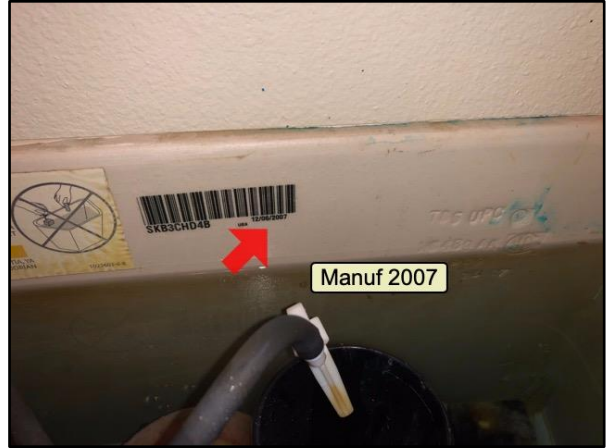
Toilet Tank Manufacture Date
2007

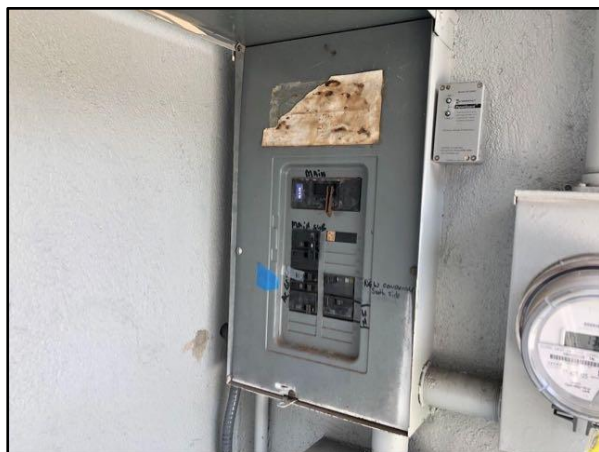
Located on front of home, Primary Data on label unreadable. Based on the visible information this panel is rated for 200 amps.

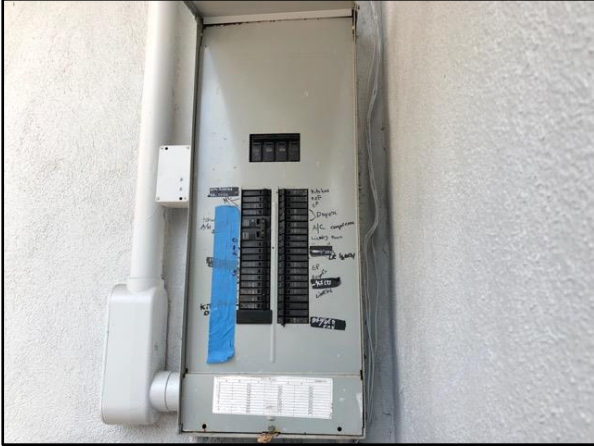
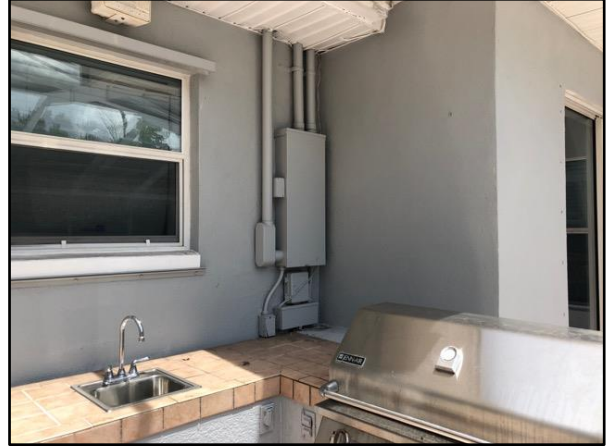
Subpanel(s)

Located on rear of home - 200amp panel

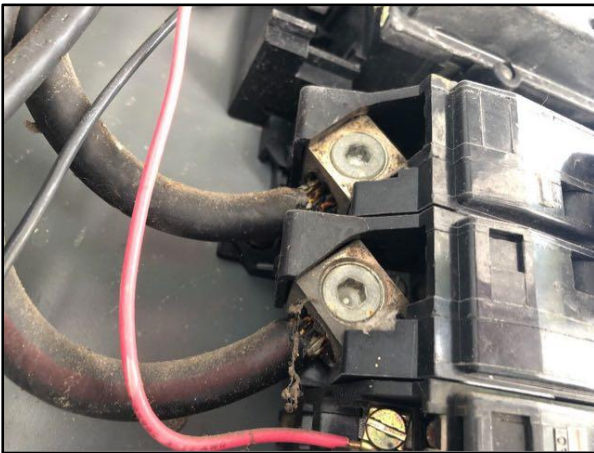
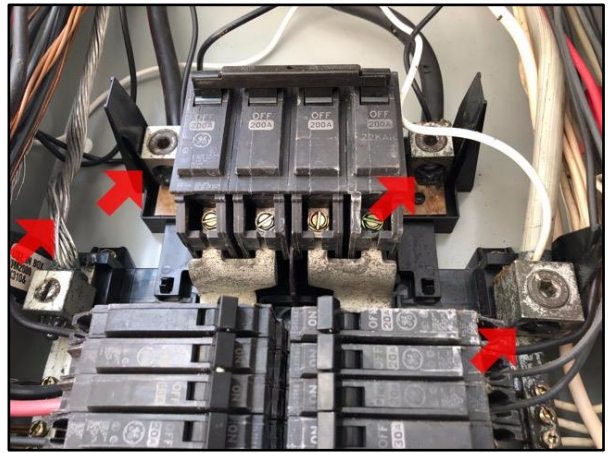
BCAW feeds main sub panel on rear of home. All BCAW is NM sheathed with no signs of corrosion. All aluminum wiring in both panels is recently protected with an anti-oxidation coating. See receipt from owner.

4) Installed aluminum isolation inhibitor on aluminum wiring in sub panel above outdoor kitchen.

1) Install aluminum inhibition inhibitor on aluminum service entrance conductors.
