Your Inspection Report

129 Avenue St, Suite 1003
Toronto, ON M2N 7B4

RE: Report No. 10101, v.2
129 Avenue St, 1003
Toronto, ON
M2N 7B4

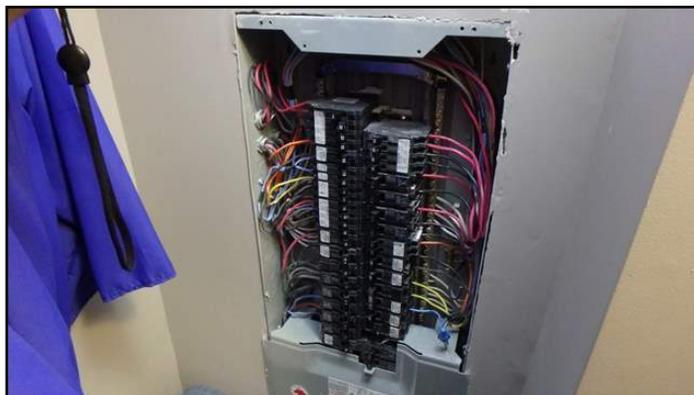
Located in master bedroom closet.

Breaker Panel With Cover Removed

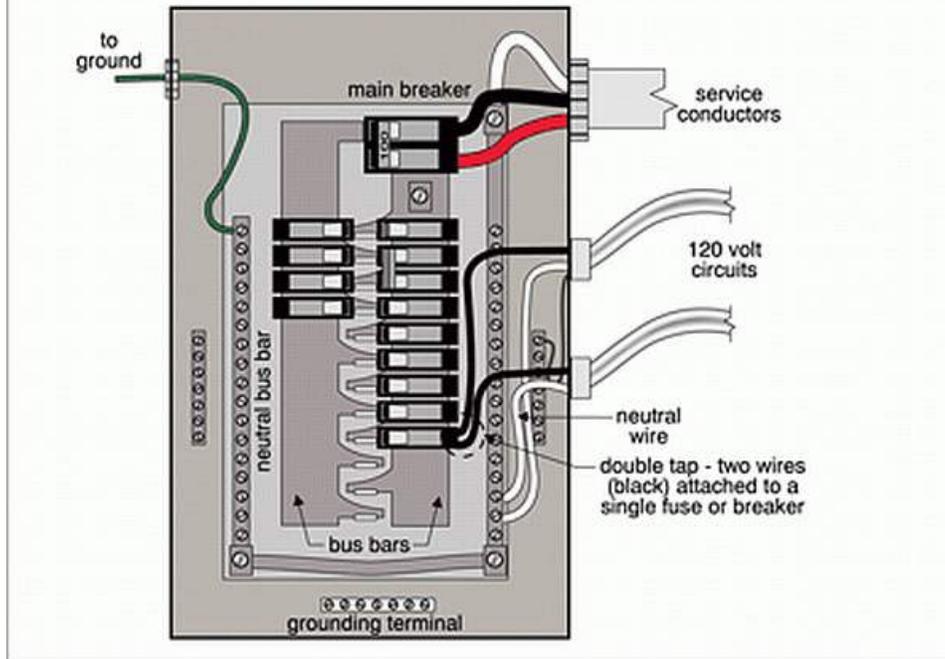
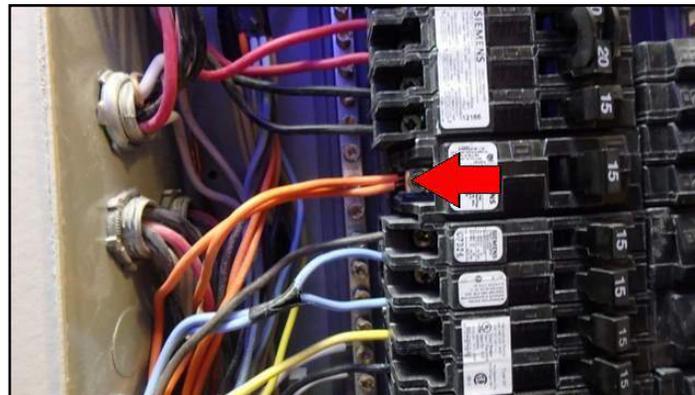
Double tapping (double lugging)

Condition: • [Double taps](#)

Two wires connected to a single breaker:

Double tap

Task: Monitor / Improve

Time: As soon as practical

Cost: Minor

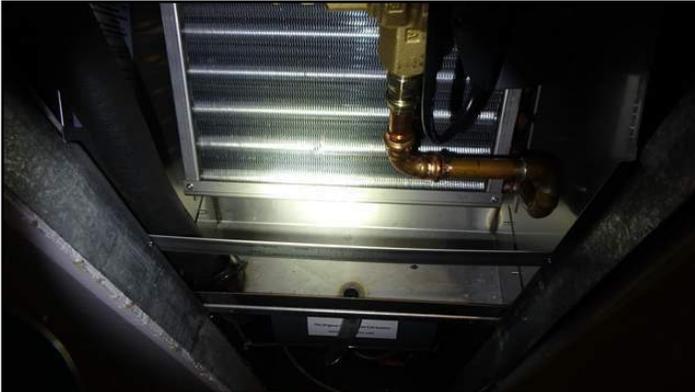
New components

(Suspect main components were upgraded in 2017 - verify with seller)

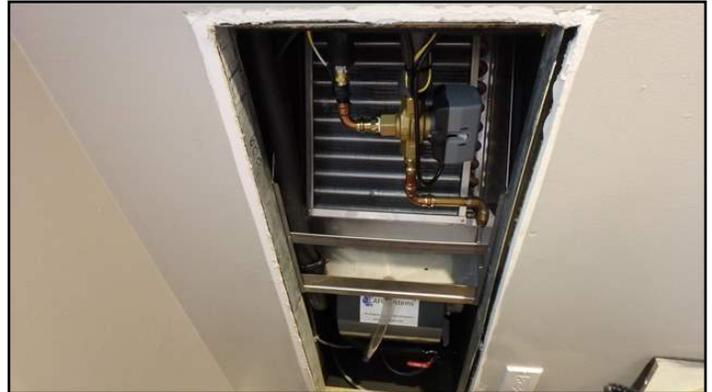
Note: Two 2-pipe fan/coil systems are used to heat and cool the unit. Each is controlled by its own thermostat. The interior components (coils, fans, condensate trays, piping, valves, etc.) appear to have been recently updated and both systems were working well at time of inspection.

Fan/Coil Unit (Master Bedroom)

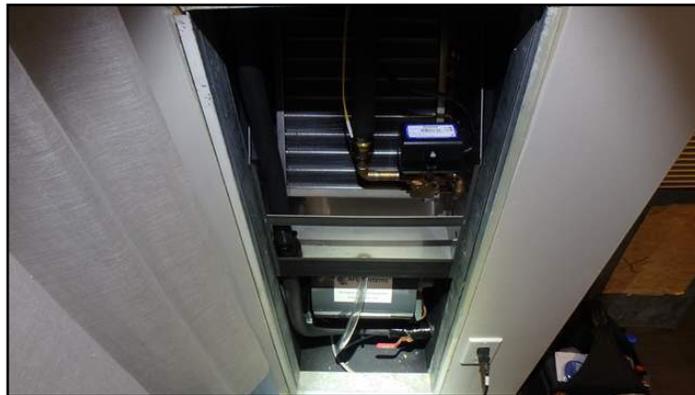
Fan/Coil Unit (Main living space)

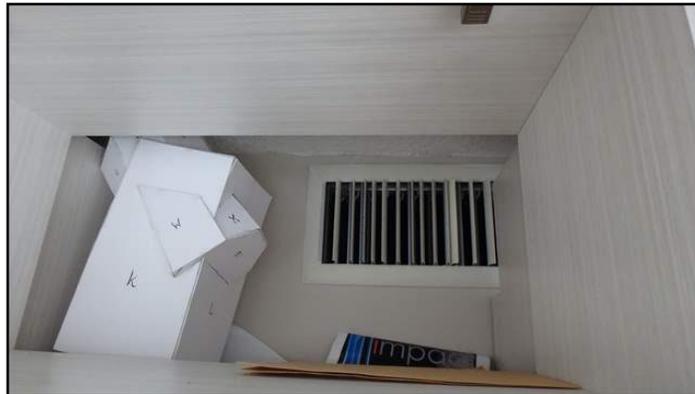
Condition: • Supply register in corner bedroom is set back in cabinet. This can reduce airflow and the overall ability to heat and cool the space.

Register in cabinet

Task: Monitor

Time: Ongoing

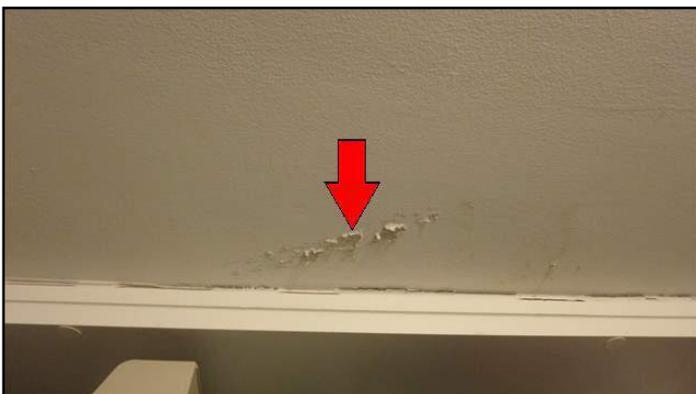
Ex. Patch on master bedroom wall, paint chips on window frames and around pot lights, gaps in flooring outside main bathroom, peeling paint on laundry room ceiling. Ensure moisture levels are monitored in laundry area (and throughout the unit). Keeping the laundry room door ajar is one way of improving airflow.

Ex. Peeling paint

Task: Monitor/Improve

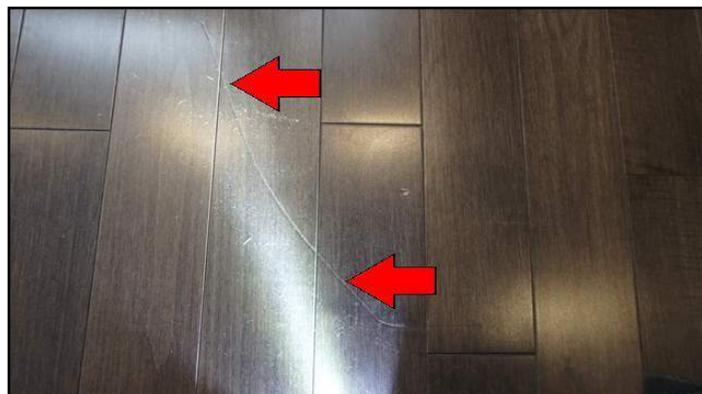
• Typical minor flaws were noted on floors, walls and ceilings. These cosmetic issues reflect normal wear and tear.

Ex. Typical wear on floors throughout

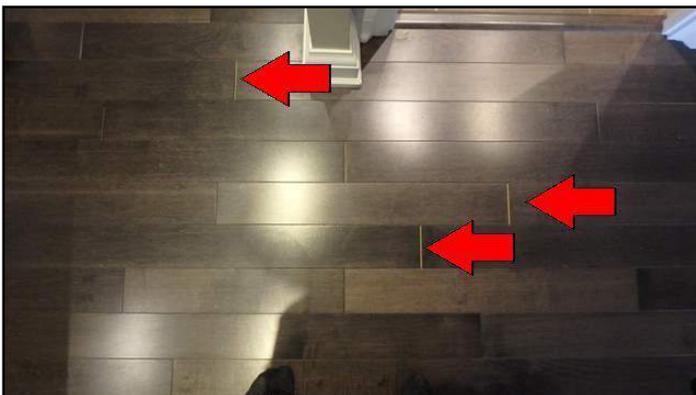
Ex. Gaps in flooring

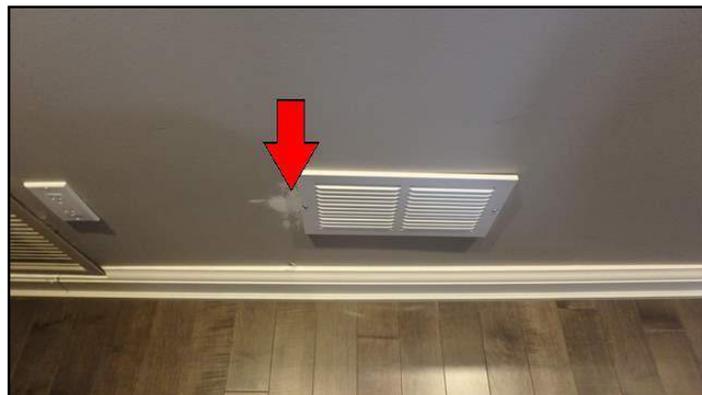
Ex. Patch

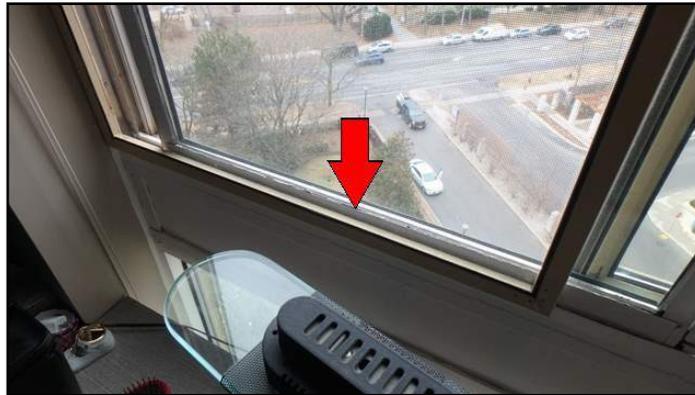
Condition: • Screen not installed in master bedroom. The other screens have been installed in an unconventional manner. Although non-standard, this appears to function as it should.

Ex. Non-standard installation

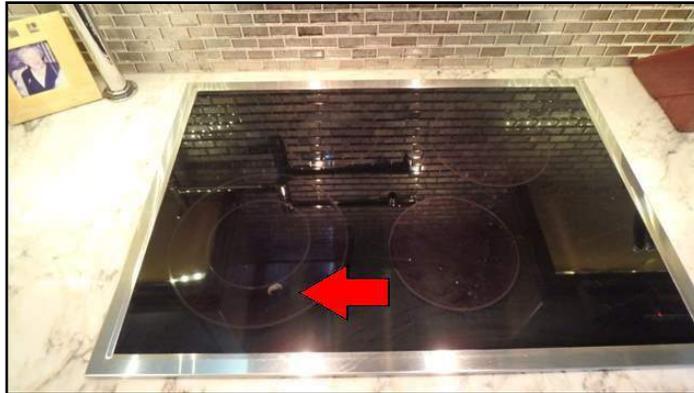
Condition: • Typical wear and tear on cooktop.

Ex. Typical wear

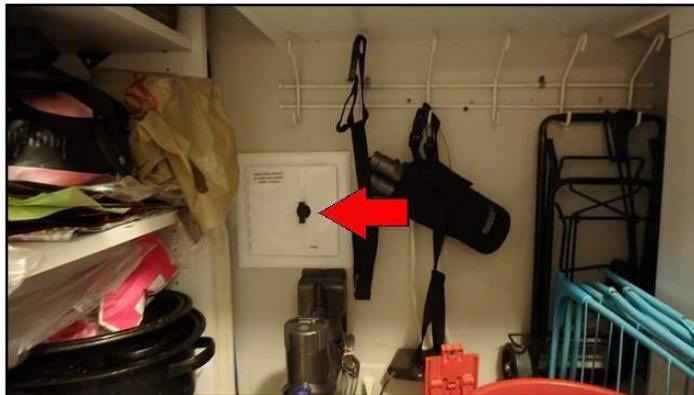
Condition: • Auxiliary dryer lint trap (located in ceiling above dryer) must be cleaned every 3 loads or more often as required.

Duct will likely need to be cleaned as part of routine maintenance.

Auxiliary dryer lint trap (located in...

Task: Clean

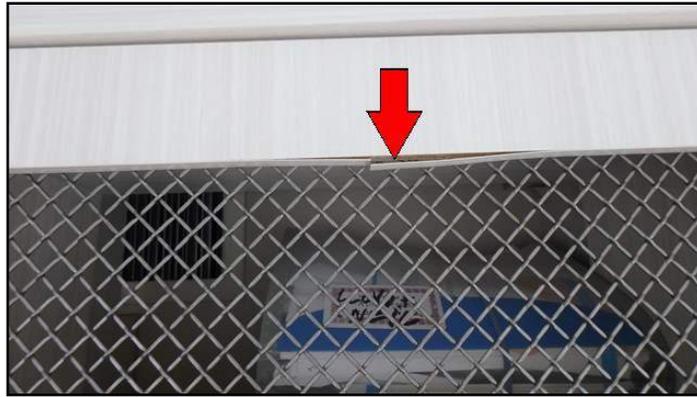
Condition: • Loose veneer noted

Location: Vent above bed in corner bedroom

Ex. Loose finishes

Task: Repair
