Structure

INTRODUCTION

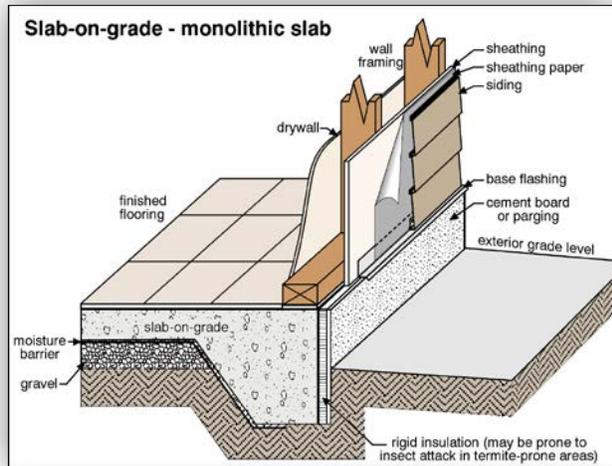
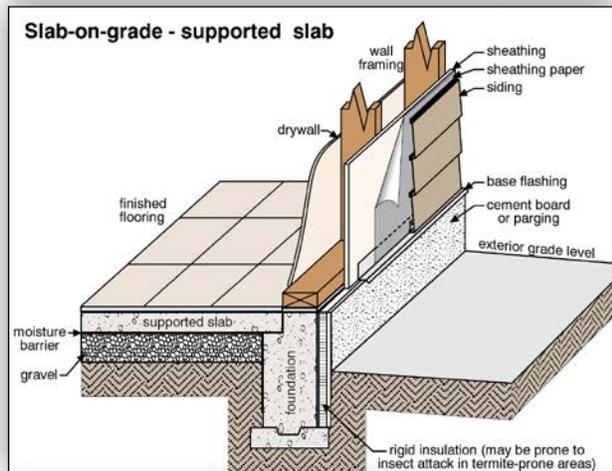
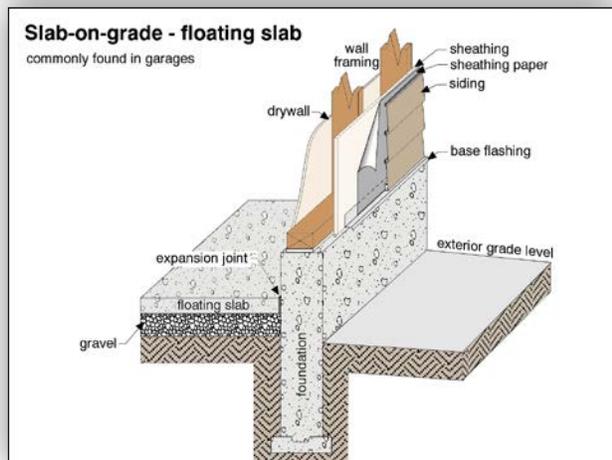
There are several types of slab-on-grade construction, including monolithic slab, supported slab, and floating slab. A monolithic slab is a concrete floor and foundation all poured as one. This can be thought of as a floor slab that is thicker around the edges.

A supported slab is not poured together with the foundation, but it does rest on the foundation. The footings and foundation wall are installed first, with a ledge at the top of the foundation to support the slab. Basement floor slabs are often supported slabs.

The floating slab is entirely independent of the foundation. The foundation is poured or built first. The slab is not supported by or connected to the foundation. This type of slab is common in garages.

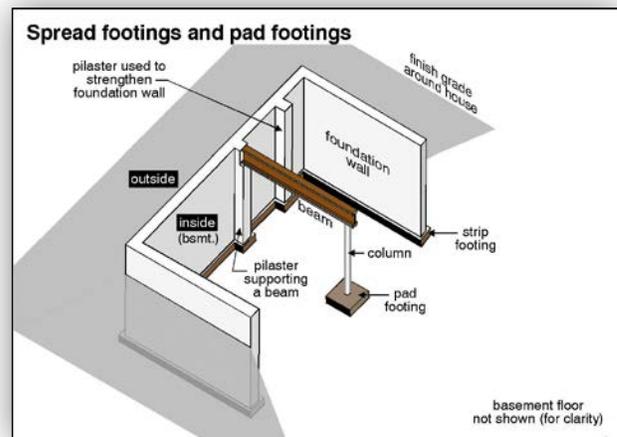
FOOTING TYPES Strip footings (also called spread footings) run continuously below foundation walls, typically around the building perimeter. Pad footings (also called spot footings) are smaller and typically support columns or piers.

PIER AND GRADE BEAM Pier and grade beam construction is common in areas with expansive soils. Concrete piers are poured down to a depth where the soils are stable. Grade beams, which often form foundation walls, span between the piers. These grade beams are often reinforced concrete.

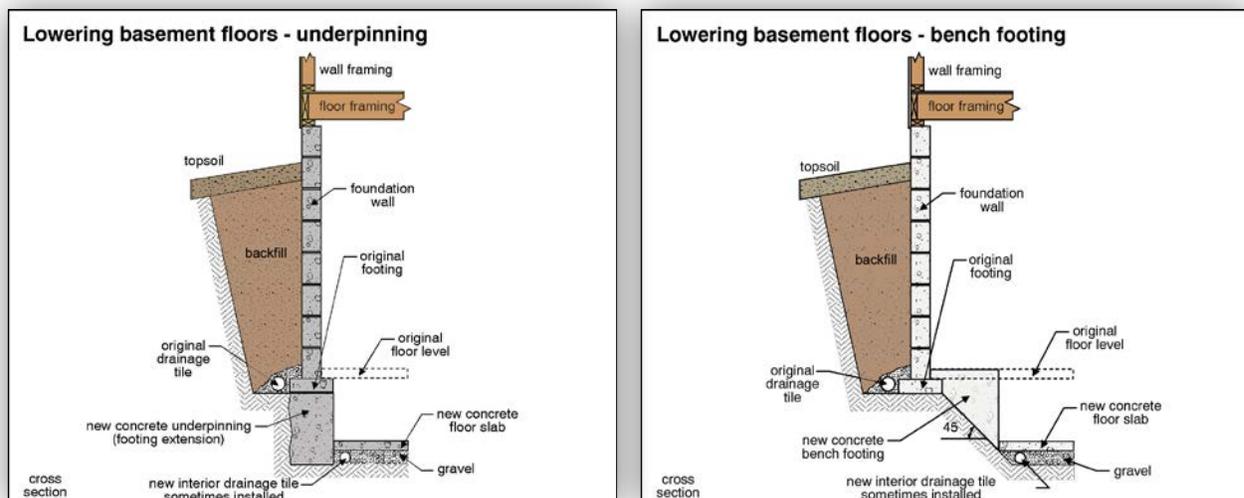
SETTLEMENT/WALL FAILURE – LOWERED BASEMENT FLOORS When a basement floor is lowered, the footings should be underpinned (lowered and, in some cases, enlarged). Alternatively, only the central section of the basement should be lowered, to avoid disturbing any of the soil near the footings. Depending upon how much the basement floor is lowered, the required clearance from the footings varies. A soils engineer is often consulted and a concrete curb (also called a bench footing or Dutch wall) may be needed around the inside edge of the footings to ensure they are not compromised. Building settlement and failure of foundation walls are both risks when lowering basement floors.

One of the dangers in lowering basement floors is the increased risk of basement leakage. Notice in the following illustrations how the drainage tile outside is no longer in the correct location once the floor is lowered. It is too high to be effective.

When excavation is done on the exterior, (e.g. for an addition or swimming pool) the footings can be damaged or undermined in a similar fashion.

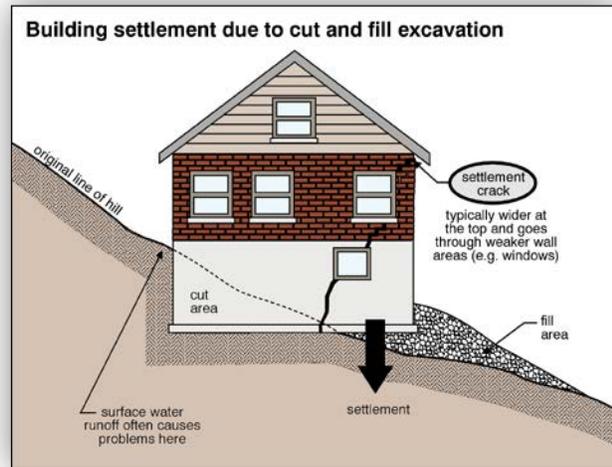
SETTLEMENT – CUT AND FILL LOTS – Houses built on sloping lots may be more prone to footing and foundation failures. The chances of building on disturbed soil are increased on lots such as these. Efforts made to level and terrace the lot may result in soil being cut out of the hill to form a level terrace under the back half of the house. This soil is then used as fill in the adjacent area where the front half of the house is to stand. The downhill half of the house may be built on fill that may not be well compacted or may not be able to stay in place and support the house.

On sloping lots, large lateral earth thrust and hydrostatic pressure can be built up by the soil on the high side of the home.

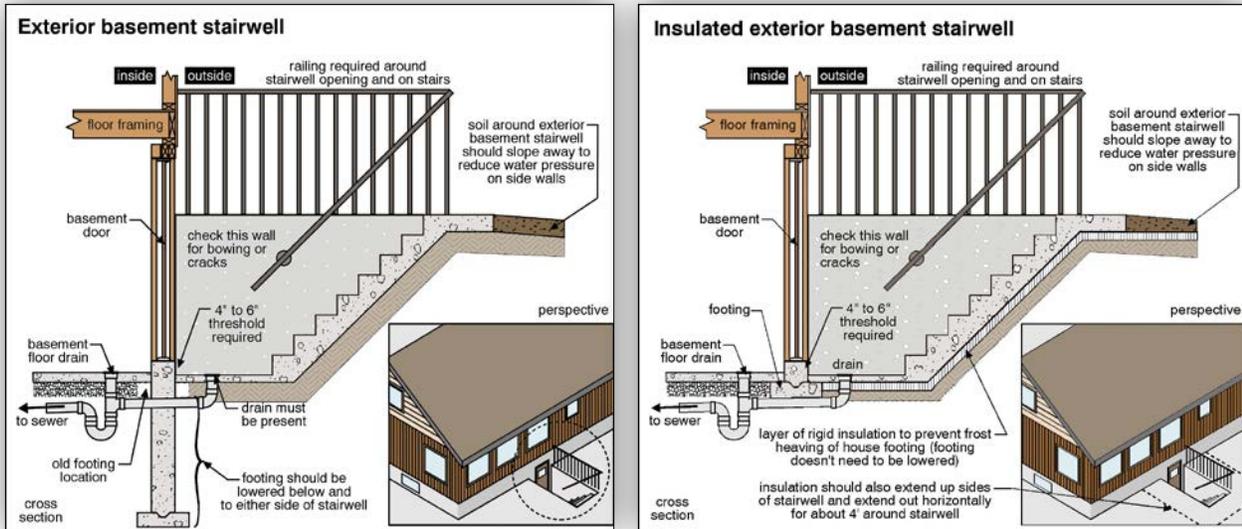
- FROST HEAVE – FOOTINGS TOO SHALLOW** If the footings and foundations are not deep enough, the ground below them may freeze. Frozen ground expands and may pick up all or part of the building. This can do serious damage.
- FROST HEAVE – OUTSIDE BASEMENT STAIRWELL** Exterior basement stairwells may compromise the footings in cold climates. In order to be effective, the footings in cold climates must be below the frost level. When an exterior basement stairwell is added, the stairwell opening effectively lowers the exterior grade level, and also lowers the depth to which frost can penetrate. After the stairwell is in place, the frost can go several feet below the bottom of the stairwell opening. This can lead to frost heaving of the footings and the foundations.

A properly added exterior stairwell will include deepened foundations, or a completely insulated approach, to prevent frost penetration below the building footings.

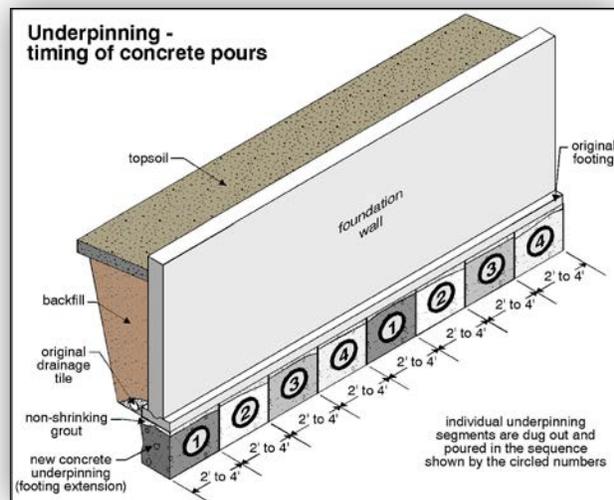
REPAIRS – UNDERPINNING The usual corrective action is to underpin the footings. This means digging under the existing footing, and adding a new footing wider and/or deeper than the original. This may have to be done in small sections on strip footings since one cannot excavate under the entire house at one time. Usually two to four foot sections are done at a time. This is very expensive work.

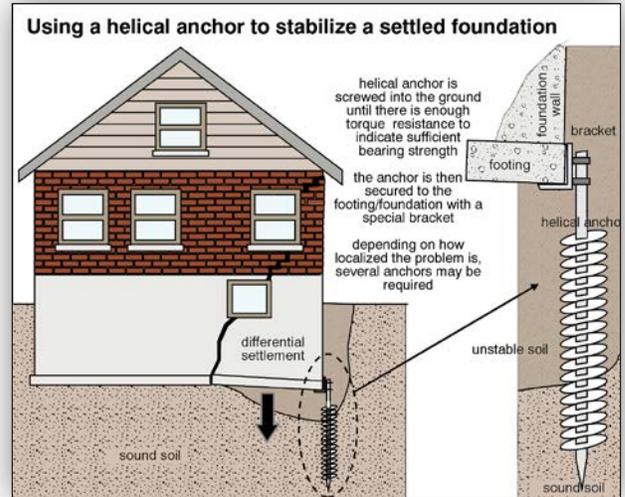
REPAIRS – PILES AND HELICAL ANCHORS In some cases, where the soils are moving or are likely to move, underpinning is not appropriate. Piles driven deep into the ground are an alternative, but may not be cost-effective for an existing building. Helical anchors are sometimes screwed into the soil to support failed footings.

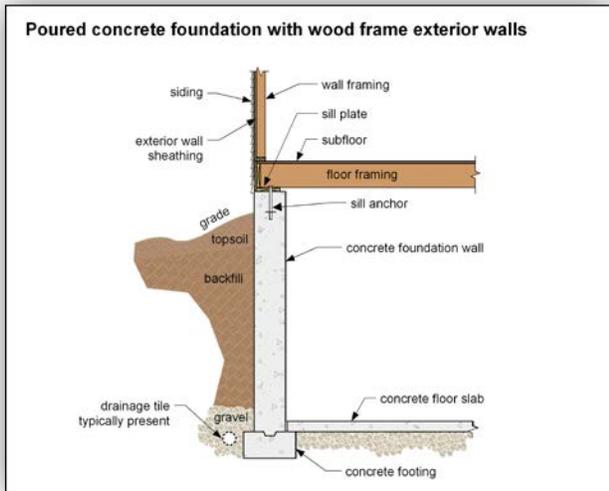
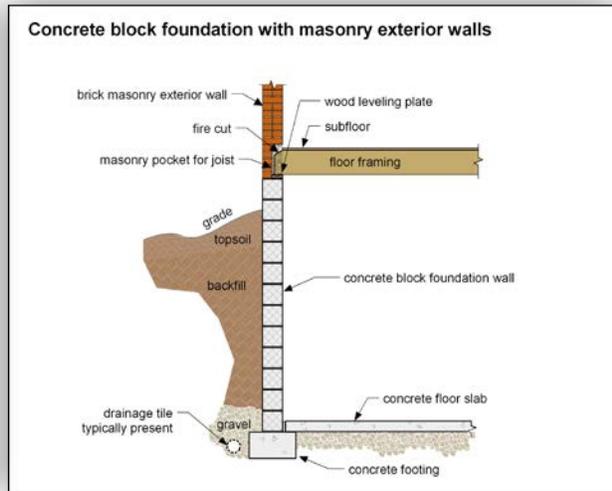
COMMON FOUNDATION TYPES Foundations may be continuous walls (stem walls), often made of concrete, masonry block or insulated concrete forms (ICF). Foundations may also be piers supported by pad footings.

Two common foundation arrangements are illustrated below.

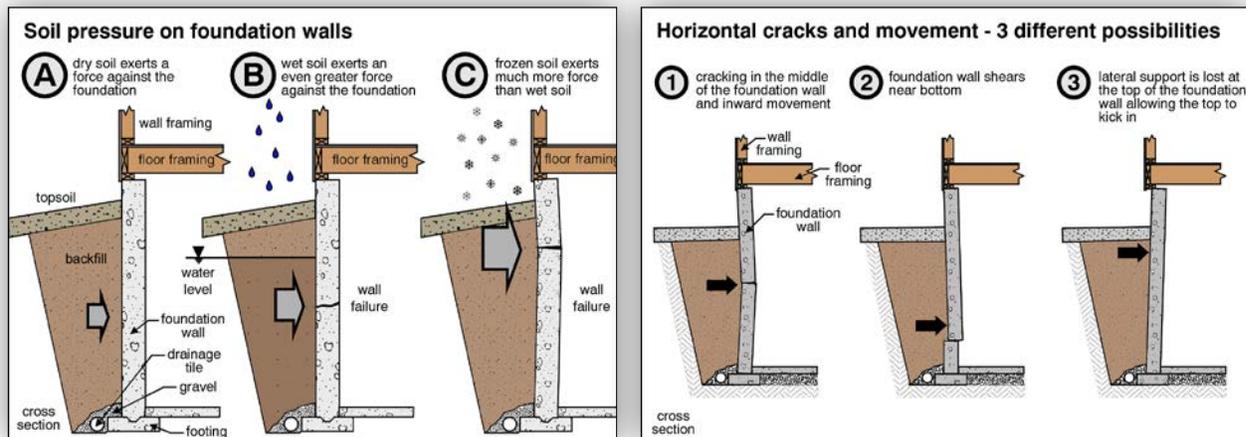
INADEQUATE LATERAL SUPPORT Basement and crawlspace foundations are really retaining walls, holding back the soil outside. If the foundations do not provide enough lateral support, they will deflect inwards. This may be the result of mechanical forces exerted during back-filling; back-filling with frozen soil (cold climates only); unusual frost development in the soil immediately outside the building (cold climates only); foundation walls that are too thin, too tall or do not have adequate reinforcement; or the house floor system does not provide adequate bracing for the top of the foundation wall. This last problem is common on the high side wall on a sloping lot. Both masonry walls and poured concrete walls can fail if not properly built.

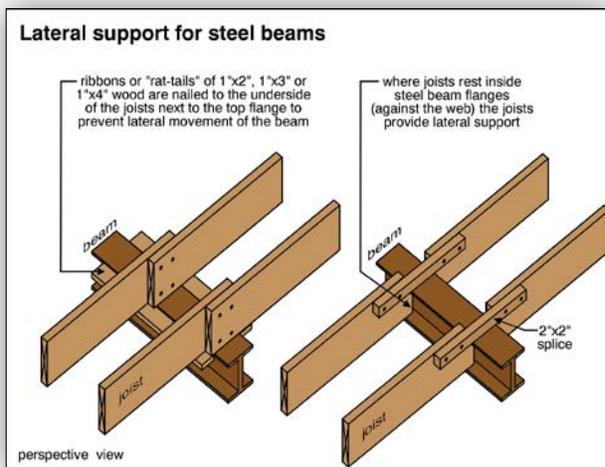
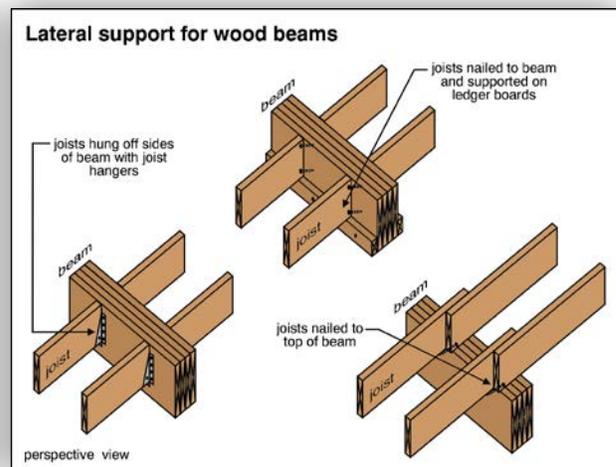
LATERAL SUPPORT Lateral support for steel beams is typically provided by wood strapping secured to the joists. There are several ways to provide lateral support for wood beams. See the illustration below.

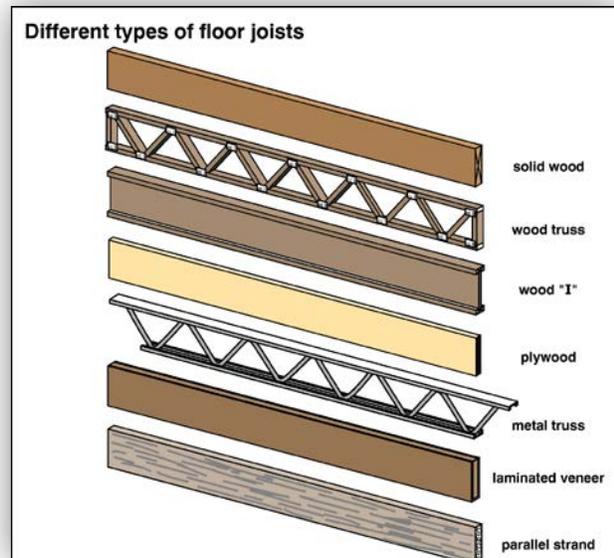
JOIST STRENGTH The strength of a joist comes largely from its depth. Doubling a joist by putting another of the same size beside it will double its resistance to bending. Doubling the depth of a joist increases its resistance to bending by eight times! For example, the equivalent strength (considering deflection only) of two 2x10s compared to four 2x8s can be compared by multiplying the base times the height cubed. It is interesting that two 2x10s are more resistant to bending than four 2x8s.

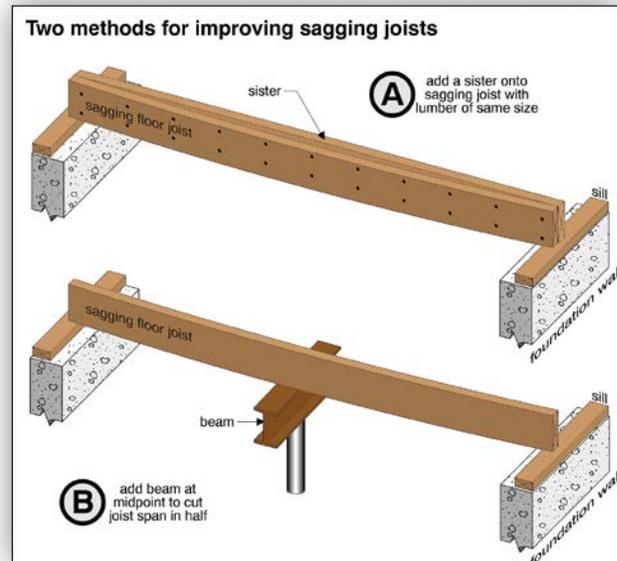
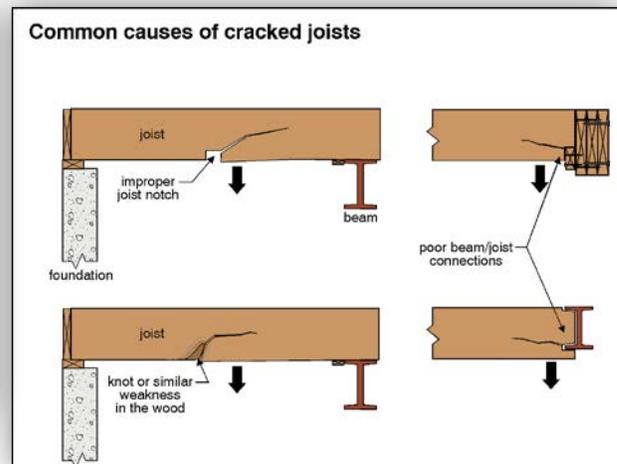
DAMAGE/ NOTCHED/ DRILLED Mechanical damage to joists is common. Joists are commonly notched, drilled and cut through to accommodate heating, plumbing and electrical systems. In some cases, joists are cut around stairwells to improve headroom. Some damage is typical, and there are several guidelines on acceptable limits. Joists are sometimes notched at the end to rest on a beam or foundation wall. This can weaken the joist considerably. The joist usually cracks horizontally from the top of the notch towards the mid-point of the span.

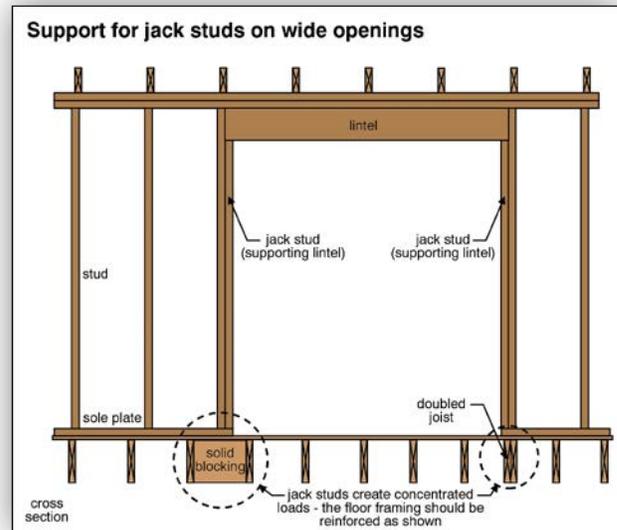
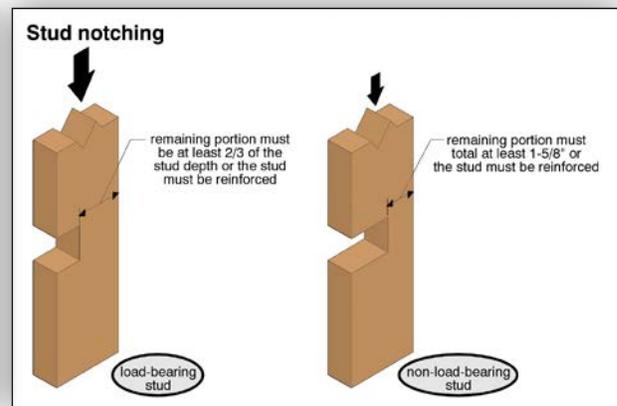
NOTCHES AND HOLES Holes and notches can weaken studs if they are too large. The illustrations below provide some guidelines.
