# Well System Evaluation

**123 Any St., Townsville**

Prepared by: Stefan Gruescu P.Eng., RHI,  
BCIN 45402 (House 2012, Onsite Sewage Systems)  
On behalf of: Carson Dunlop & Associates Limited

March 15, 2018

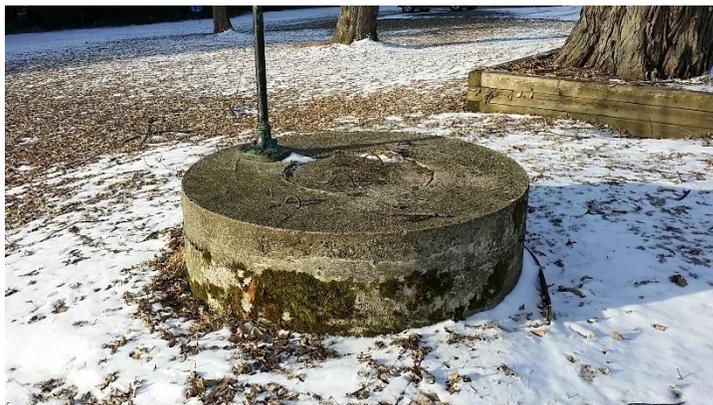
**Figure 1: Bored Well (Lid Installed)**

The well is located at the east side of the property north of the house and south of the barn.

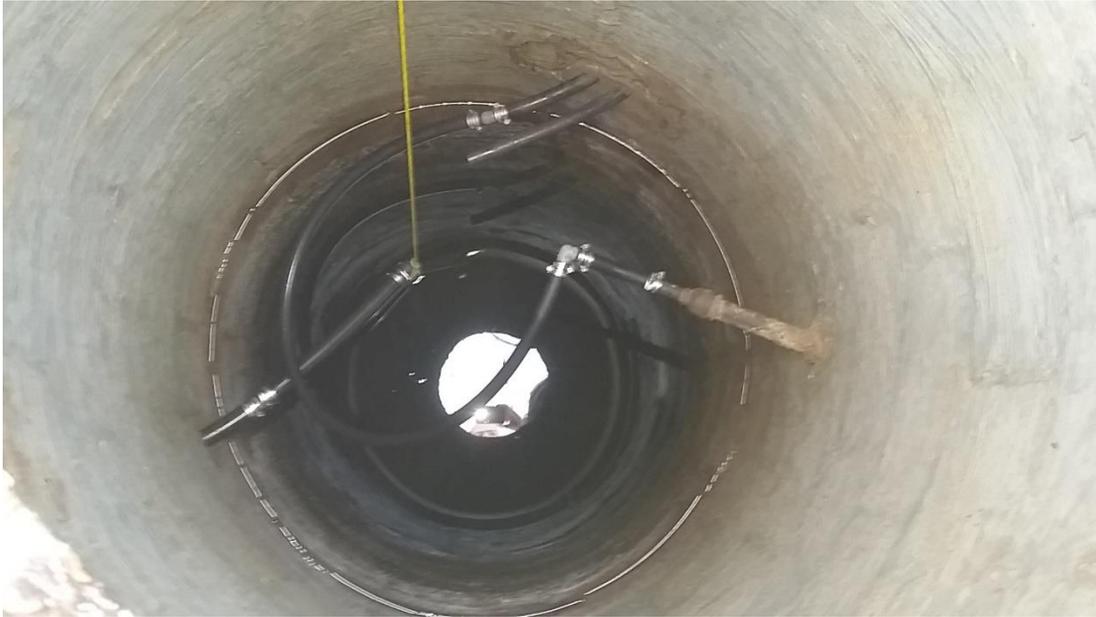
***Figure 2: Looking down the well (Note that any replacement of these components will be difficult)***

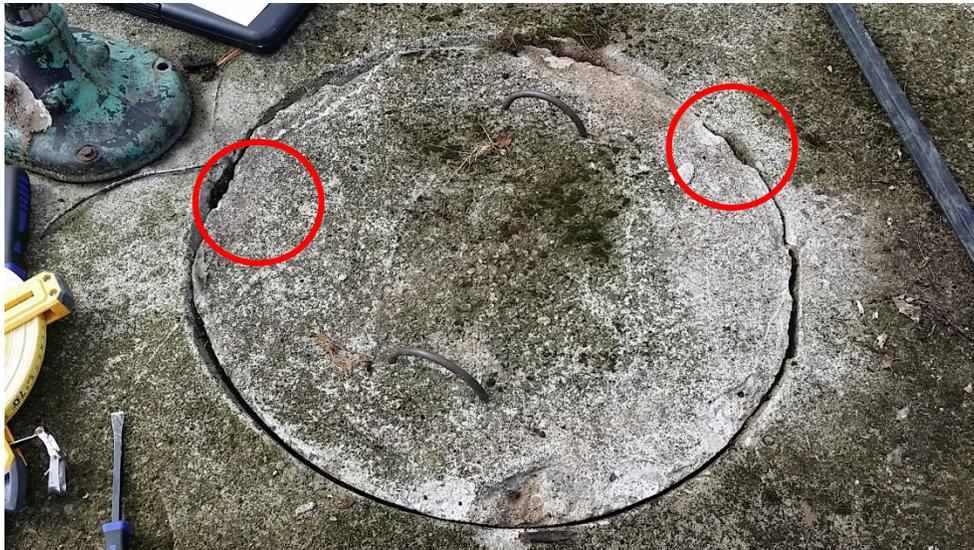
The concrete lid over the well should also be more water tight as it does not fit tightly allowing contamination to enter from the top.

Bored wells are vulnerable to surface contamination and running out of water. The lid of the well has been damaged and could lead to surface contamination. Upgrading to a modern drilled well is recommended. Drilled wells can deliver more water and cleaner water since the water is coming from a deeper ground level, often from an aquifer.

***Figure 3: Well cover has been damaged***

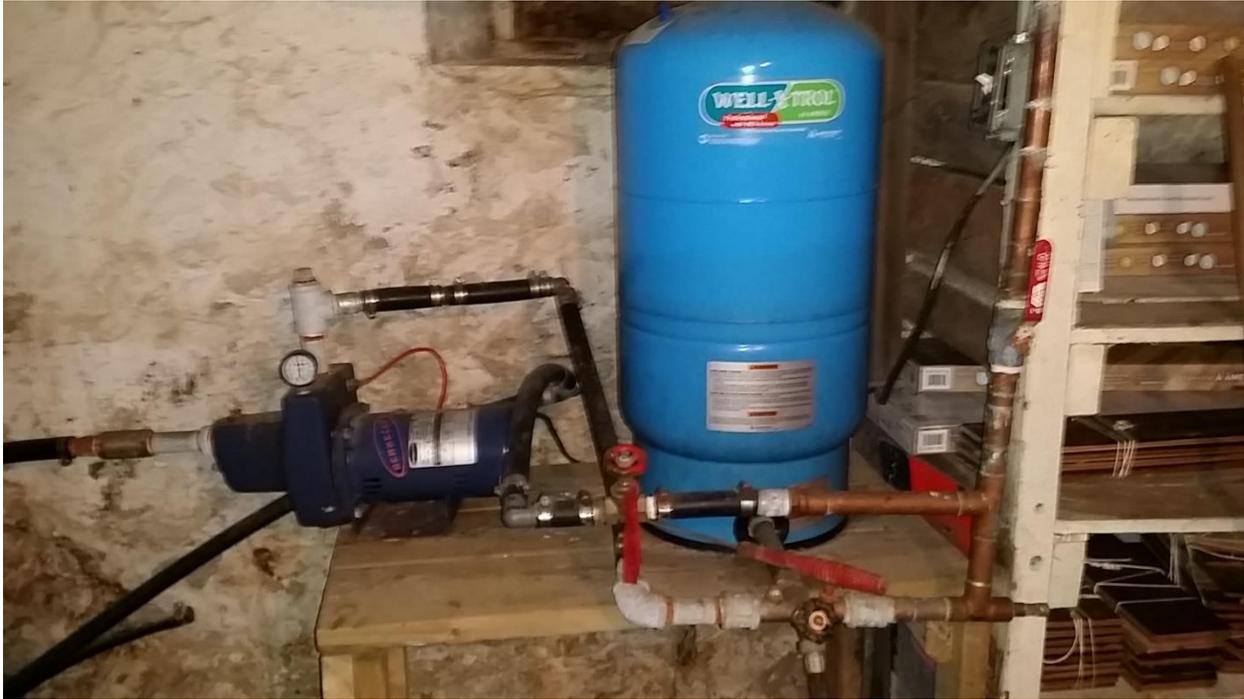
**Figure 4: Jet Pump (left), Pressure tank (blue tank), Pressure Gauge and Switch (behind pump)**

The cut-in pressure for the pump (well pump turns on) was 35 psi and the cut-out pressure (well pump turns off) was 50 psi. Both values are acceptable for a well pump system.

A larger pressure tank is recommended in the basement. A larger tank will prevent the jet pump from short cycling (turning on and off too quickly).

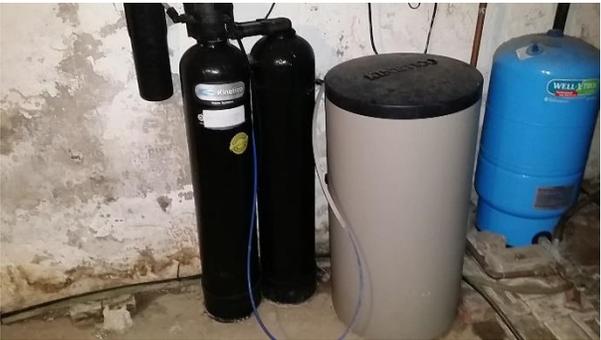
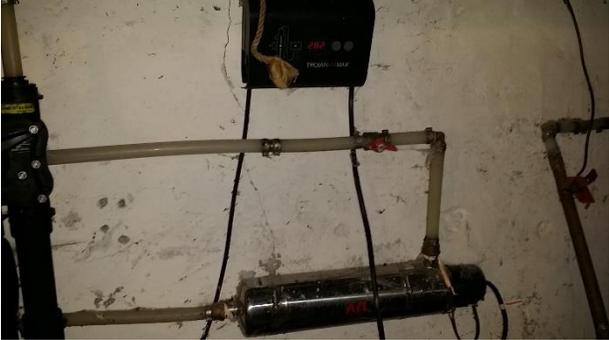
**Figure 5: Water Softener (Left) and UV Light System (Right)**

A Watersafe Test Kit from Silver Lake Research Laboratories was also used to test water chemistry. This test was conducted after the water treatment equipment. This test also showed NEGATIVE for bacteria which shows that the UV light system is effective in killing bacteria. The test for total nitrite/nitrate was slightly high and the pH was high (alkaline). In addition, other parameters were tested as shown in the figures below.

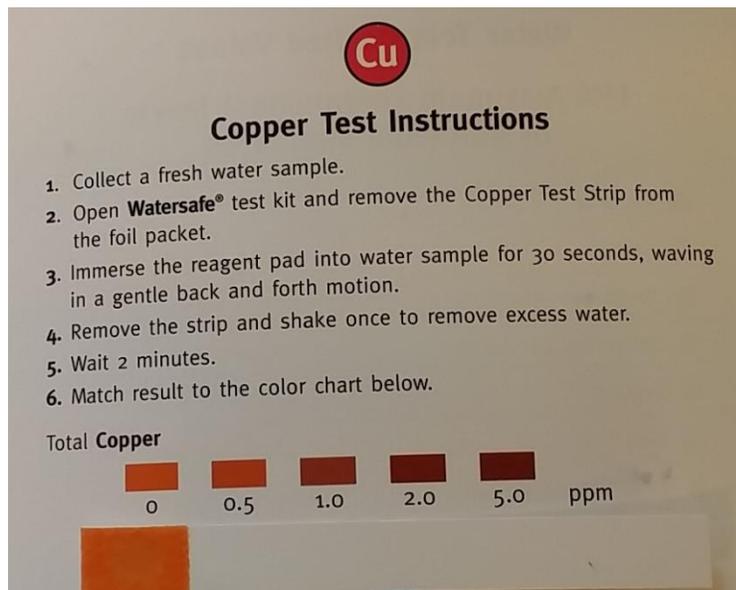
**Figure 6: Watersafe Copper Test showing 0 ppm**

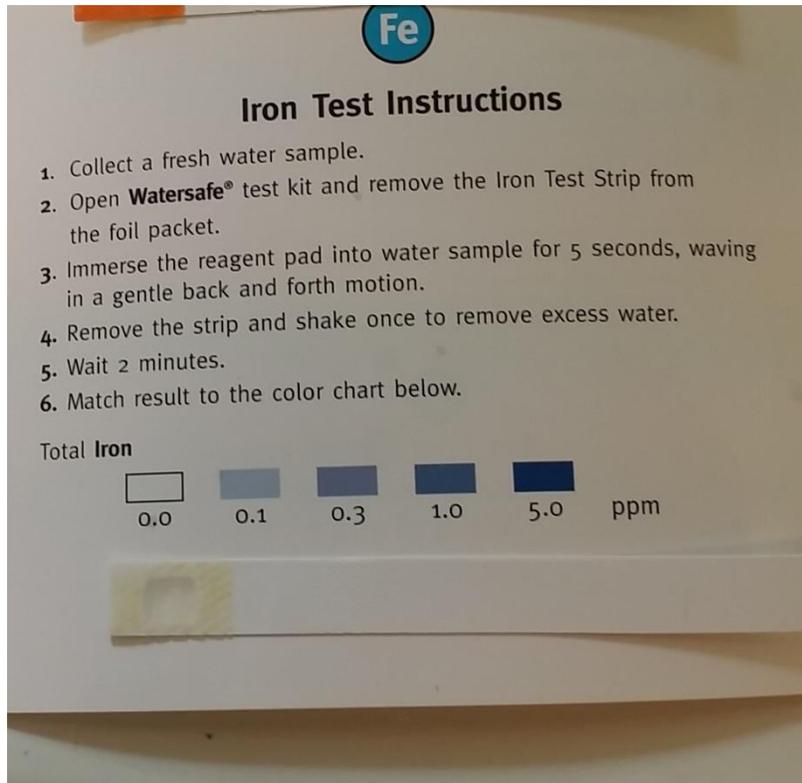
**Figure 7: Watersafe test for Iron showing 0 ppm**

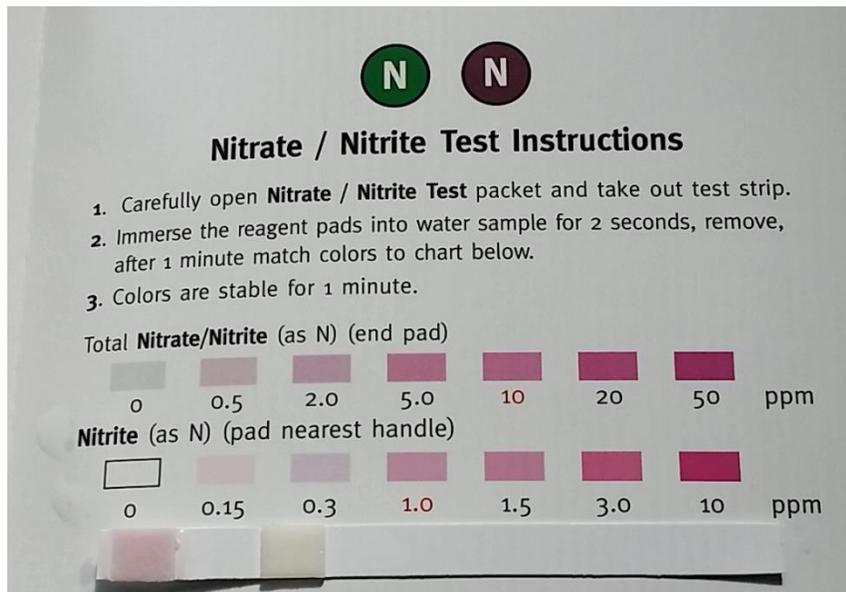
**Figure 8: Watersafe for Nitrate/Nitrite Test showing elevated Total Nitrate/Nitrite**

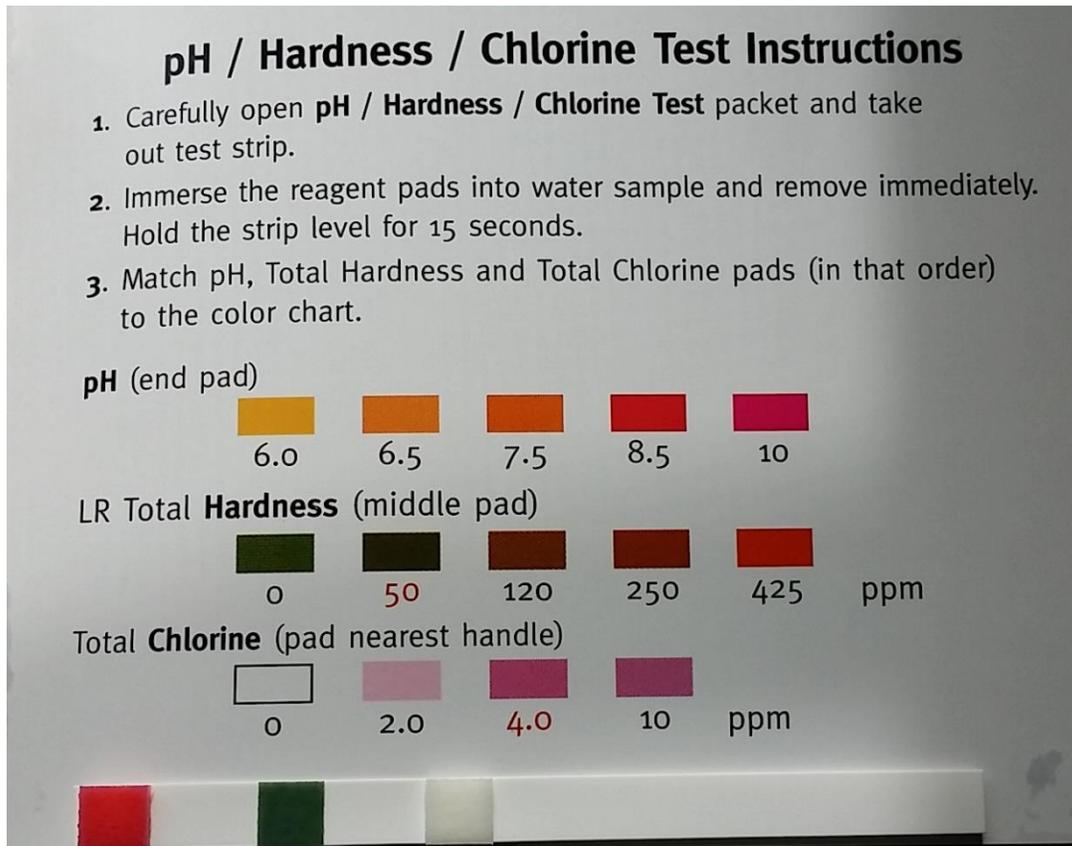
**Figure 9: Watersafe test showing pH of approximately 9, Total hardness of 0, and 0 ppm of chlorine (High pH should be investigated further)**
