YOUR Inspection Report

443 Madison St.
Chicago, IL

Monday, January 16, 2017

RE: Report No. 1366, v.39
443 Madison St.
Chicago, IL

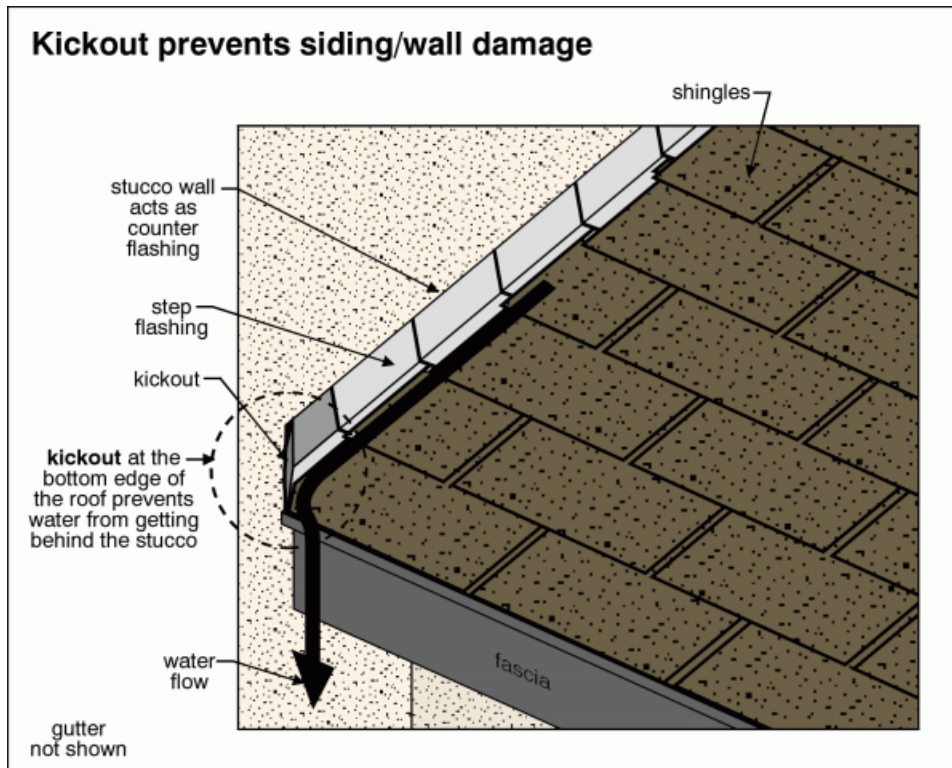
2. **Condition:** • [No kickout flashing](#)

Implication(s): Chance of water damage to contents, finishes and/or structure

Task: Improve

Time: Less than 1 year
