Inspection Report

4048 Robson St., Calgary IN
55555

Monday, September 30, 2023

Jacques Laplante

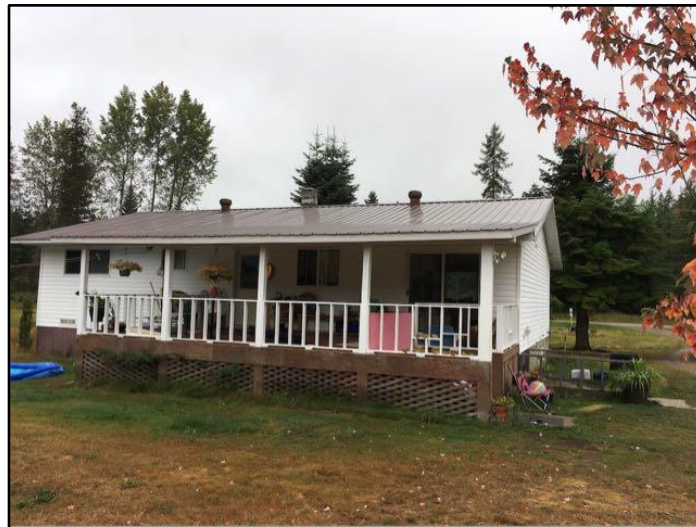
Roofs may leak at any time. Leaks often appear at roof penetrations, flashings, changes in direction or changes in material. A roof leak should be addressed promptly to avoid damage to the structure, interior finishes and furnishings. A roof leak does not necessarily mean the roof has to be replaced. We recommend an annual inspection and tune-up to minimize the risk of leakage and to maximize the life of roofs.

1. Roofs may leak at any time. Leaks often...

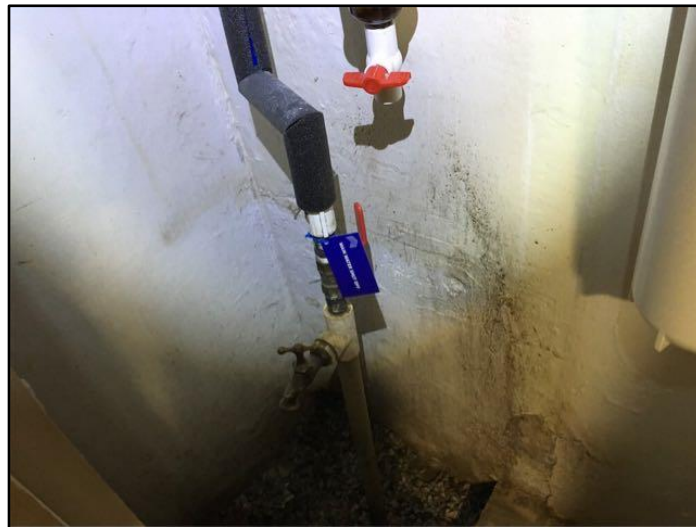
32. Front of the basement

MAIN WATER SHUT OFF VALVE AT THE

Front of the basement
