by Carson Dunlop

The Story of Kitec® Plumbing

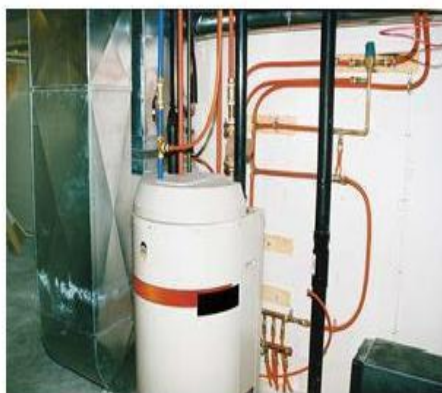
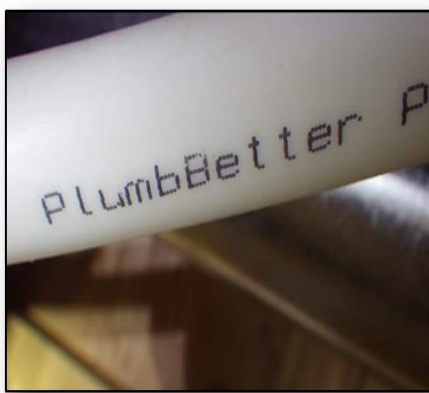
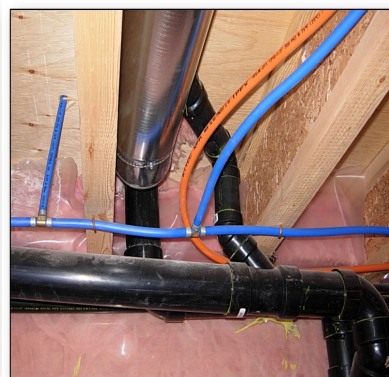
Images of Kitec® plumbing from www.kitecsettlement.com

- It's usually blue on cold water piping and red or orange on hot water piping. It may also be black, white or grey. Heating system piping is most often orange.
- Piping named in the lawsuit includes the following brand names: Kitec, Plumbetter, IPEX AQUA, WarmRite, Kitec XPA, AmbioComfort, XPA, KERR Controls or Plomberie Améliorée.
- Fittings may also say Kitec or KT.
