Your Inspection Report

2027 St. John Street
Oshawa, ON L1J 8C1

INSPECTION DATE:
Tuesday, August 27th, 2019

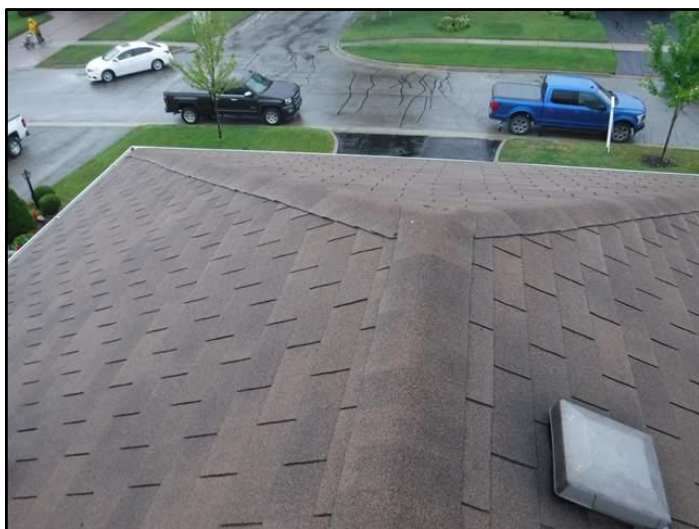
Asphalt shingles

Notes: The south (front) facing portion of the roof is older than the north (rear) facing portion. The south facing is showing signs of granular loss, cupping and damage. Maintenance and annual check-up will be required but plan on replacing within 3 years.

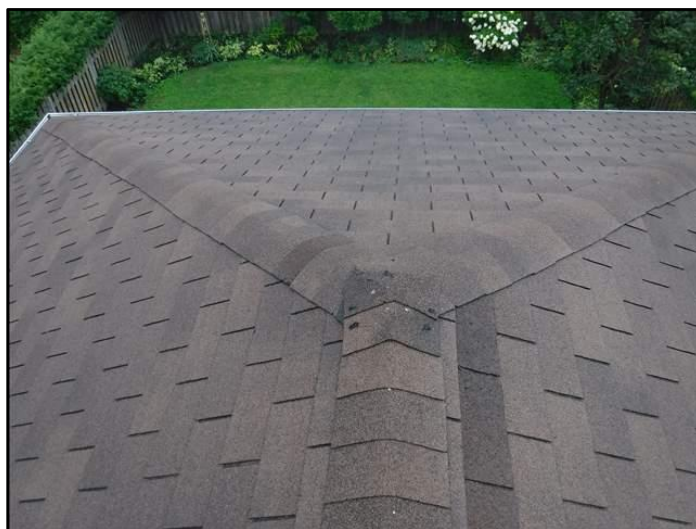
Asphalt shingles

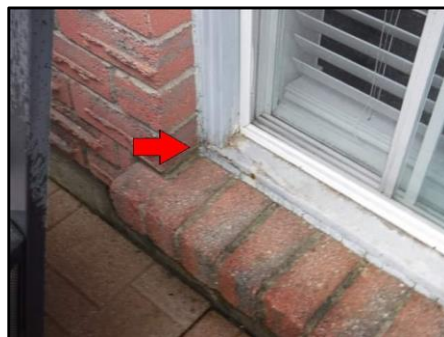
Paint and Caulking - deteriorated / missing

Implications: Increased heating and cooling costs | Reduced comfort**Location:** Rear Basement**Task:** Inspect annually**Time:** Regular maintenance

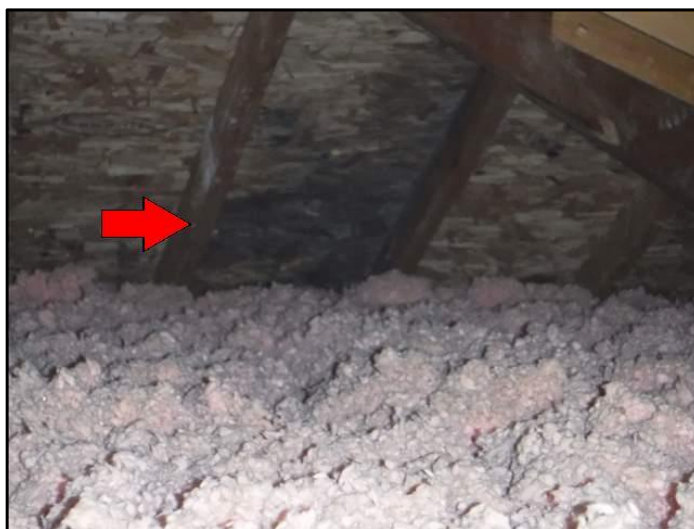
Location: Northeast Attic

See Insulation section for more information.

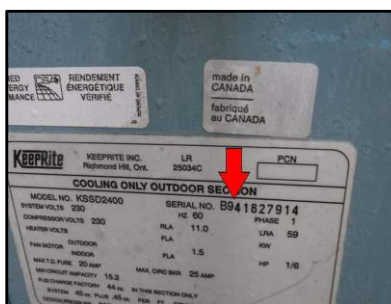
Notes: Although the system is near or at the end of its life expectancy, continue to use and maintain the unit until it fails.

25 years ('94)

Task: Replace

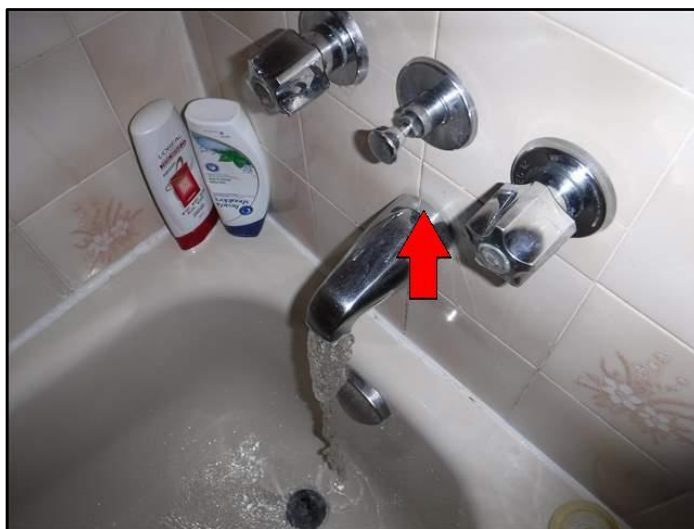
Caulking and grout should be checked every six months and improved as necessary to prevent leakage and damage behind wall surfaces.

Example - add sealant.

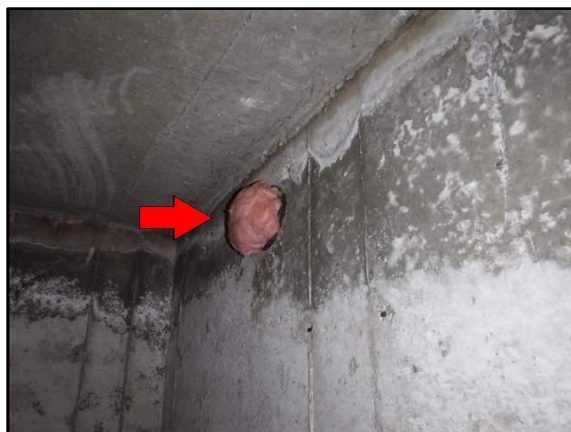
Location: Cold Room

Open vent - remove blockage.

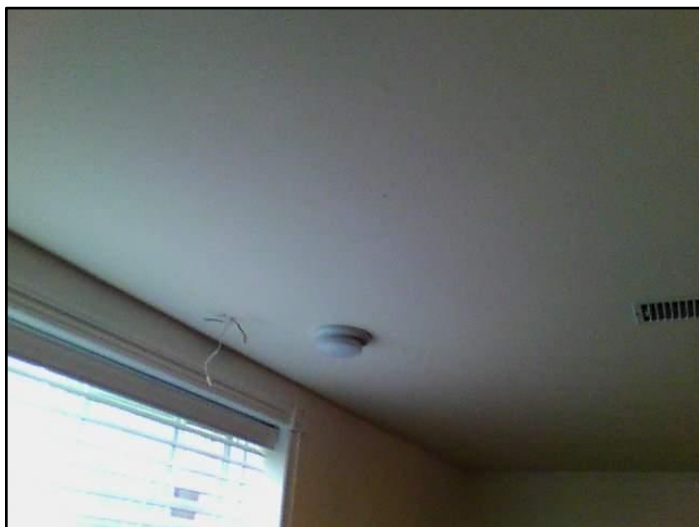
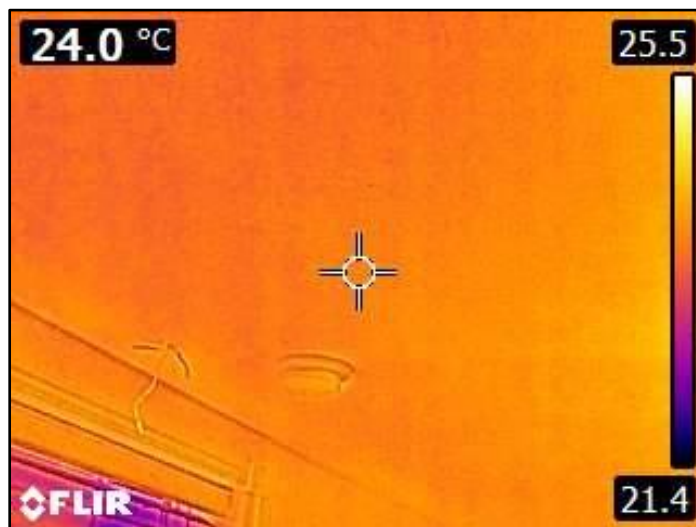
Location: Under First Floor Kitchen

Typical image

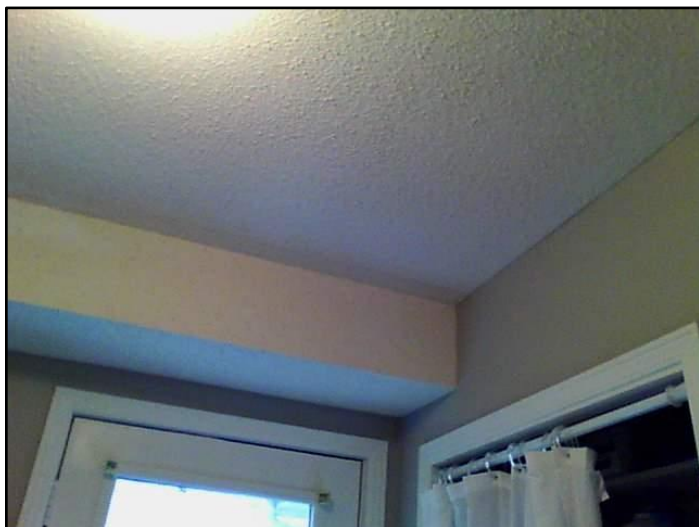
Location: Above Rear Kitchen - North

Ceilings below roofing\No anomalies noted

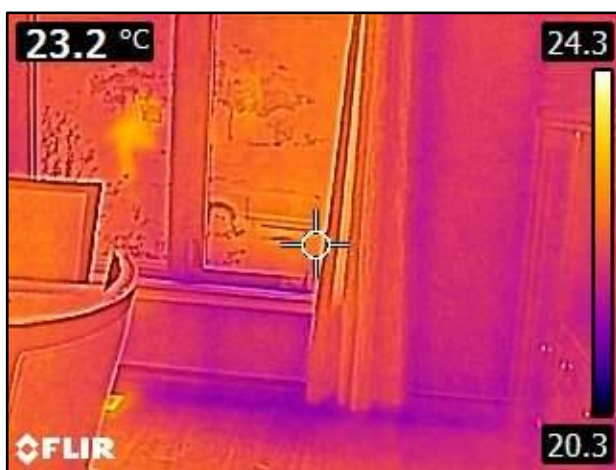
Windows\No anomalies noted

Notes: Typical image - (sample of front)**Location:** Throughout
