Your Inspection Report

100 Edenbridge Dr
Toronto, ON

INSPECTION DATE:
Thursday, May 10, 2018

RE: Report No. 62269
100 Edenbridge Dr
Toronto, ON

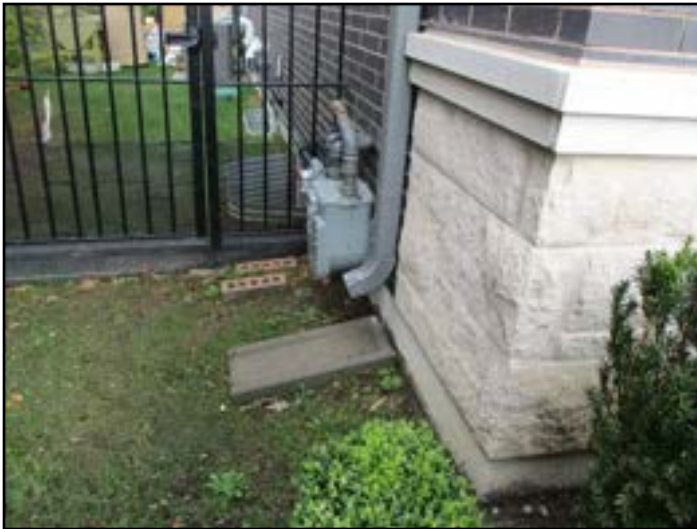
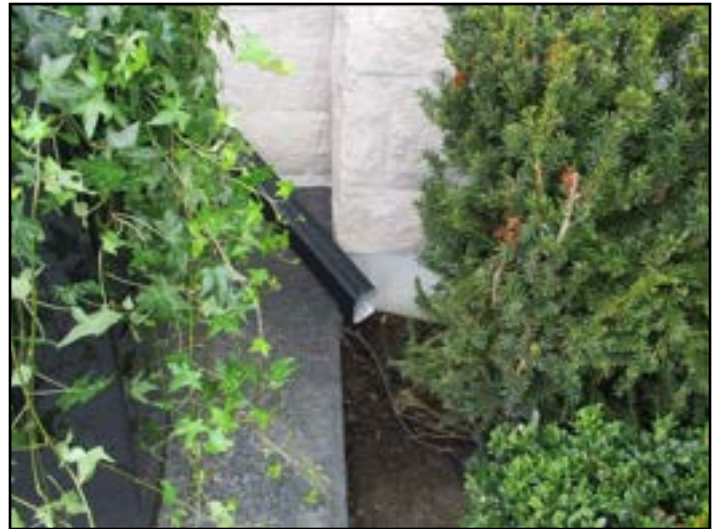
Example

Condition: • Paint and Caulking - deteriorated / missing

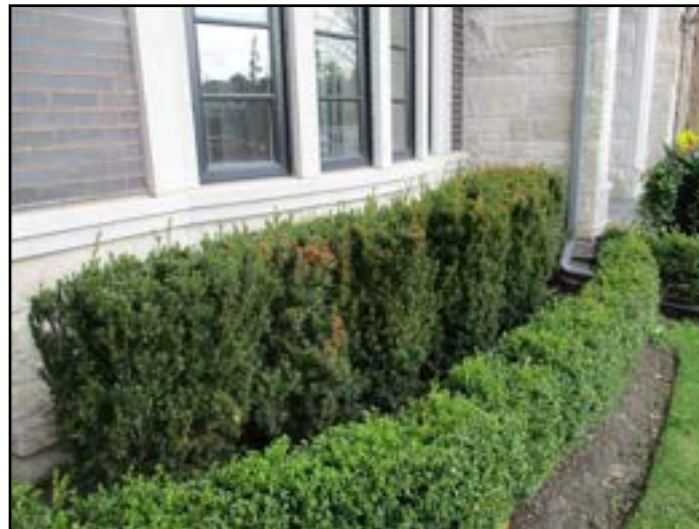
Example - example at the front

Condition: • [Planters and gardens against walls](#)

Gardens and planters (and sprinklers) next to the house increase the risk of moisture problems in the basement, especially if they are watered regularly. Watch gardens next to house

Implication(s): Chance of structural movement | Chance of damage to structure | Chance of water entering building

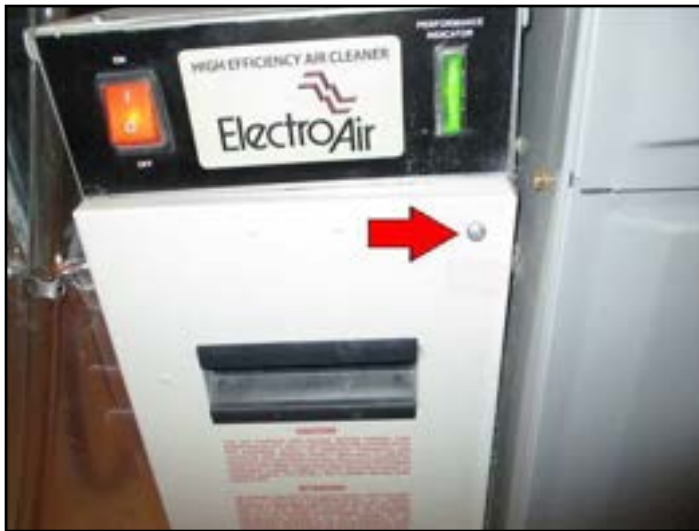
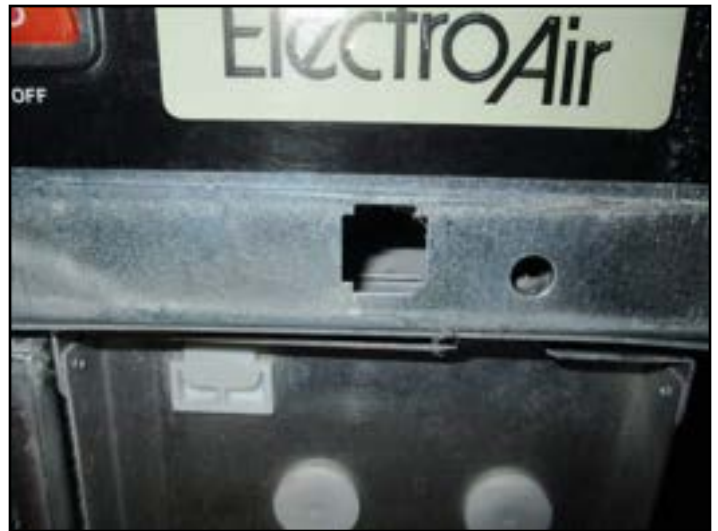
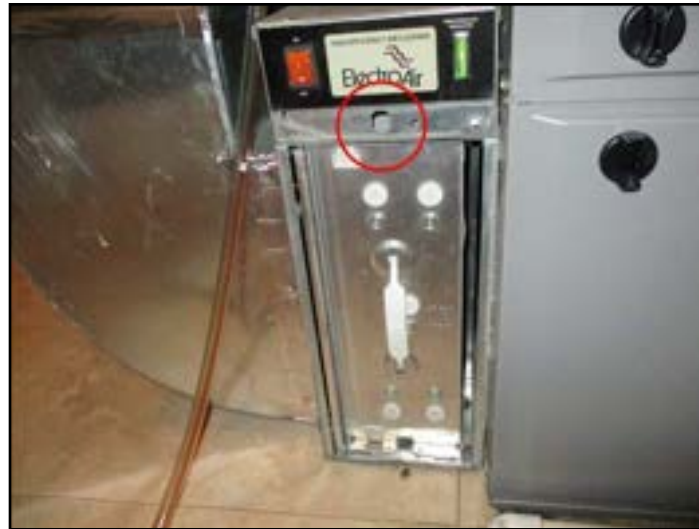
Condition: • Damaged

Task: Improve / Replace

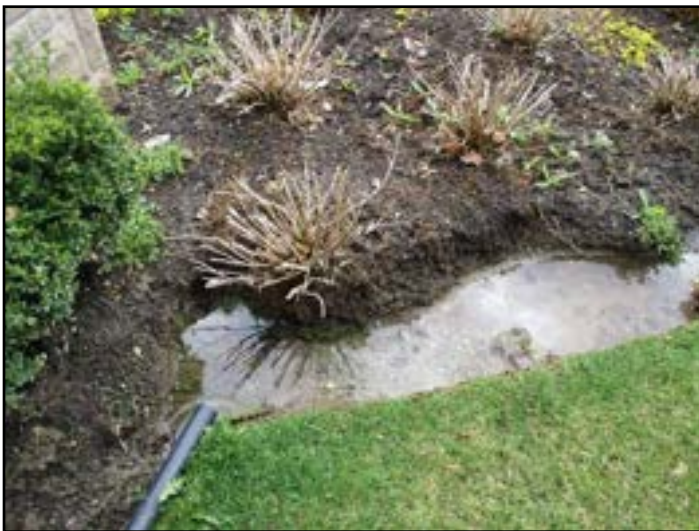
Discharge pipe problems

Task: Improve

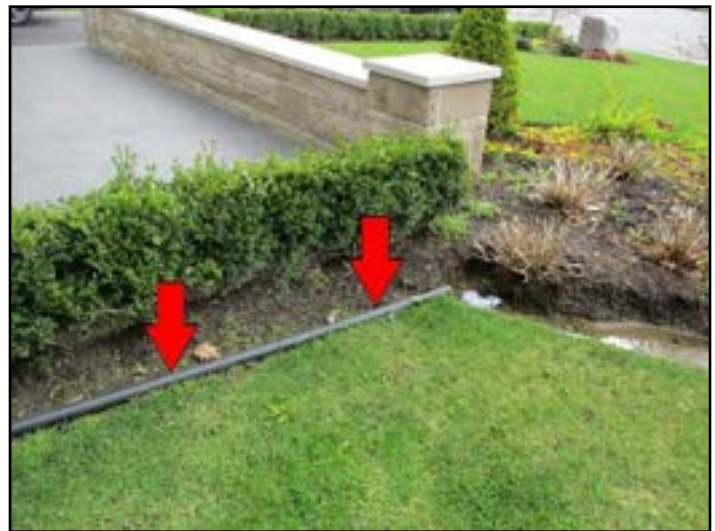
Discharge pipe problems

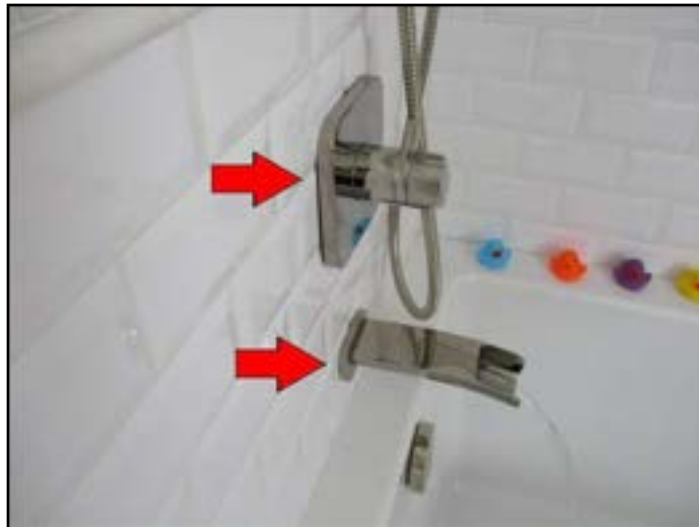
Example - 2nd floor rear bathroom.

Condition: • [Caulking loose, missing or deteriorated](#)

Implication(s): Chance of water damage to contents, finishes and/or structure

Task: Inspect annually

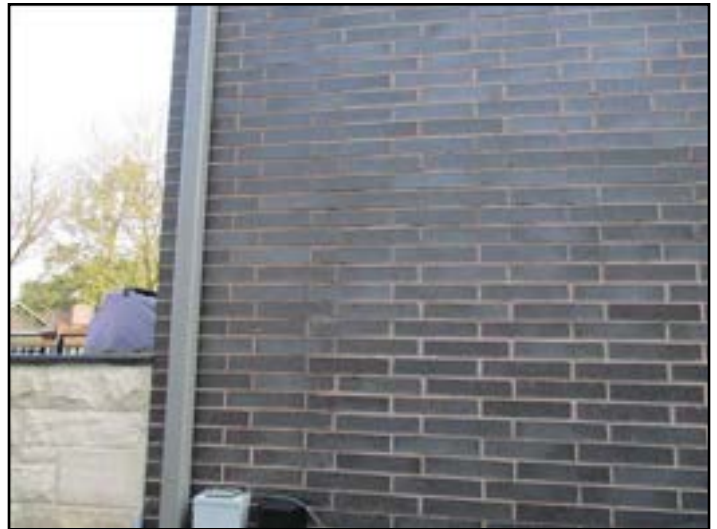
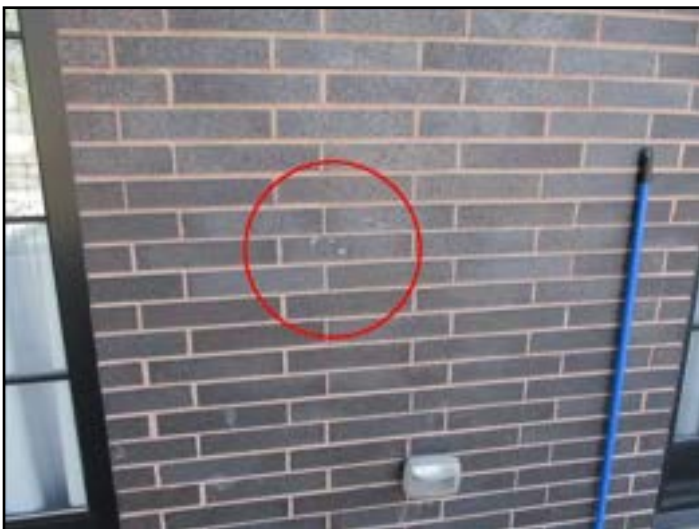
Condition: [4.16 Mortar splatters and stains on exterior masonry](#)

Example - northwest corner

Example - rear of home

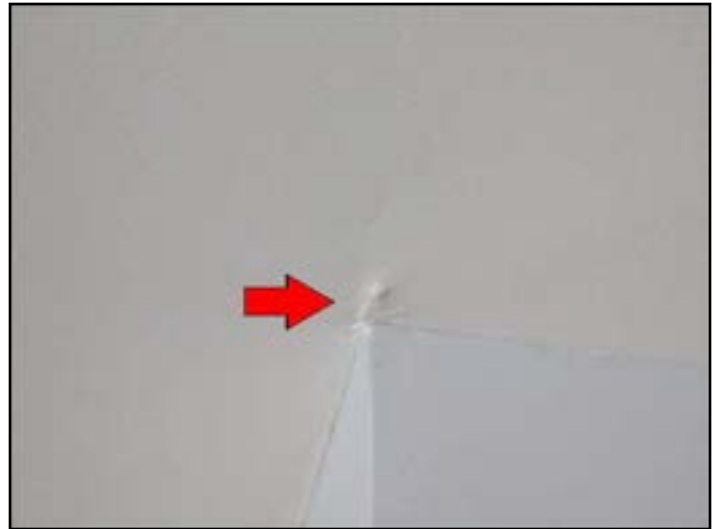
Example

Condition: • [9.8 Finished surface is rough](#)

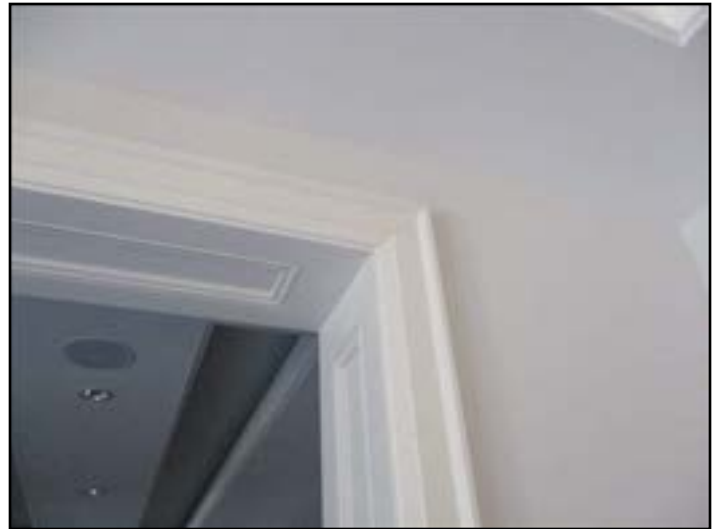
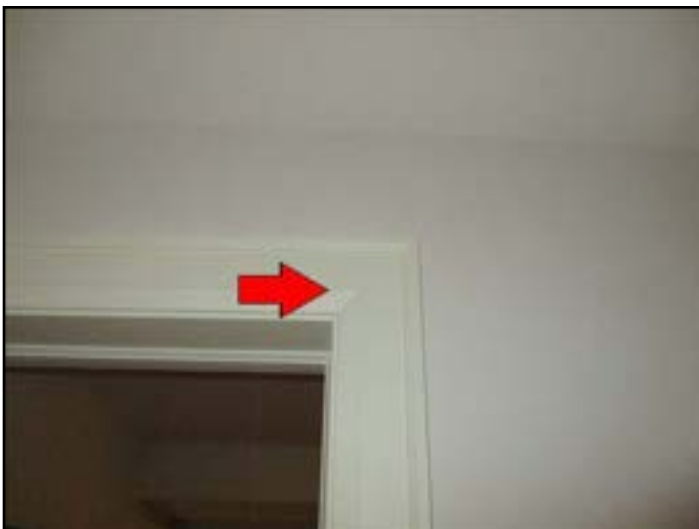
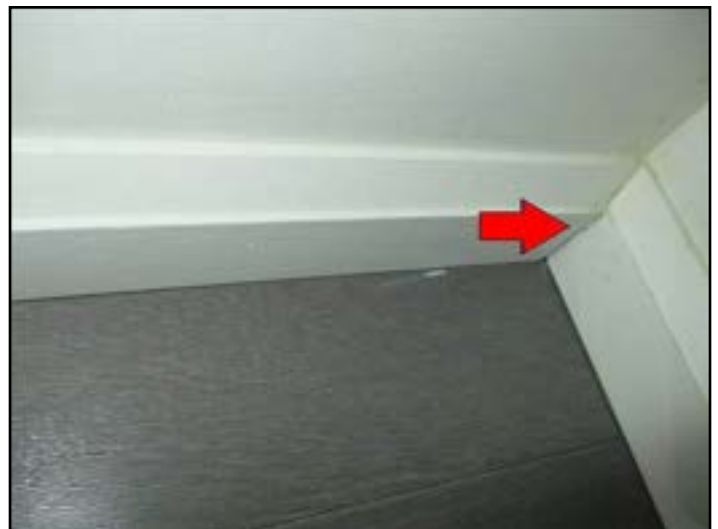
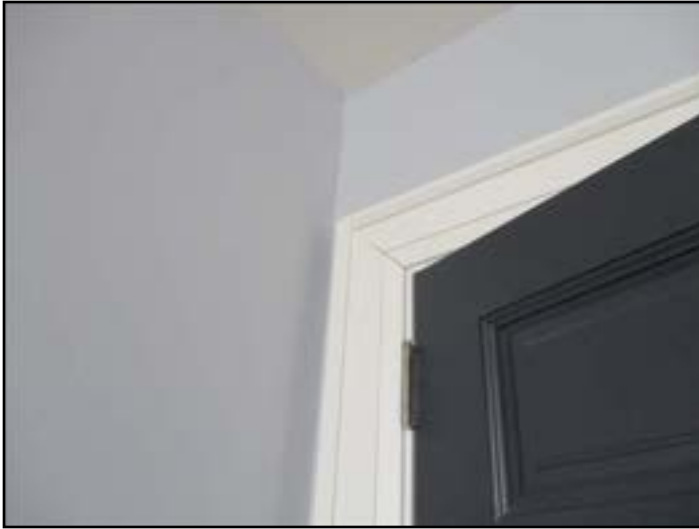
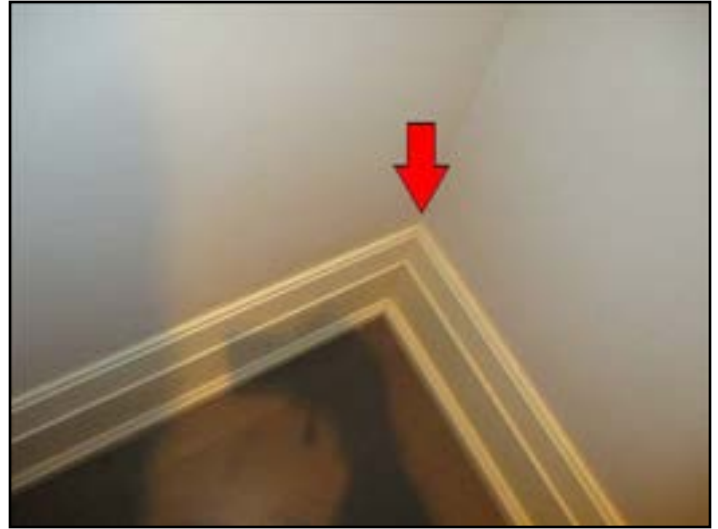
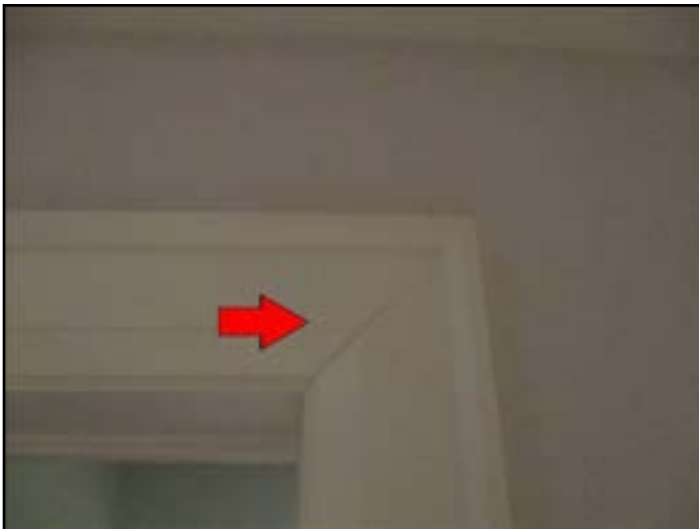
Condition: • [10.15 Joint quality of interior trim and moulding work](#)

Example - several doors through the home (2)

Example - several doors through the home

Example - northwest basement

Example - several doors through the home (3)

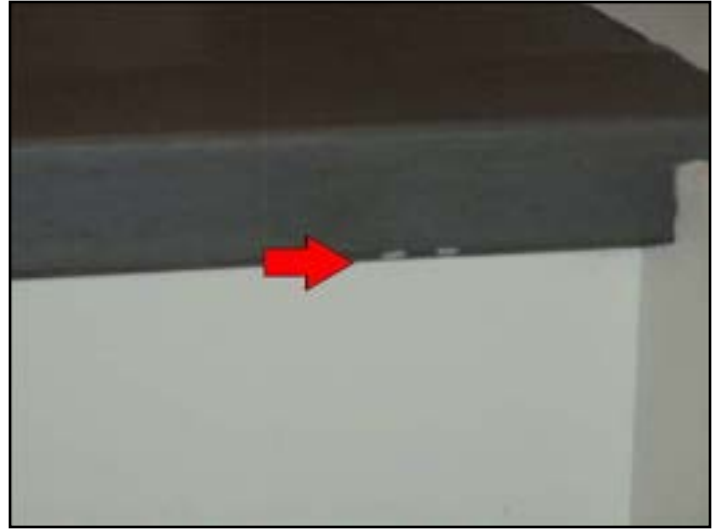
Condition: • 10.0 Missing, Incomplete or Damaged Items [TARION CPG page 15 of 297]

Paint on flooring

Example - front basement

Example - stairs from basement

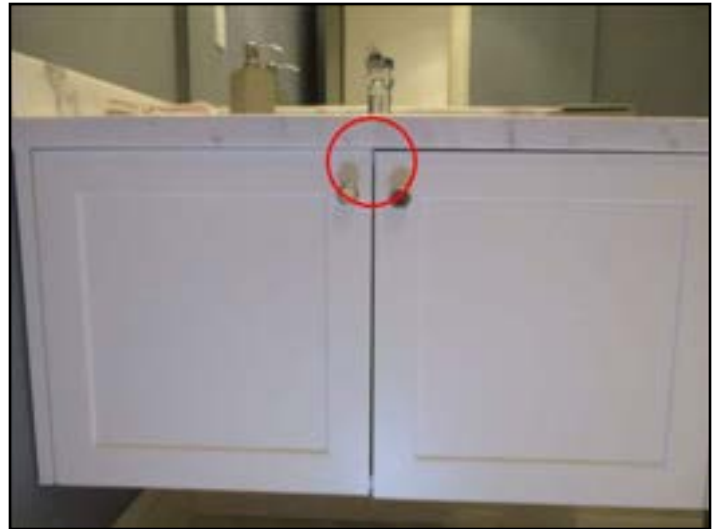
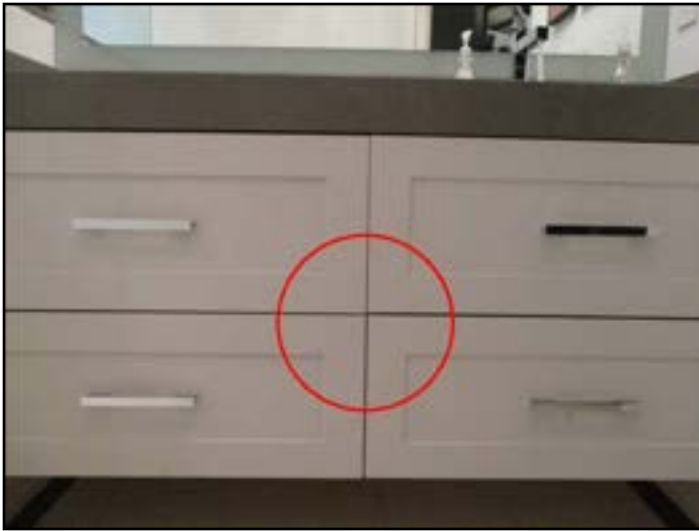
Condition: • [11.2 Cabinets do not line up with each other](#)

Basement bathroom - rear

Basement bathroom - west side

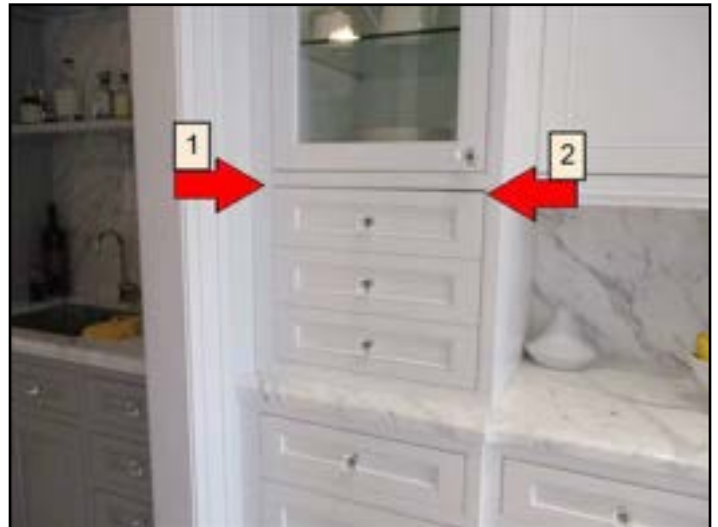
Example

Condition: • [11.2 Cabinets do not line up with each other](#)

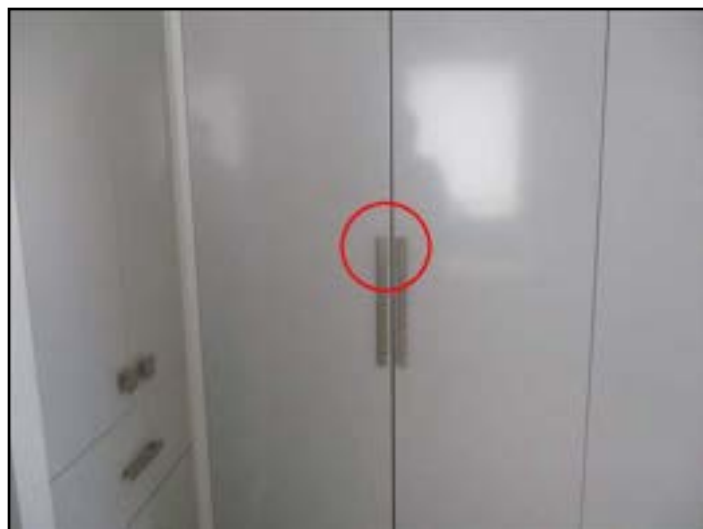
Condition: • [11.2 Cabinets do not line up with each other](#)

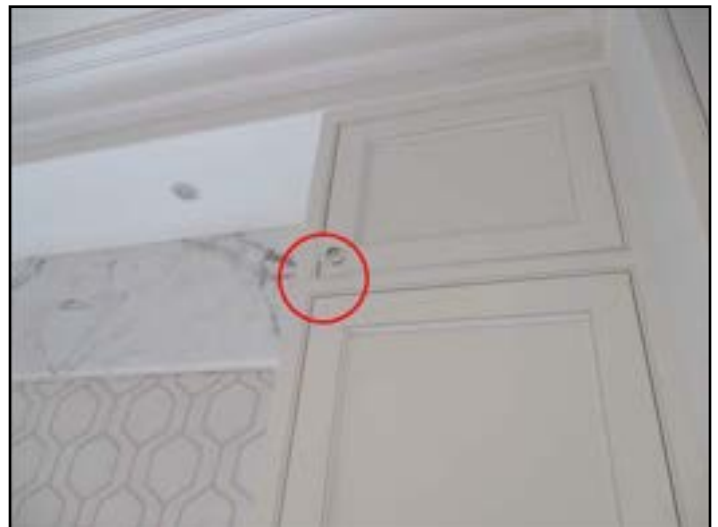
11.3 Cabinet doors or drawer faces are warped

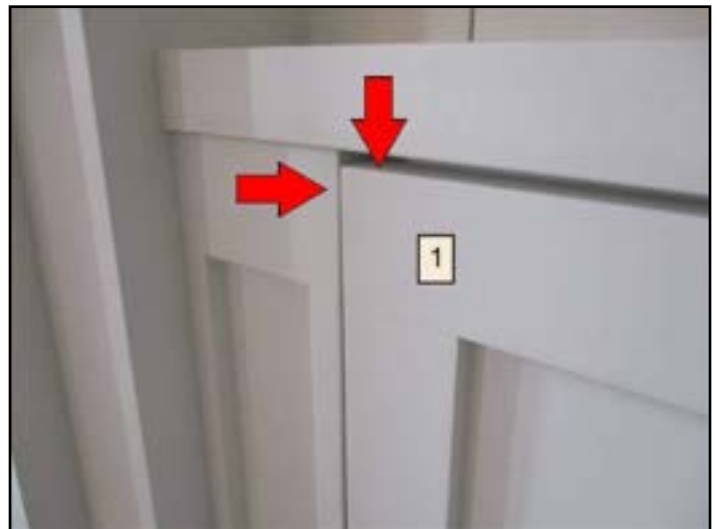
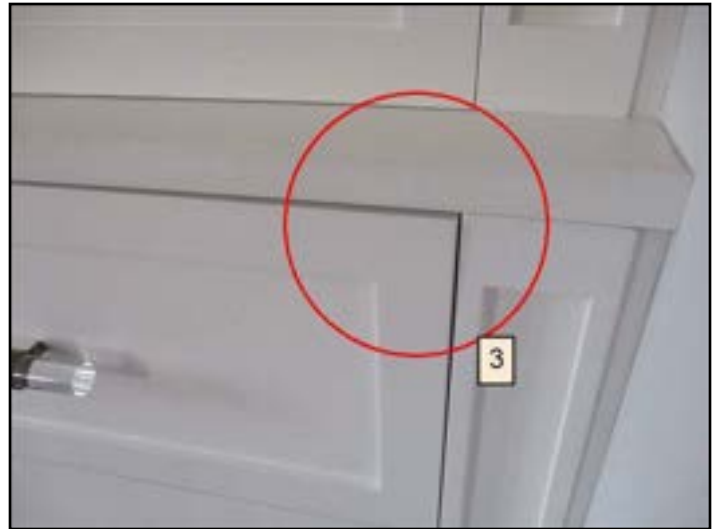
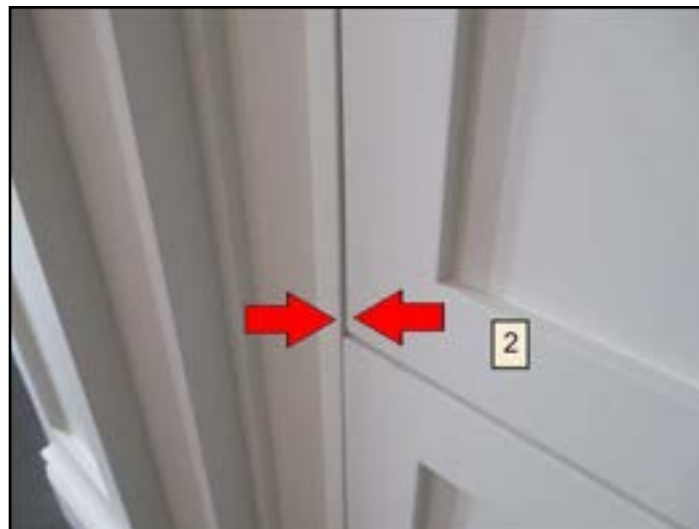
Condition: • [11.3 Cabinet doors or drawer faces are warped](#)
